SUPPLEMENTAL 2 – FIELD PHOTOGRAPHS

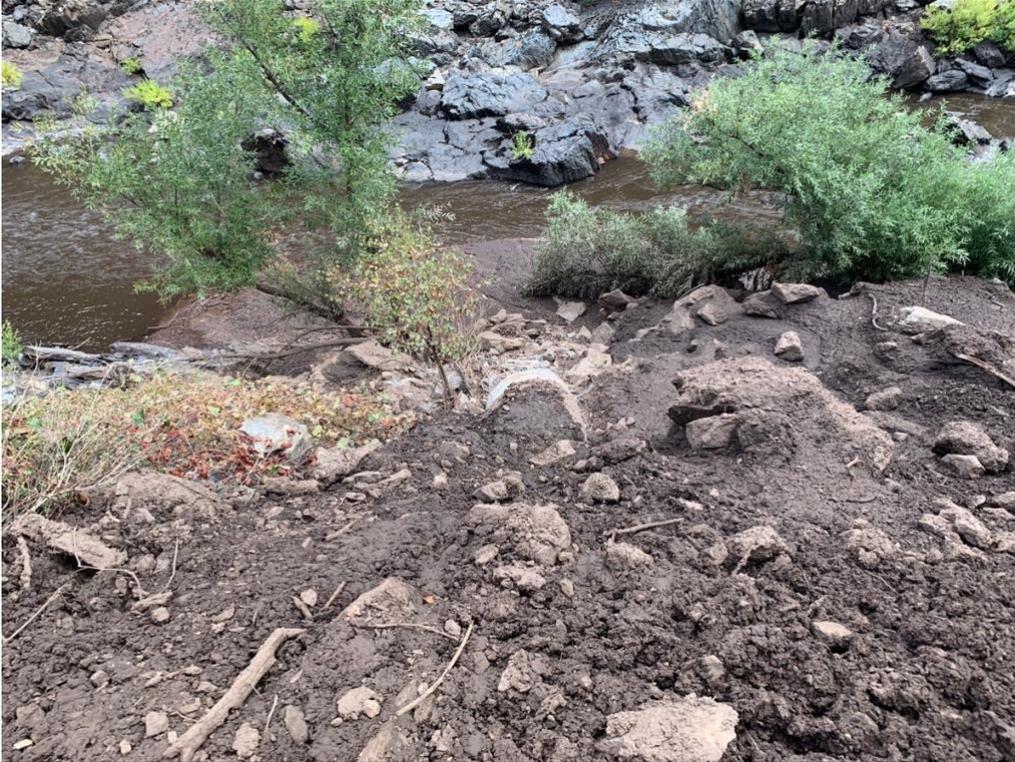
Photograph #1

Description: Debris fan in Merced River left by debris-flow from Ferguson Fire.

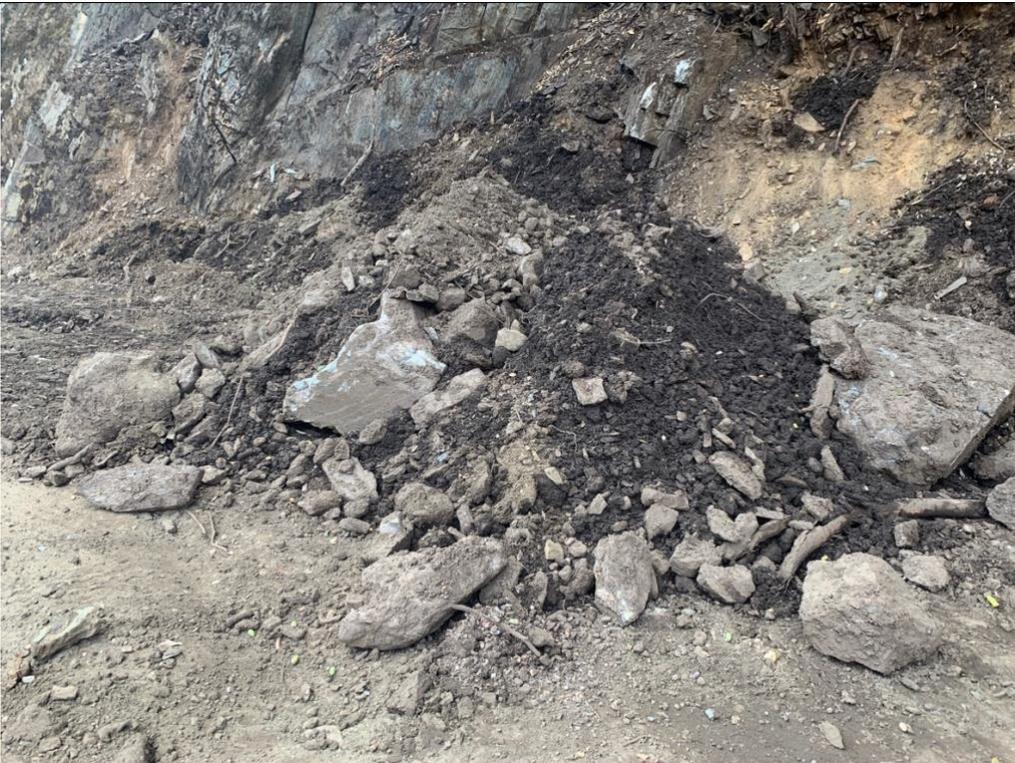
Photograph #2

Description: Disturbed debris flow material removed from CA-140 Roadway. Note extreme particle size distribution.

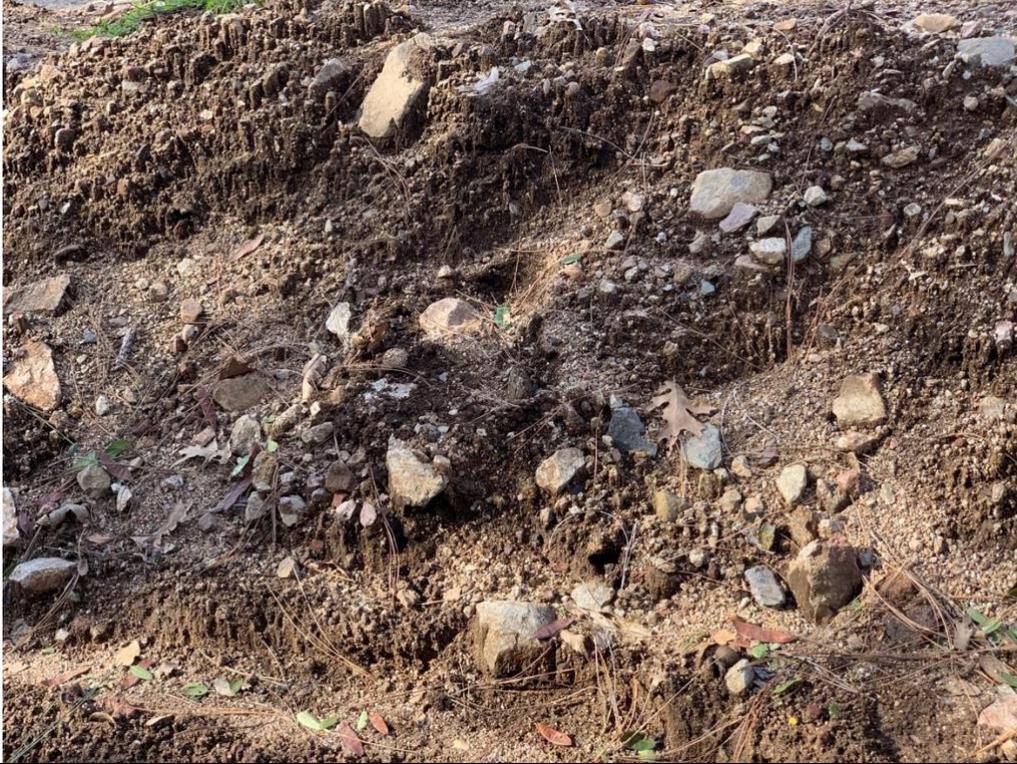
Photograph #3

Description: Ferguson Fire debris flow material which has been eroded through by subsequent runoff. Note lack of stratification, extreme particle size distribution, matrix-supported, and random clast orientation.

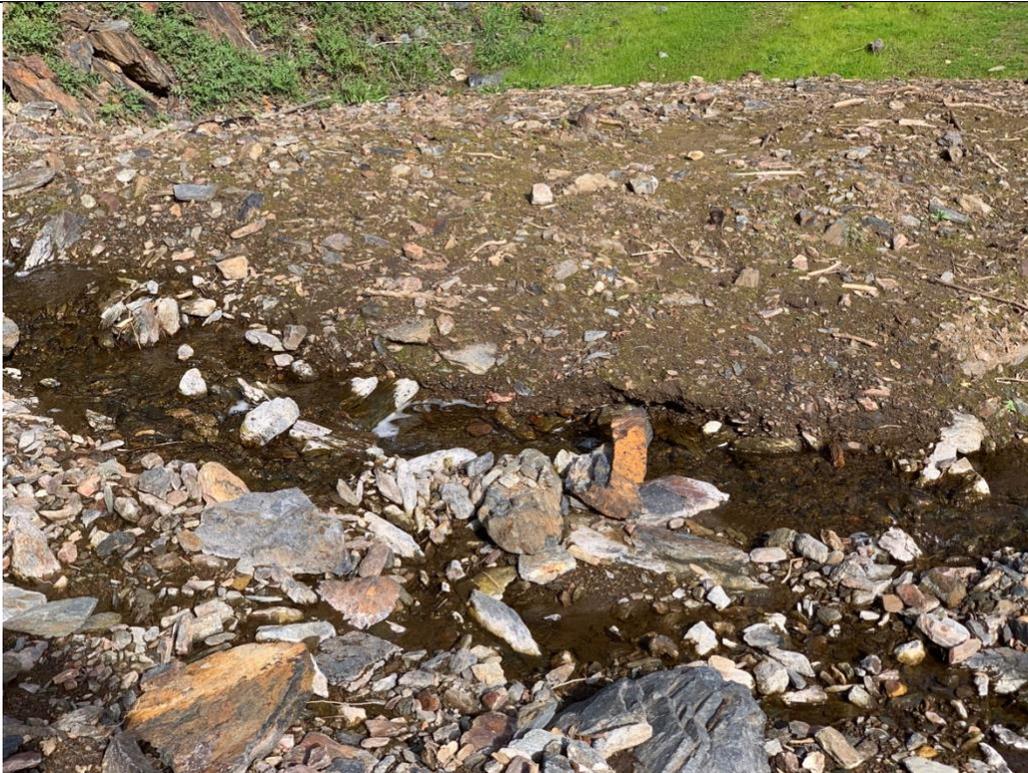
Photograph #4

Description: Ferguson Fire debris flow material which has been eroded through by subsequent runoff. Note lack of stratification, extreme particle size distribution, matrix-supported, random clast orientation, and boulder fields.

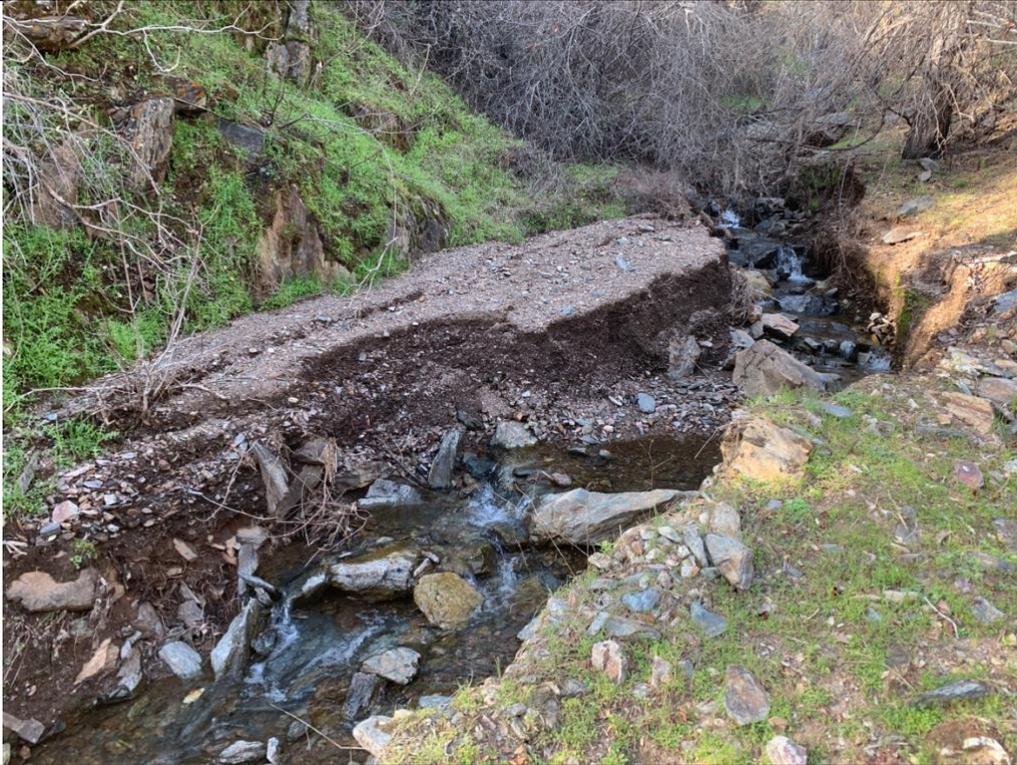
Photograph #5

Description: Ferguson Fire marginal levee and channel deposition of debris flow material has been eroded through by subsequent runoff. Note lack of stratification, extreme particle size distribution, poor sorting, and matrix-supported.

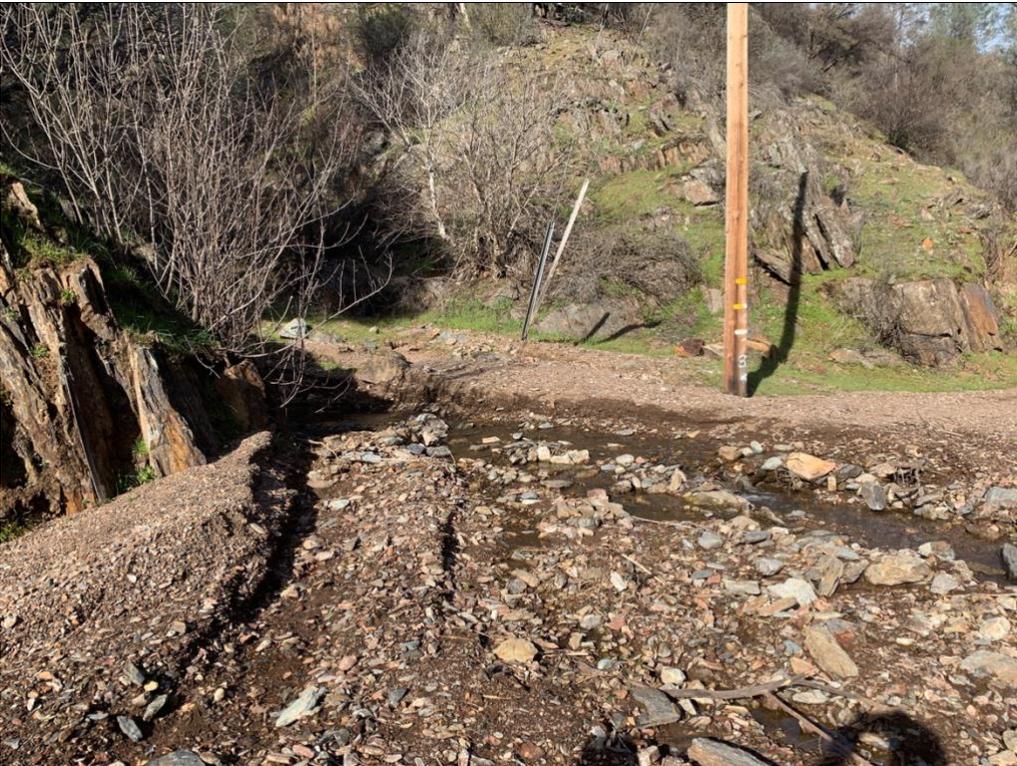
Photograph #6

Description: Ferguson Fire debris fan at the mouth of drainage has been eroded through by subsequent runoff. Note extreme particle size distribution and matrix-supported.

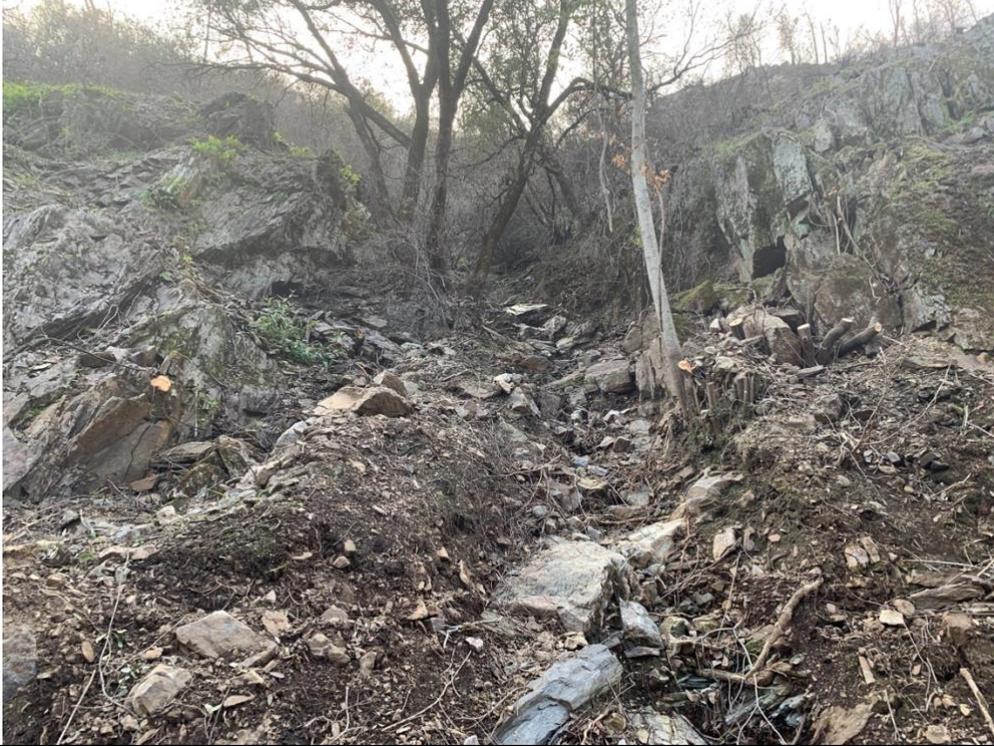
Photograph #7

Description: Ferguson Fire marginal levees along edges of a steep drainage. Note lack of stratification, extreme particle size distribution, matrix-supported, and random clast orientation.

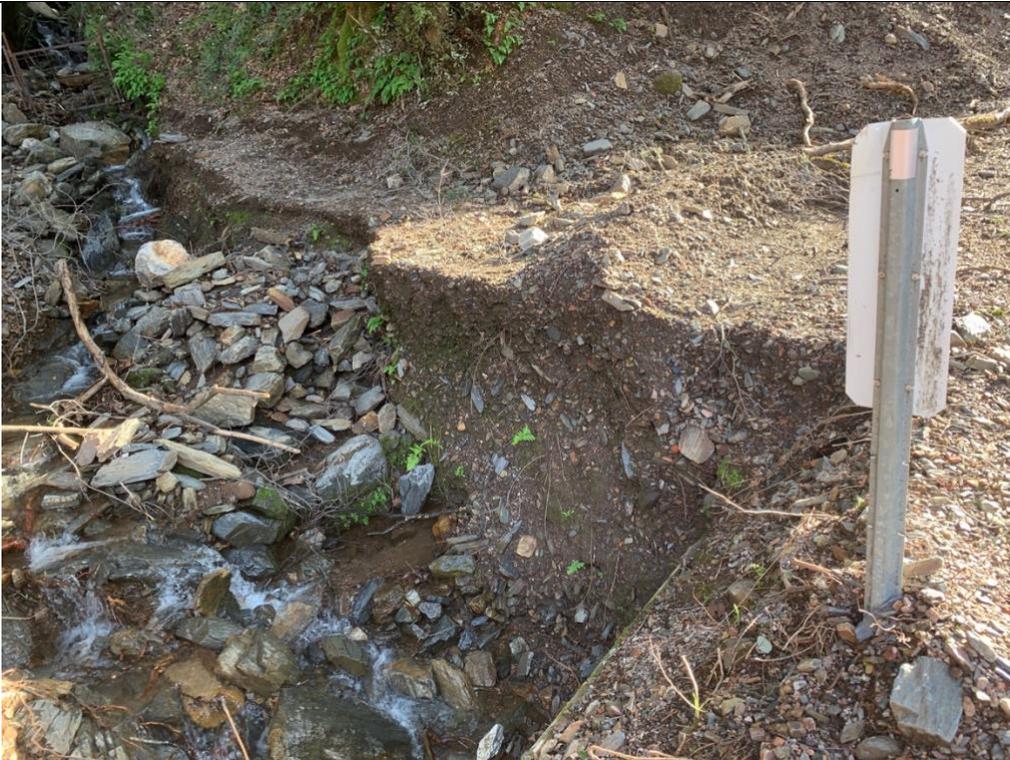
Photograph #8

Description: Briceburg Fire debris flow material which has been eroded through by subsequent runoff. Note lack of stratification, extreme particle size distribution, matrix-supported, and random clast orientation.

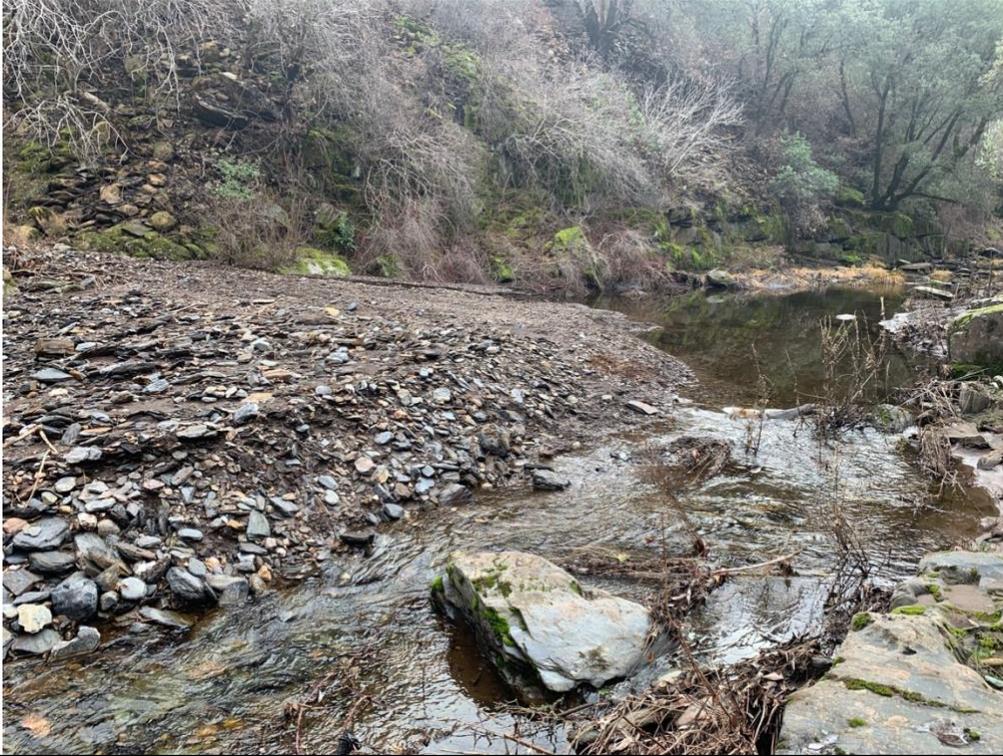
Photograph #9

Description: Briceburg Fire debris flow fan has flowed out of the mouth of drainage into Bear Creek and been subjected to subsequent erosion of fine-grained material. Note lack of stratification, extreme particle size distribution, matrix-supported, random clast orientation, and lobe-shaped terminus.

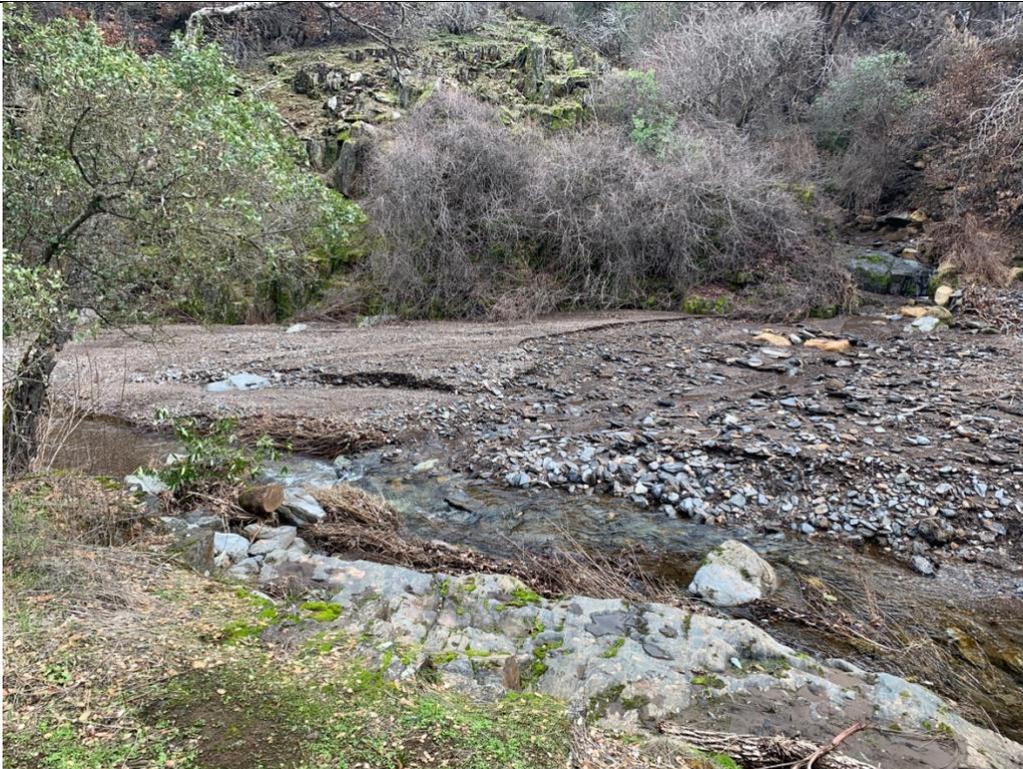
Photograph #10

Description: Briceburg Fire debris flow fan which has flowed out of the mouth of drainage into Bear Creek and been subjected to subsequent erosion of fine-grained material. Note lack of stratification, extreme particle size distribution, matrix-supported, random clast orientation, and lobe-shaped terminus.

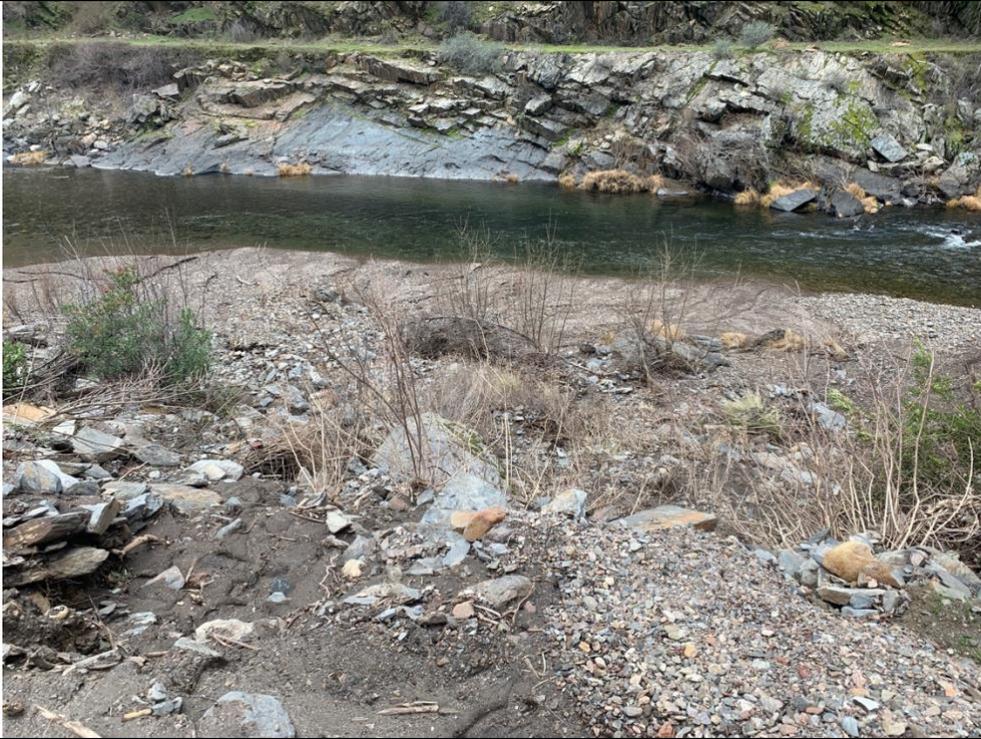
Photograph #11**Photo Date: 01/05/2020****Debris Flow Date: 12/07/2019**

Description: Briceburg Fire debris flow fan which has flowed out of the mouth of drainage, across CA-140 and into the Merced River and been subjected to subsequent erosion of fine-grained material. Note extreme particle size distribution and lobe-shaped terminus.

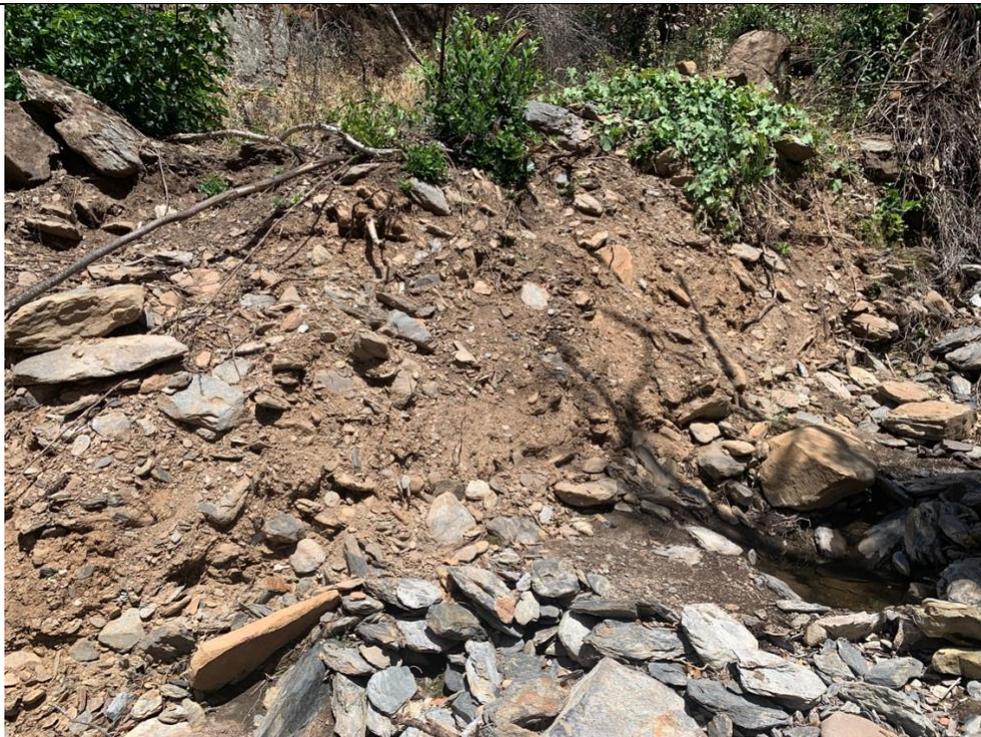
**Photograph #12****Photo Date: 06/10/2020****Debris Flow Date: 12/07/2019**

Description: Briceburg Fire debris flow material which has been eroded through by subsequent runoff. Note lack of stratification, extreme particle size distribution, matrix-supported, and random clast orientation.
