AEG/USSD Workshop  
December 6-8, 2021  
Ft. Lauderdale, Florida

# Emergency Repairs to Mosul Dam

## A High Risk Dam on a Karst Foundation

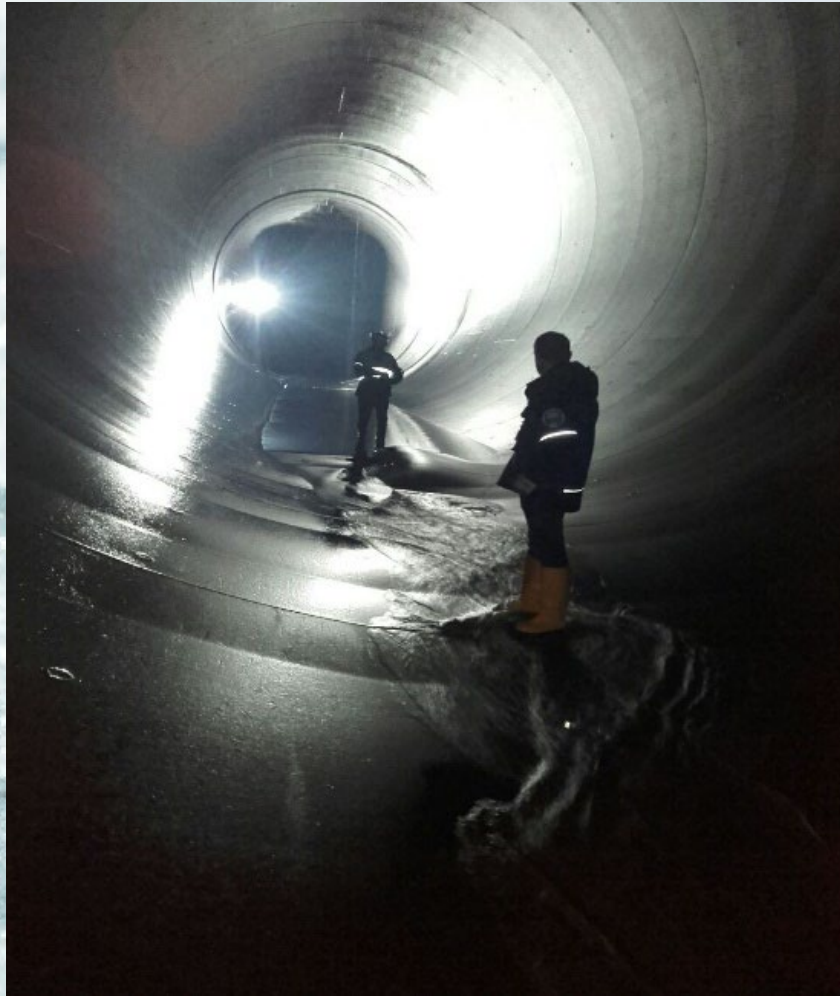
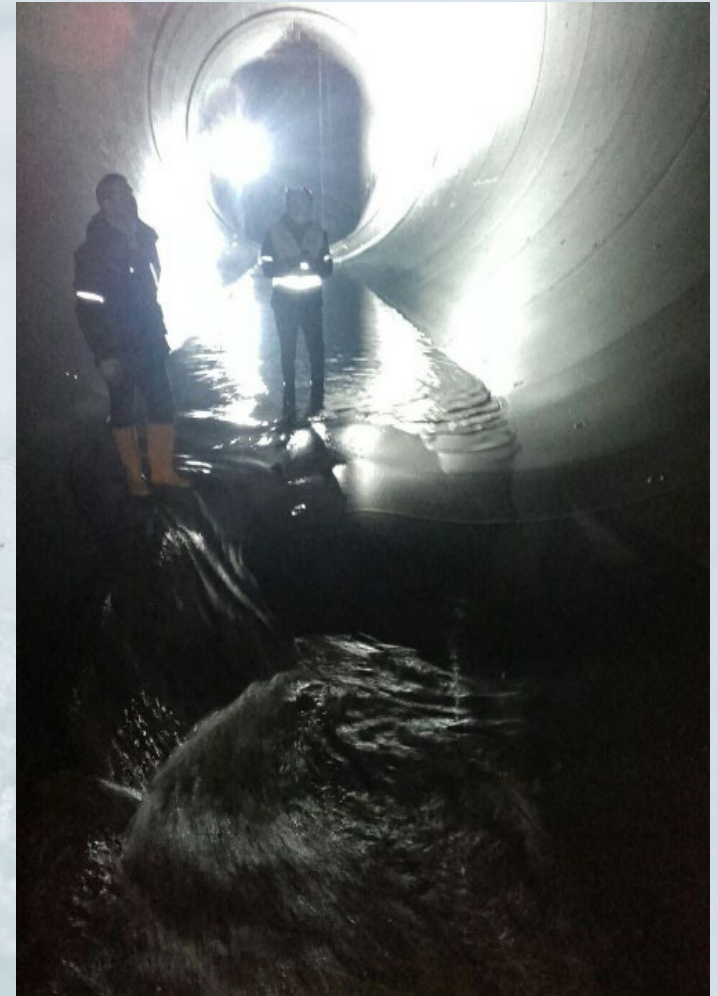
# Discovery – West B.O. Tunnel

- Last Inspected:  
March 31 2017
- 15 Nov 2017:  
Dewater West  
Bottom Outlet
- 17 Nov 2017:  
Discover  
Deformation in Steel  
Liner on East Side of  
Tunnel
- 28m downstream of  
Guard gate
  - Length=13m
  - Width= 3.9m
  - Height=1.1m

## Discovery - East B.O. Tunnel
