# RISK ASSESSMENT OF COUGAR DAM, MCKENZIE RIVER, OREGON

Kevin S. Richards, PhD  
Senior Advisor  
USACE Institute for Water  
Resources/Risk Management  
Center/East Division  
Date: 19 September 2019

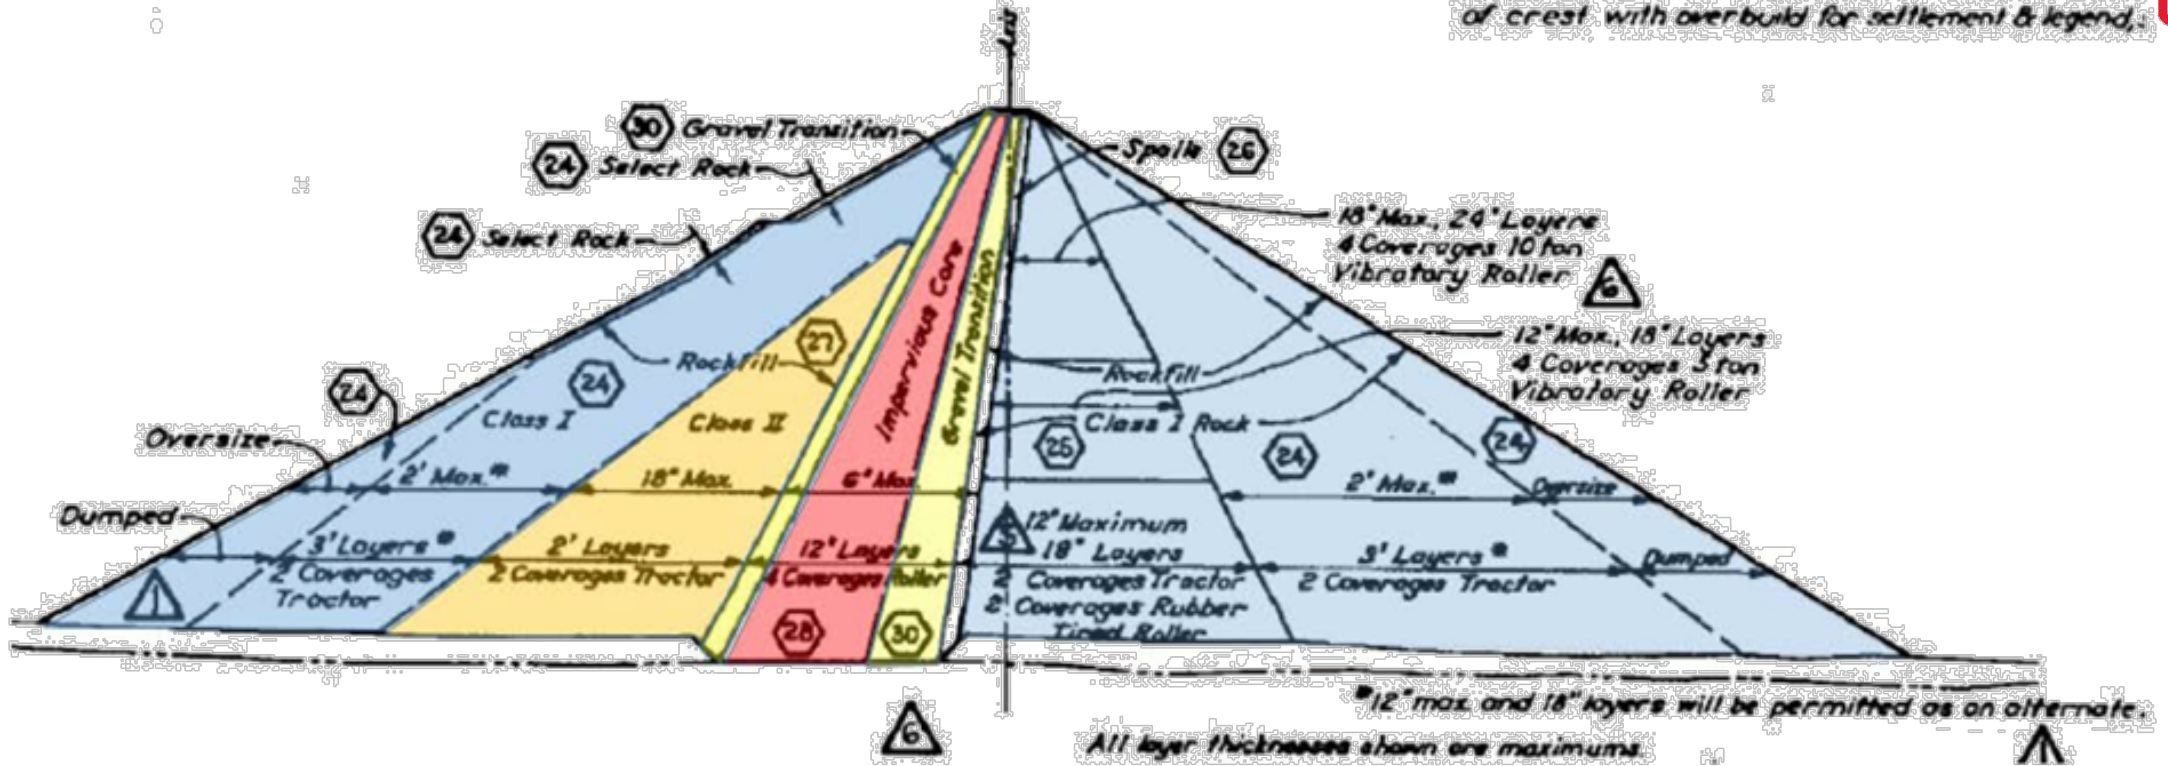
# TYPICAL CROSS SECTION

Note: Many test pits in crest of dam have documented cracks through core, gravel transition, and spalls

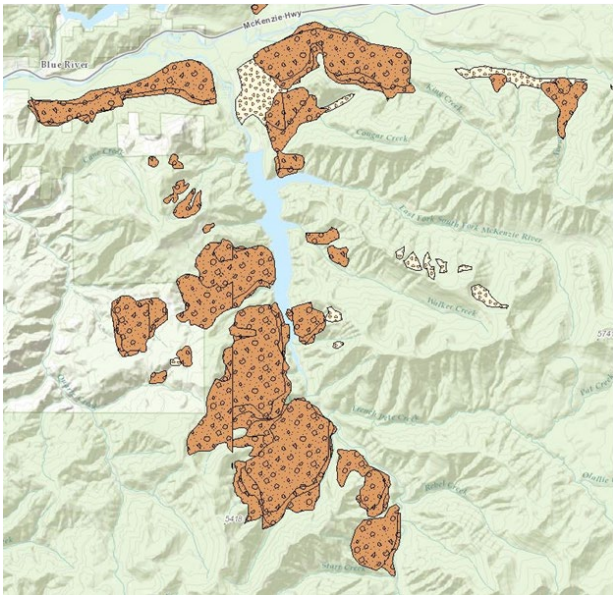
Historically active landslides in heavily forested area

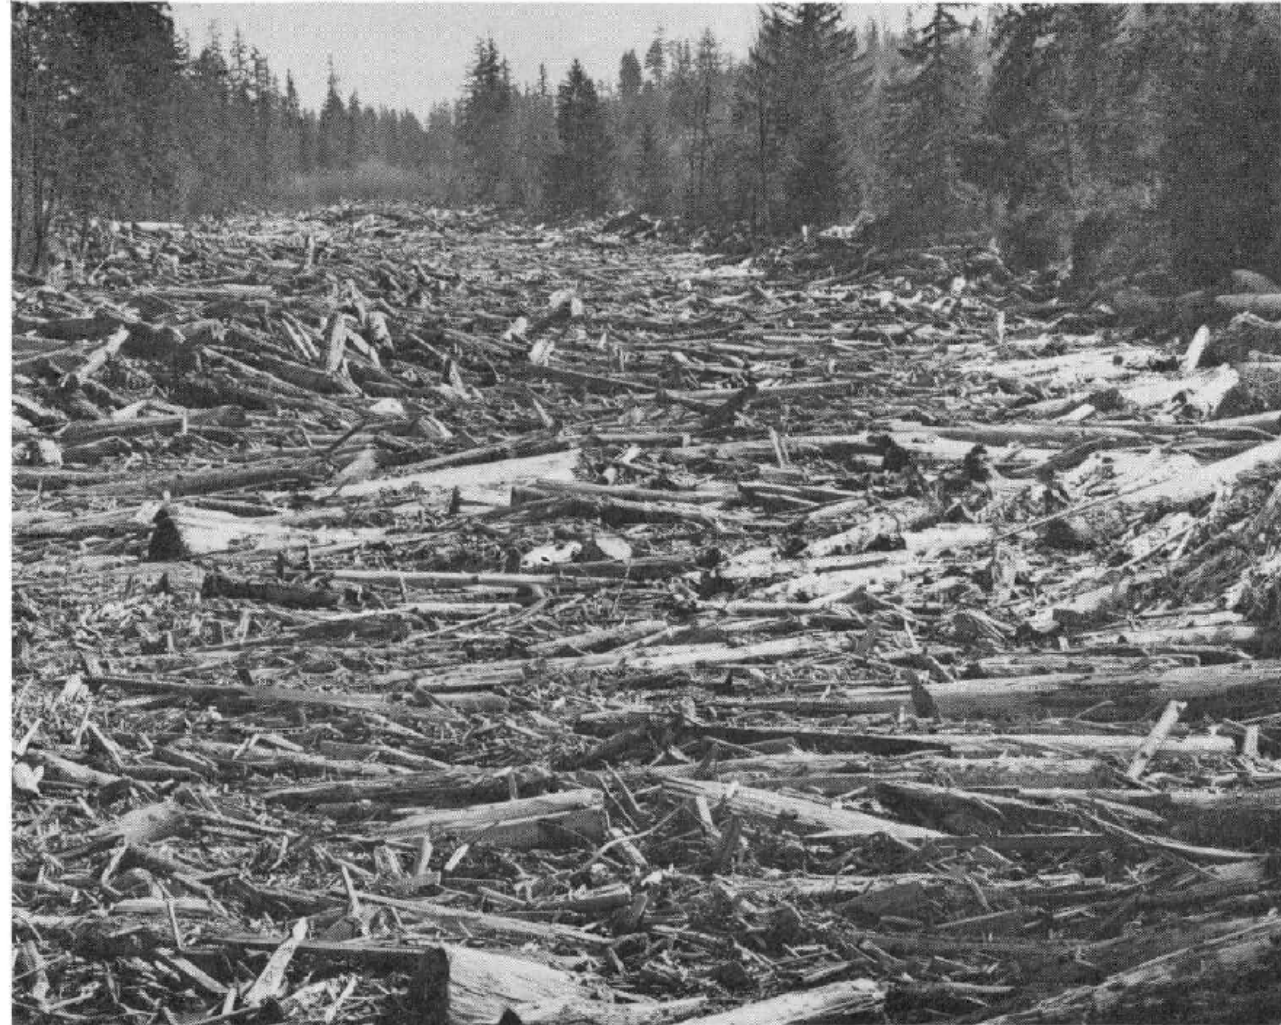
Log jam above Wiley Creek Bridge (1964)

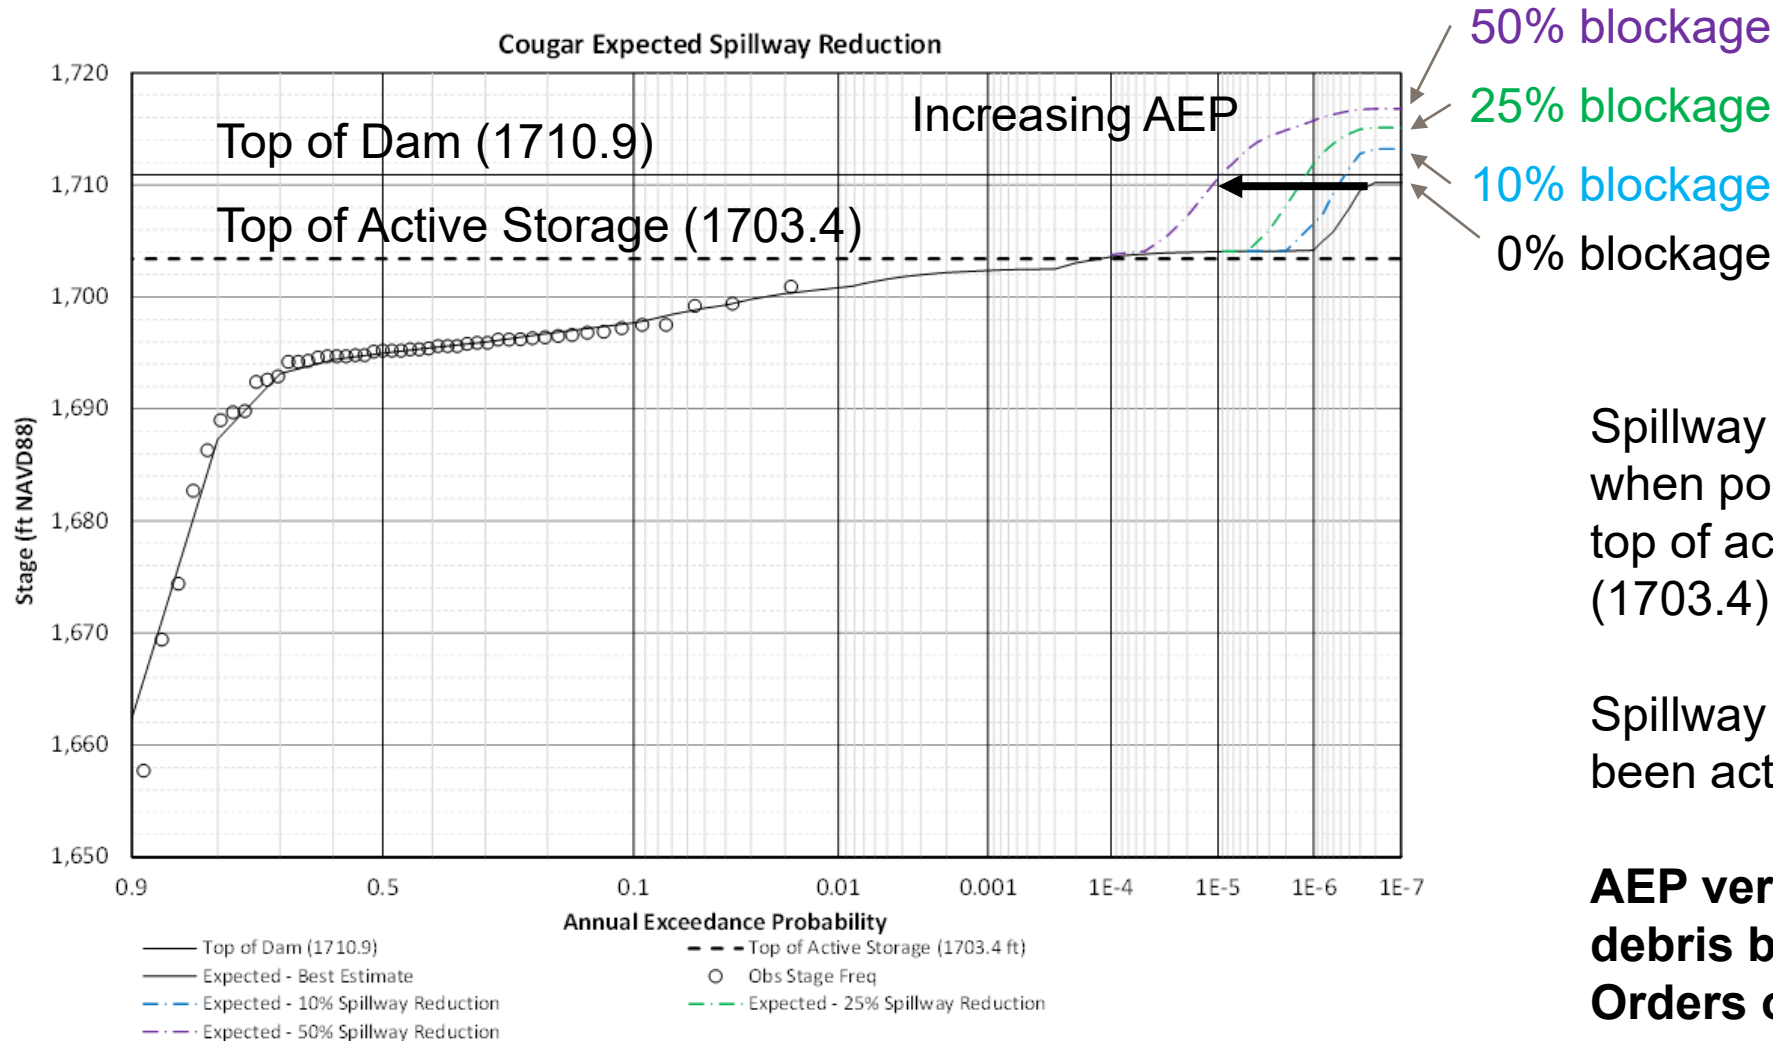
Spillway gates activate when pool approaches top of active storage (1703.4).

Spillway has never been activated.

**AEP very sensitive to debris blockage! (1.5 Orders of Magnitude)**

## Re-assess Debris Blockage Risk:

- Debris Blockage Loading Curves and
- Final Elicitation of Debris Blockage Probabilities

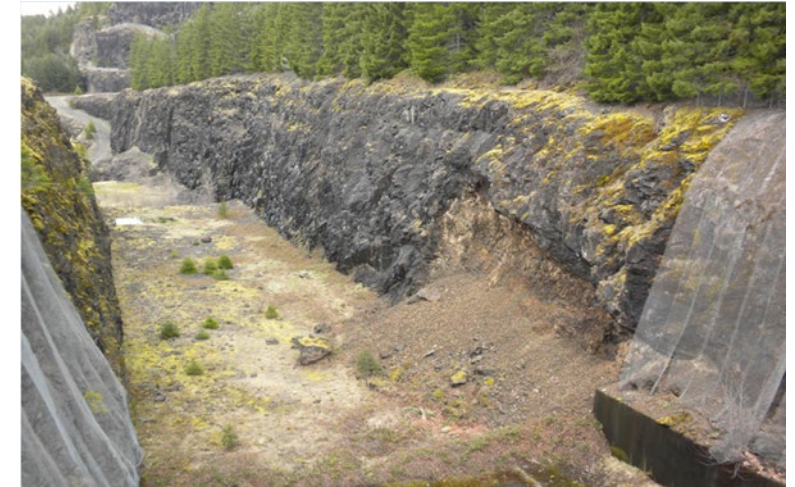
Steep contact on the right of chute (Tuff under dark grey Dacite intrusion)

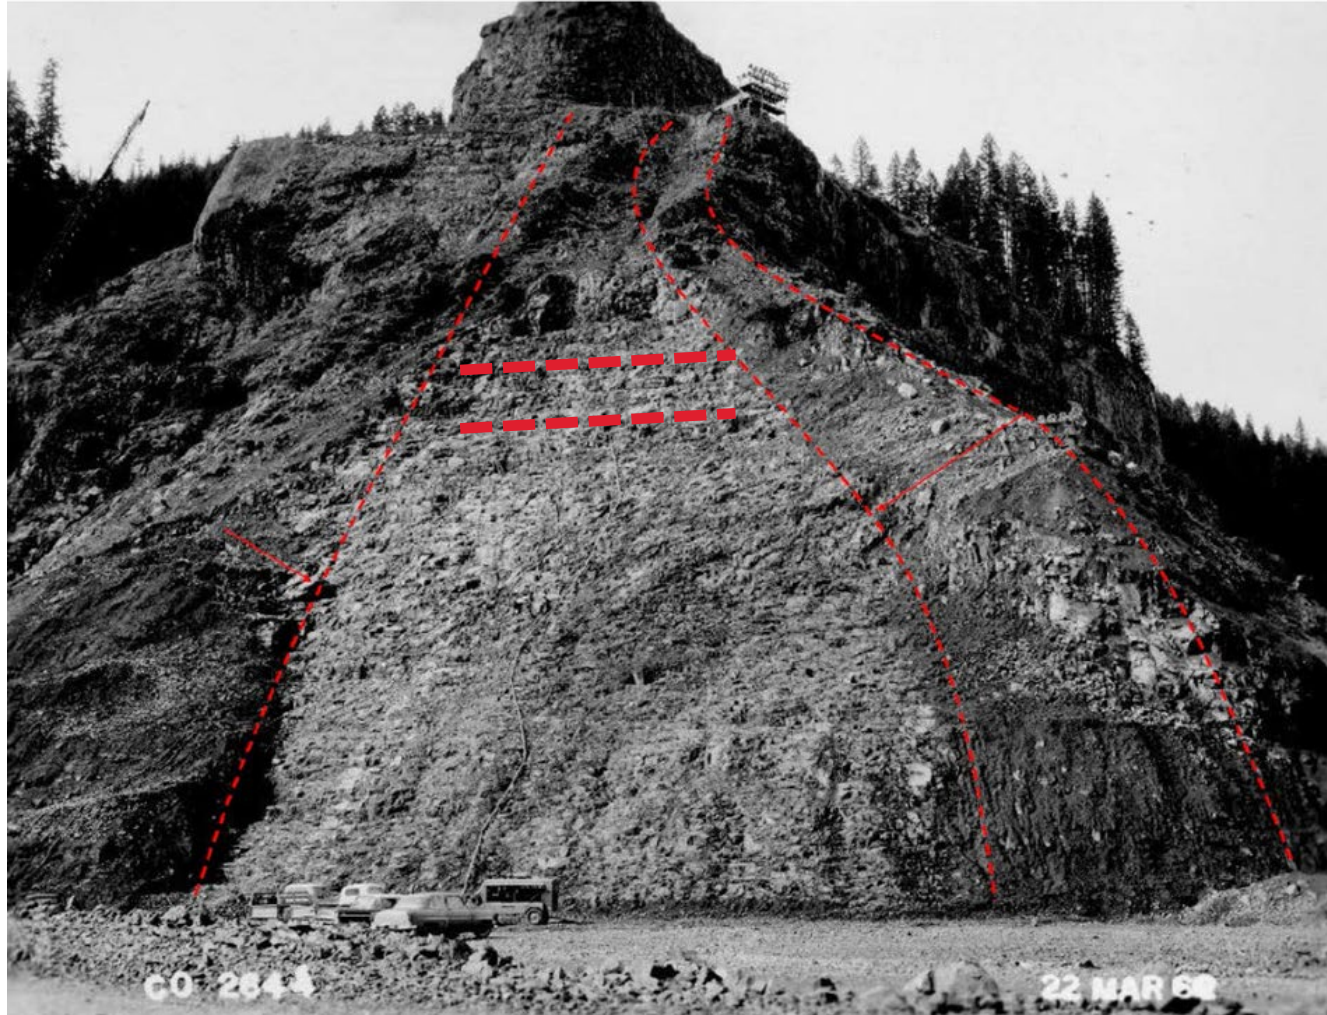
Linear asperities/benching (up to 5-ft high) through core zone (develop a flaw through dam core?)

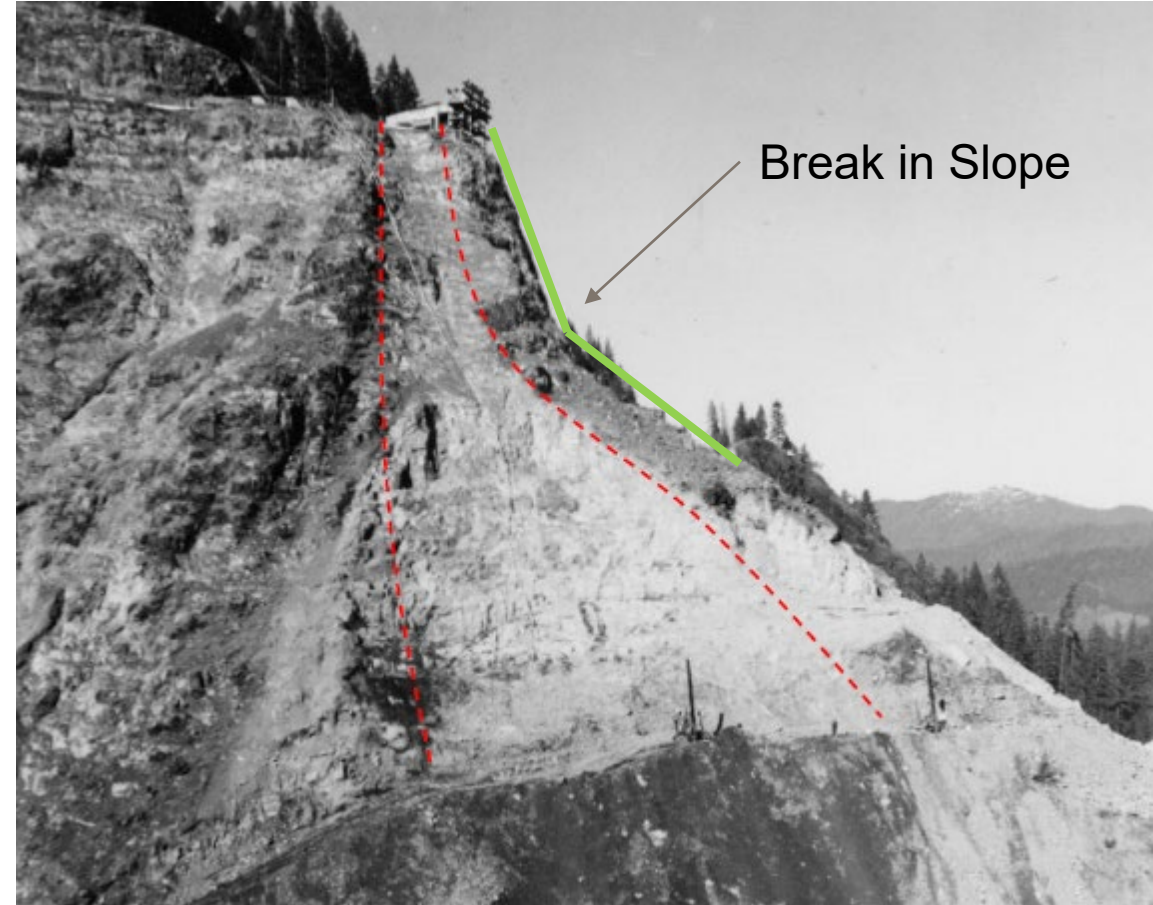
Break in slope on left abutment surface lead to development of a flaw through dam core?
