SITE CHARACTERIZATION FOR RISK ASSESSMENT OF COUGAR DAM, MCKENZIE RIVER, OREGON

Kevin S. Richards, PhD
Senior Advisor
USACE Institute for Water
Resources/Risk Management
Center/East Division
Date: 19 September 2019

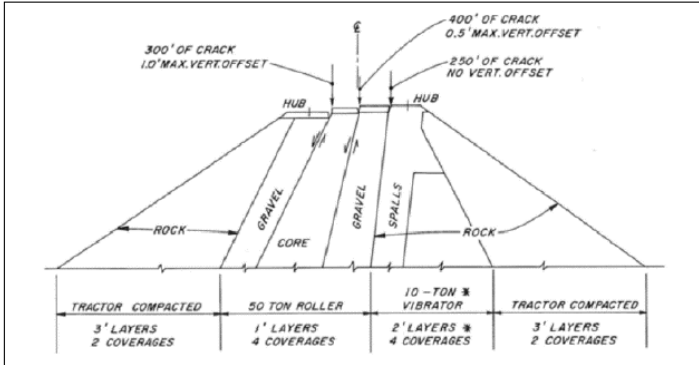
(Pope, 1967)

A number of test pits investigated cracks in the crest over the years.

- Cracks extend thru core into spalls
- Cracks primarily longitudinal
- Some upstream of core, some downstream of core, some cross core upstream-downstream
- Transverse cracks are present
- Crest stair-steps down towards reservoir (Pope 1967)
- Most shallow, but >1"-open cracks have been confirmed to extend to depths greater than 15 feet below the crest (total depth unknown)

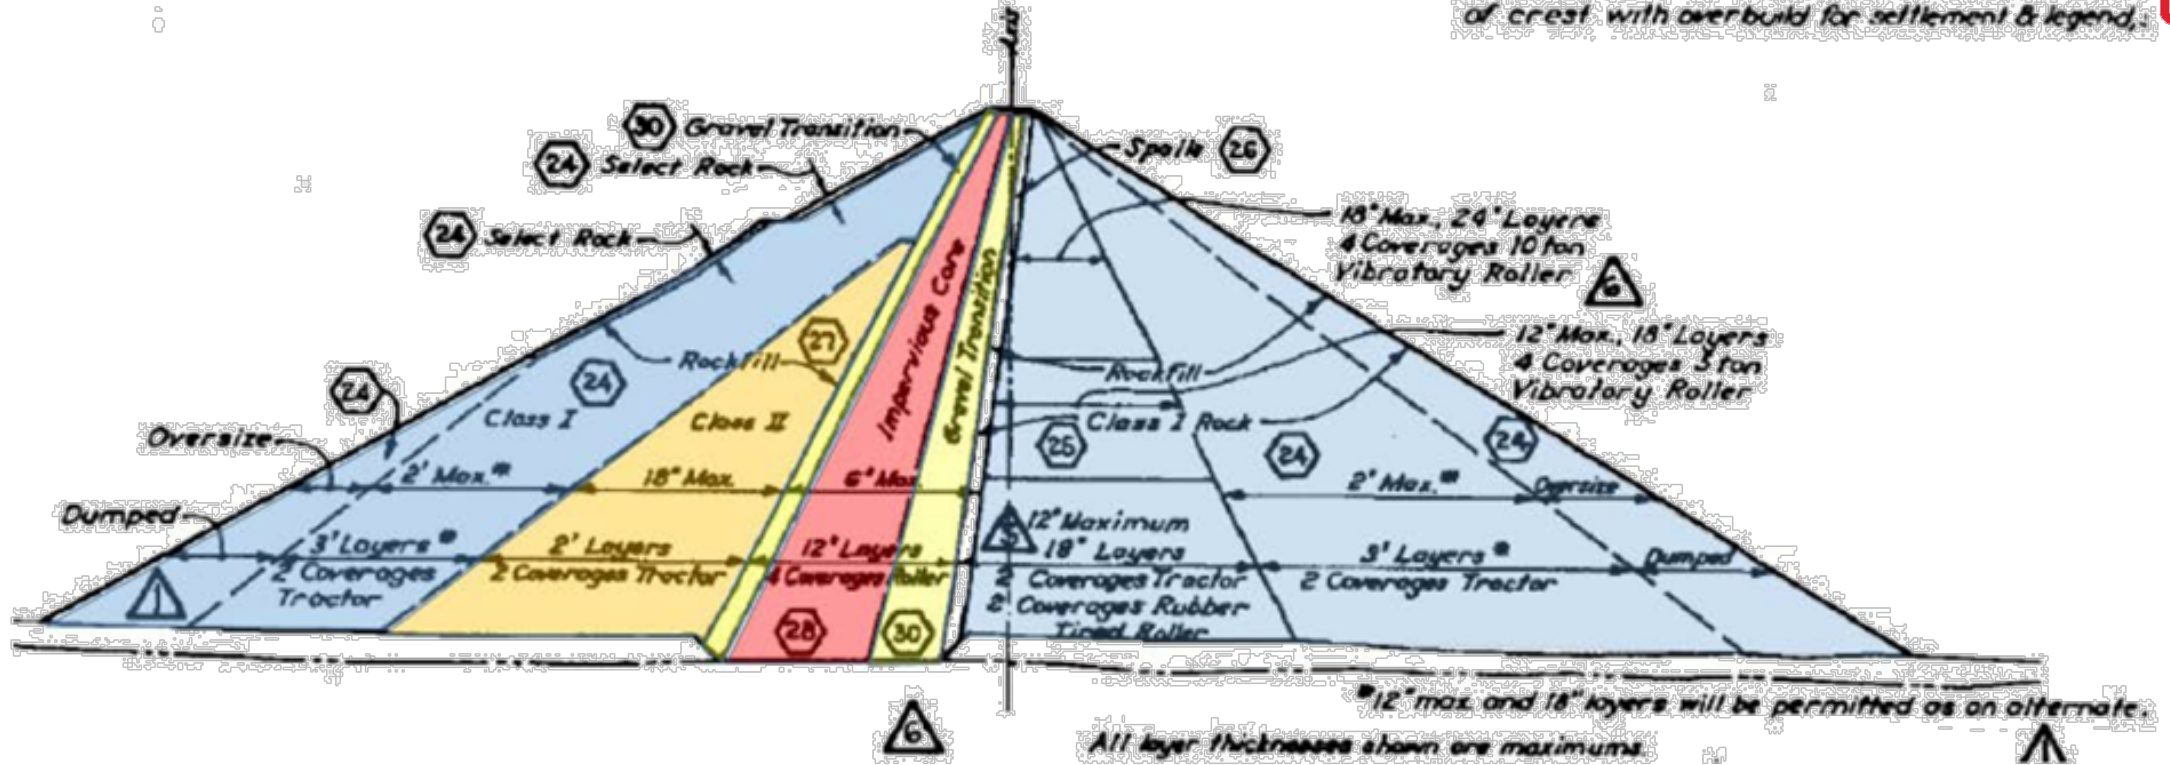
TYPICAL CROSS SECTION

Note: Test pits in crest of dam have documented cracks through core, gravel transition, and spalls

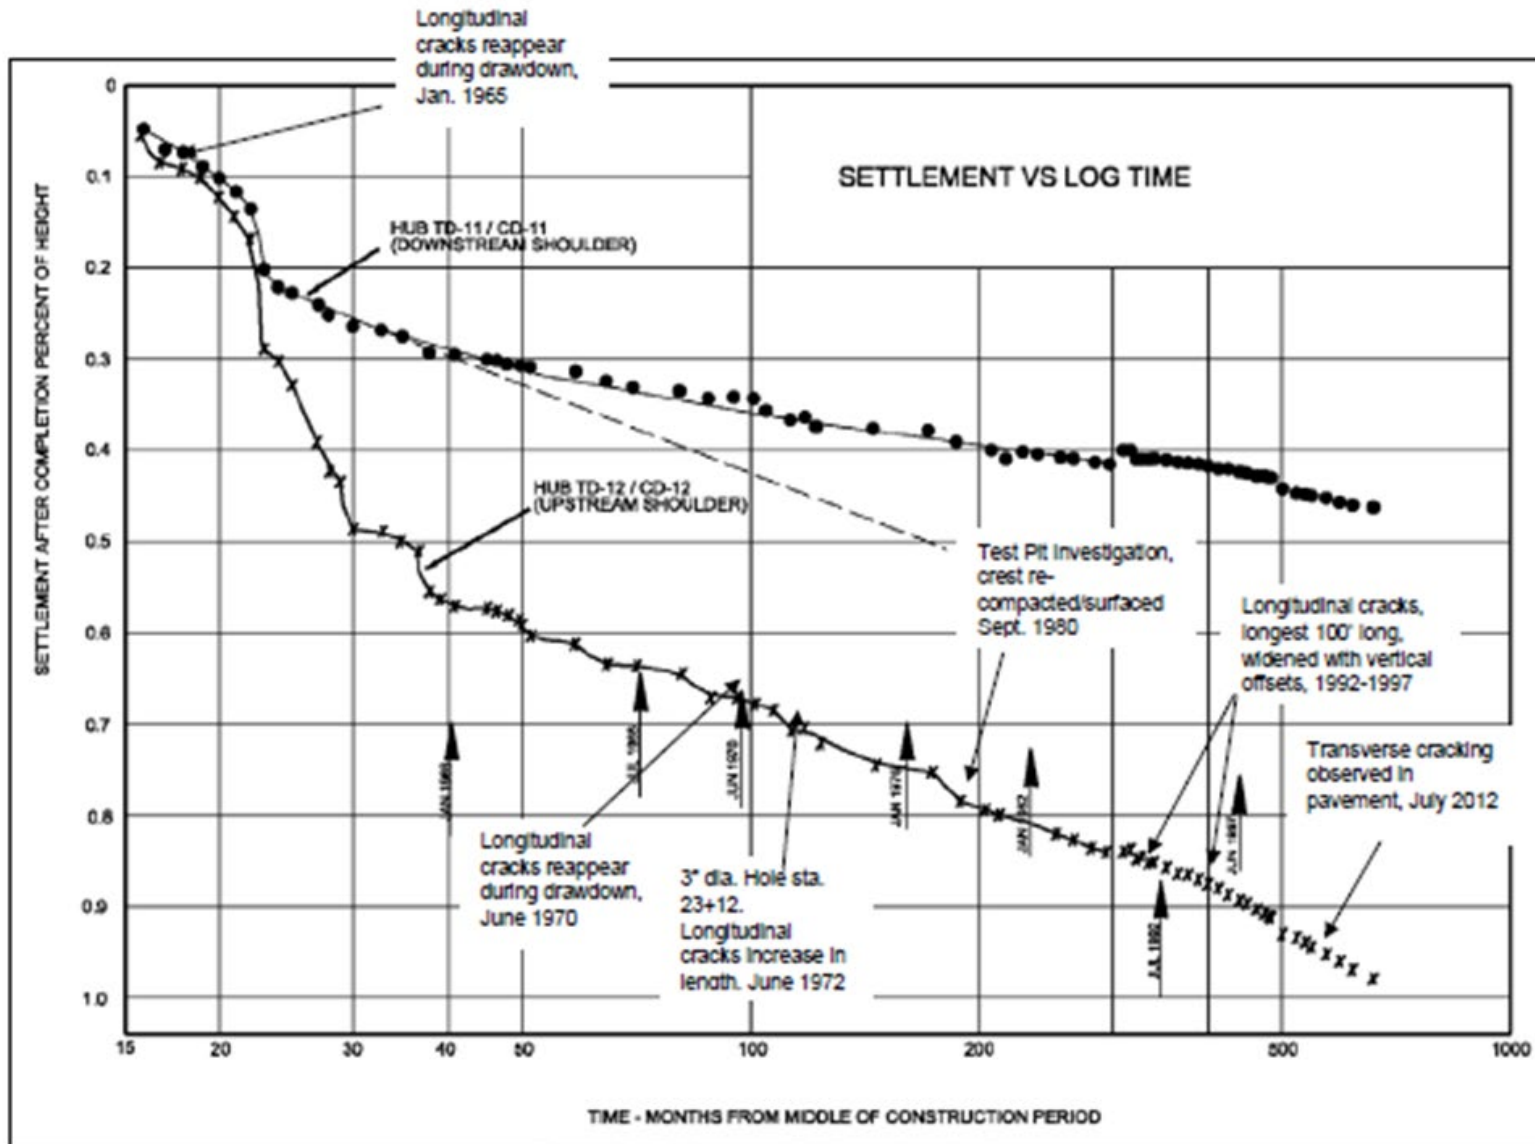
Figure 4-8: Embankment Settlement vs. log time

- Settlement as percent of height-
- Downstream Shoulder (top)
 - Upstream Shoulder (bottom)

Continuing, and sometimes rapid settlement of upstream shoulder and ongoing incidence of cracks

Important questions: is the deformation concentrated along pre-existing planes, have they experienced strain softening, and what is their geometry?
