A Post-Earthquake Investigation in the Eastern United States

AEG Webinar
May 21, 2020

Dave Fenster, AEG Past President

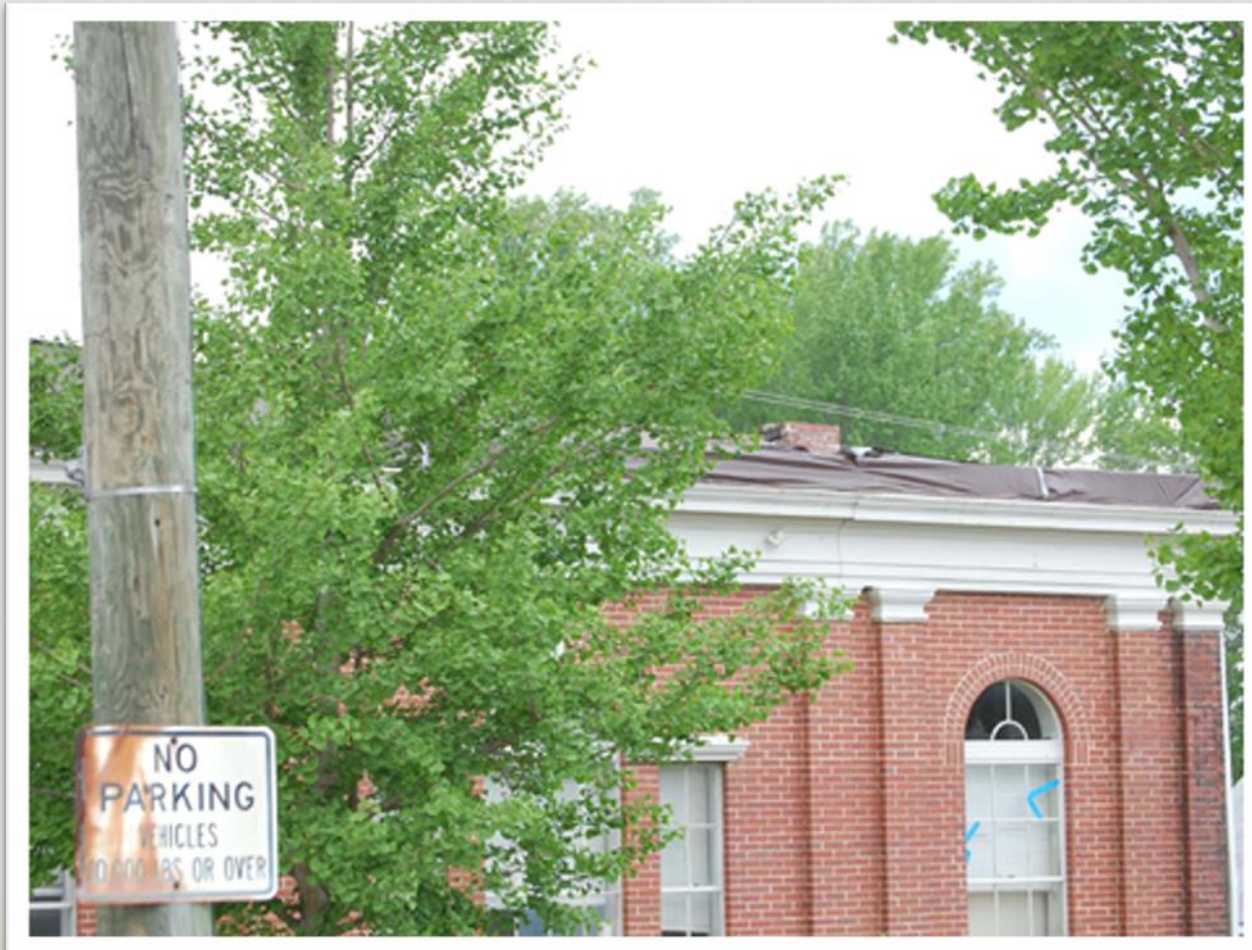
DAMAGED ROOF IN MINERAL, VA

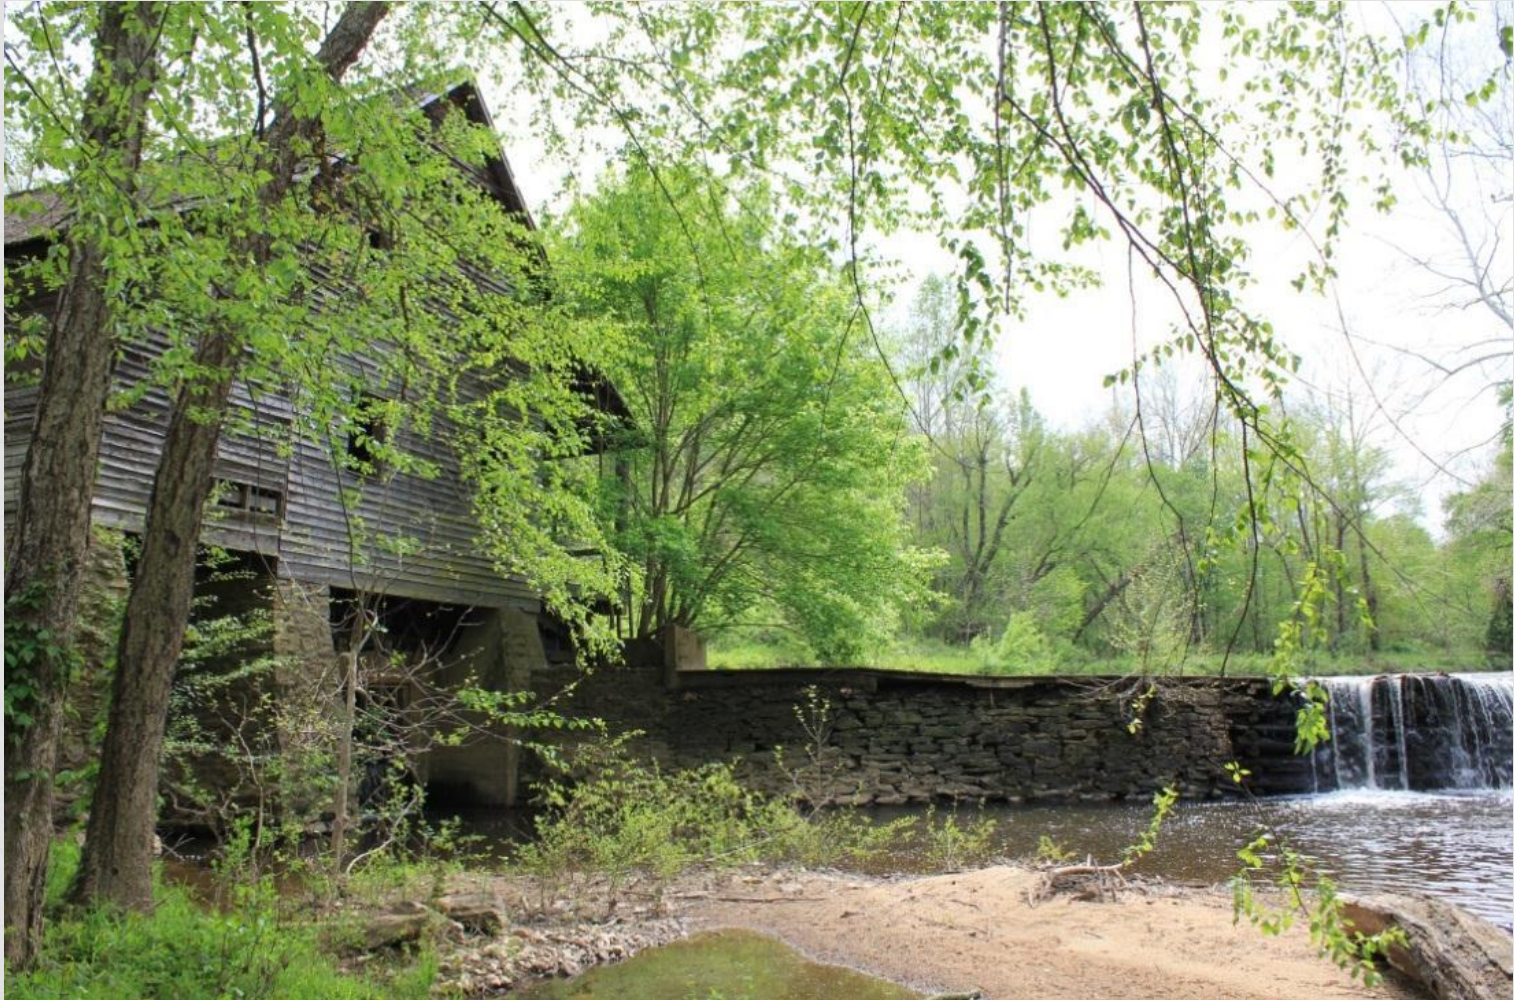
Old Yancey Mill – site of sand boils after EQ

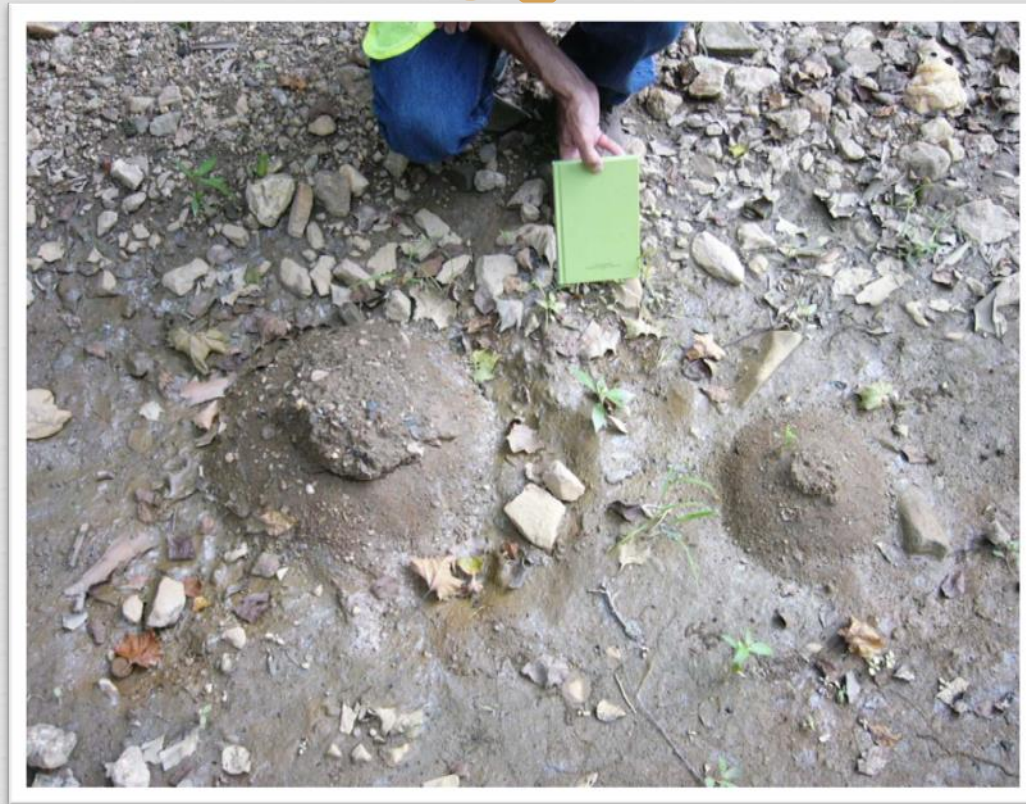
SANDBOILS

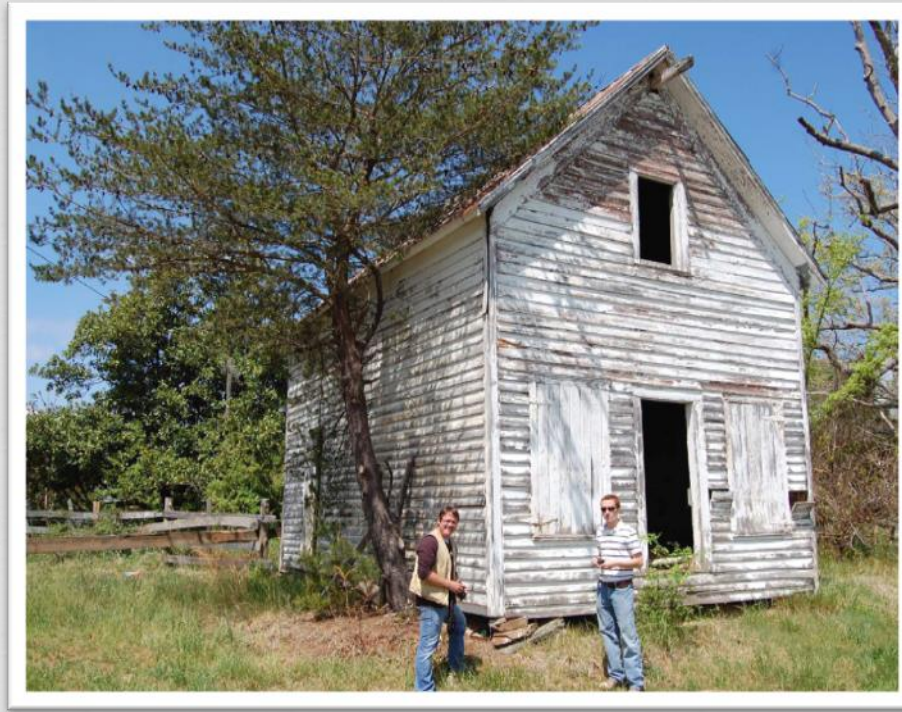
SLIGHT EQ DAMAGE

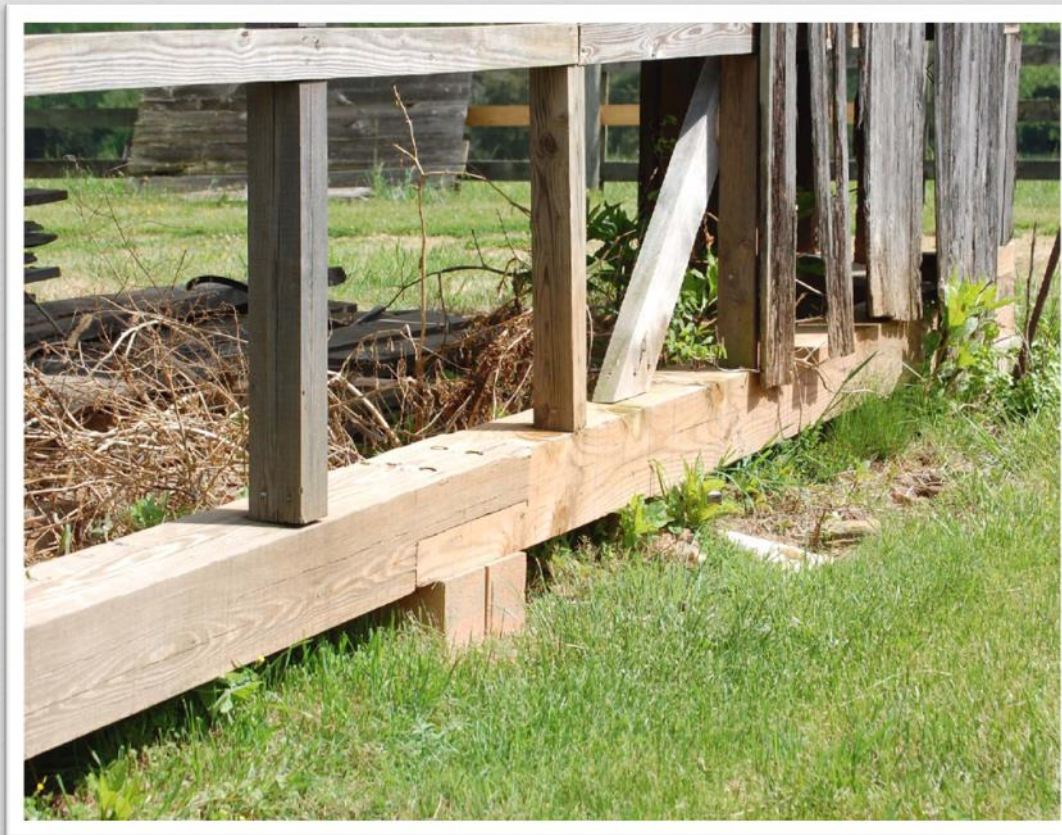
FOUNDATION DAMAGE

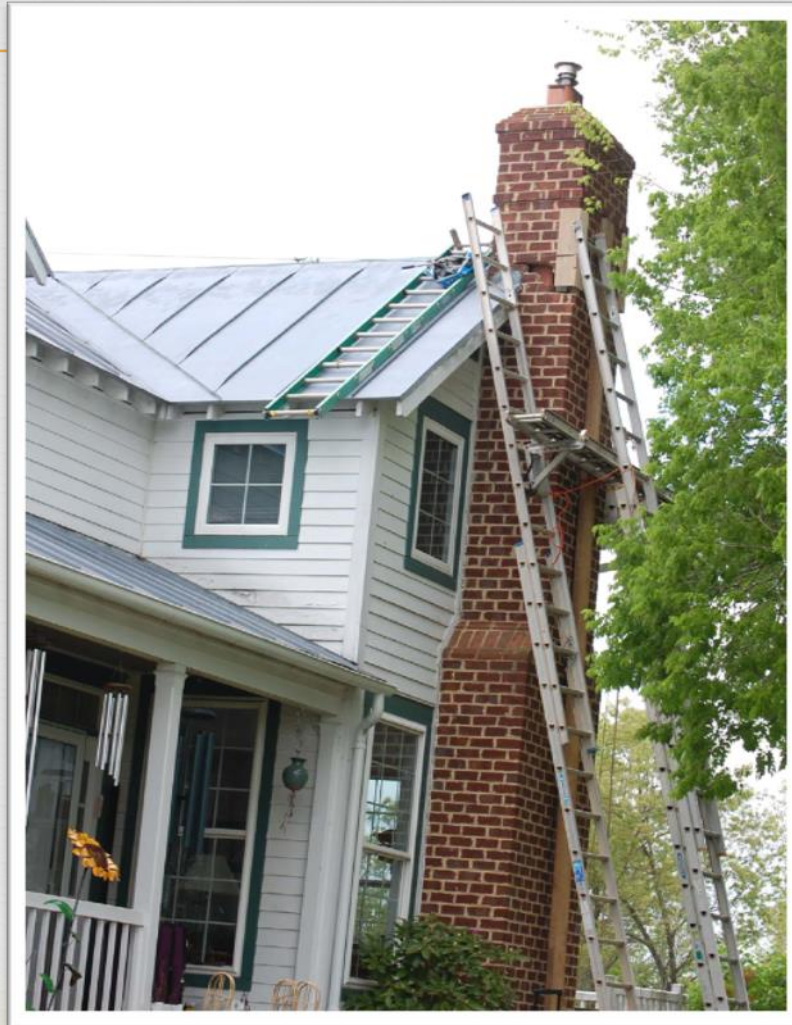
CHIMNEY DAMAGE
