The Role of Geology in the Construction of the Lake Dorothy Hydroelectric Project

Ron Wright
Senior Civil Engineer
Federal Energy Regulatory Commission

Lake Dorothy Hydroelectric Project

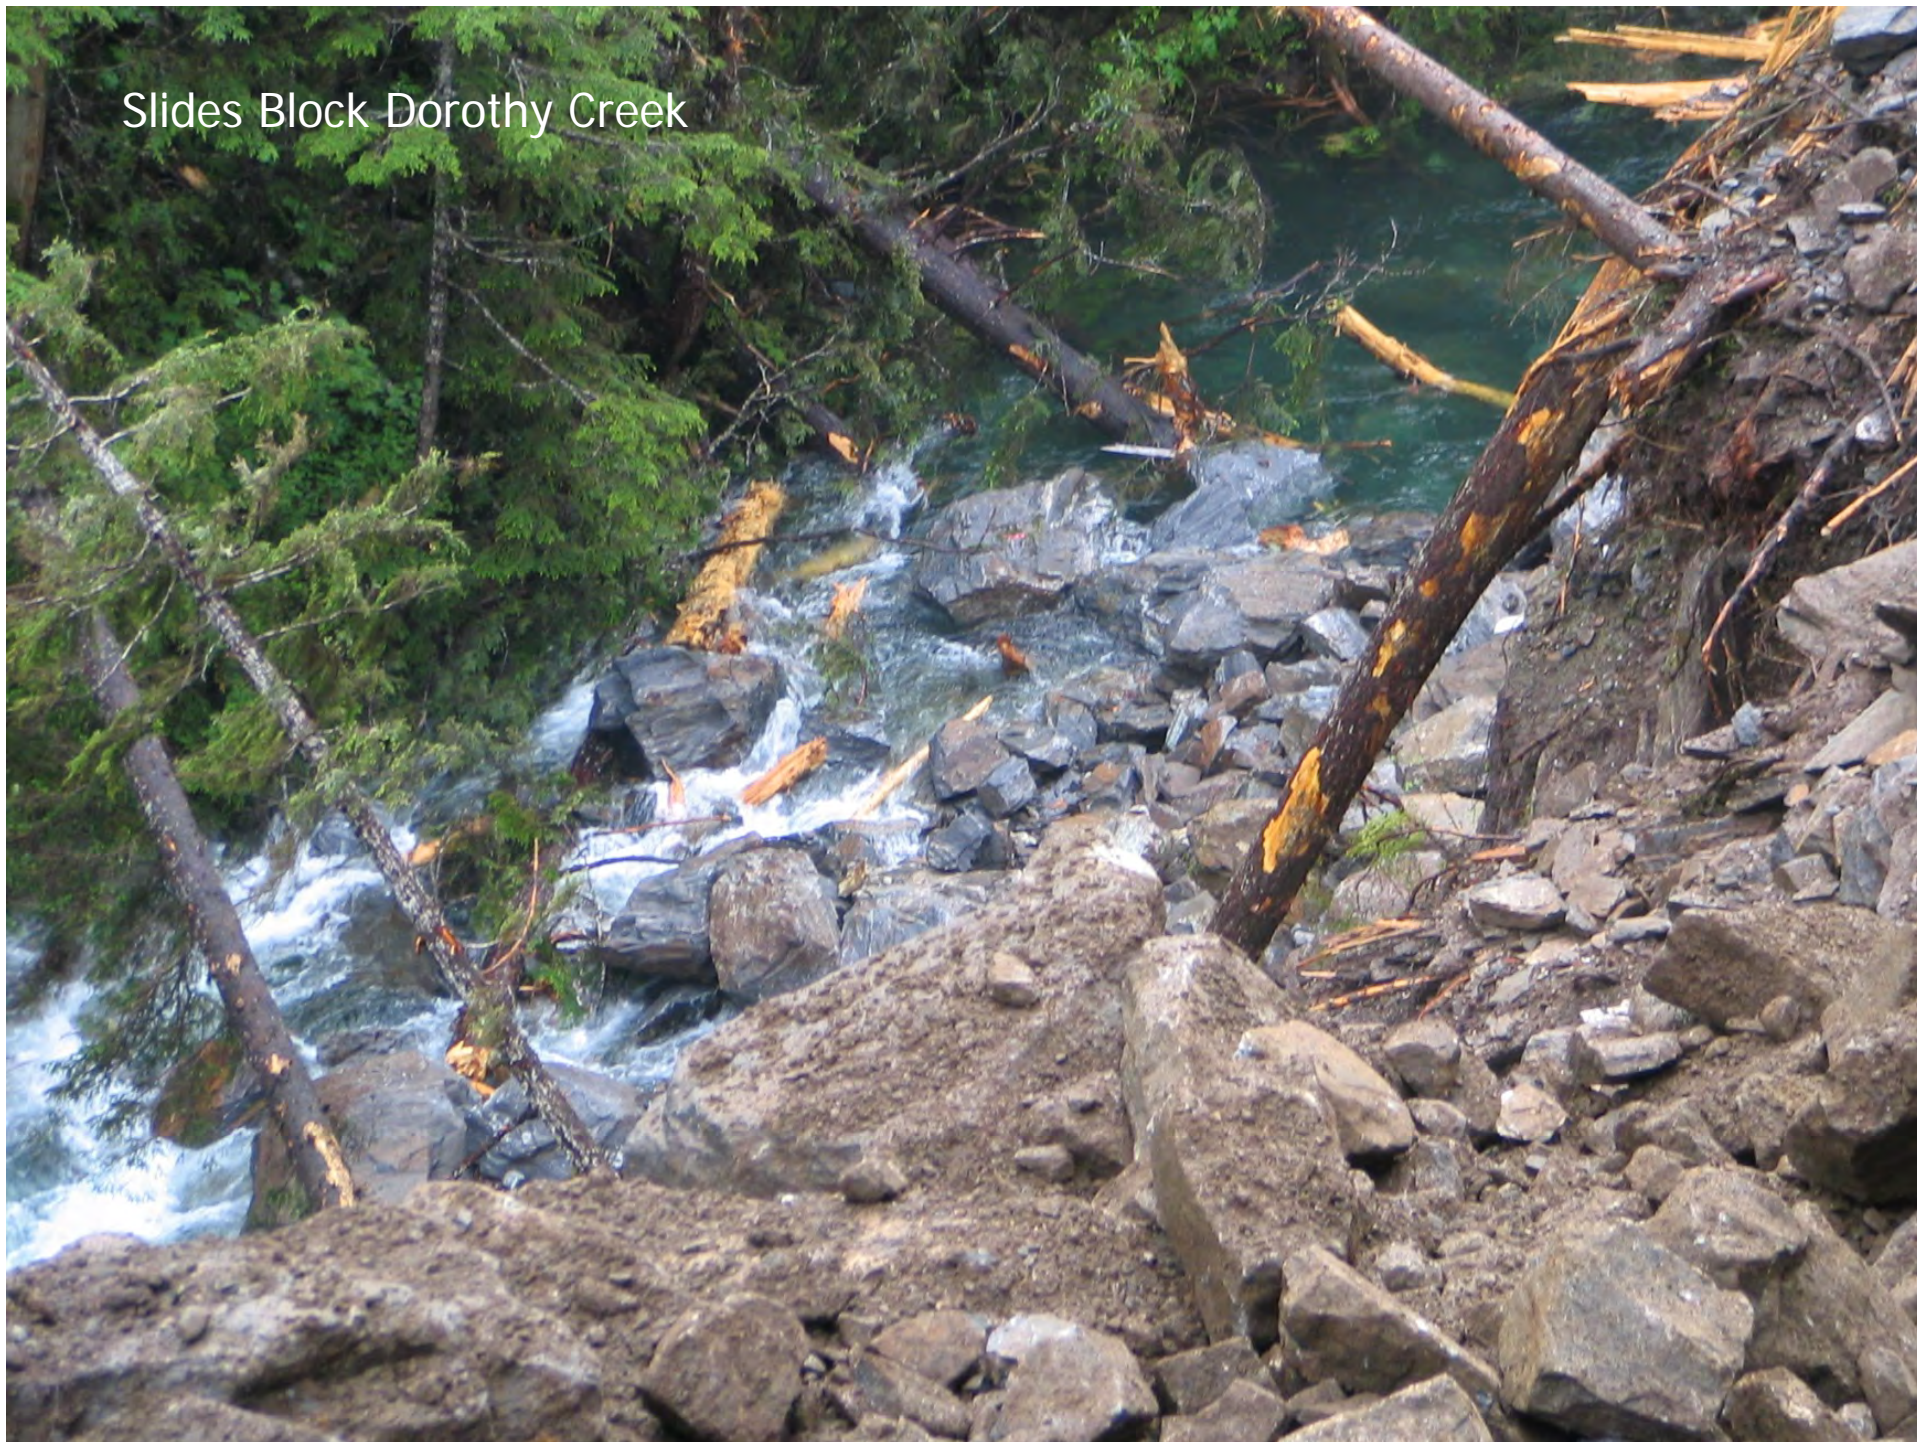
Slides Block Dorothy Creek

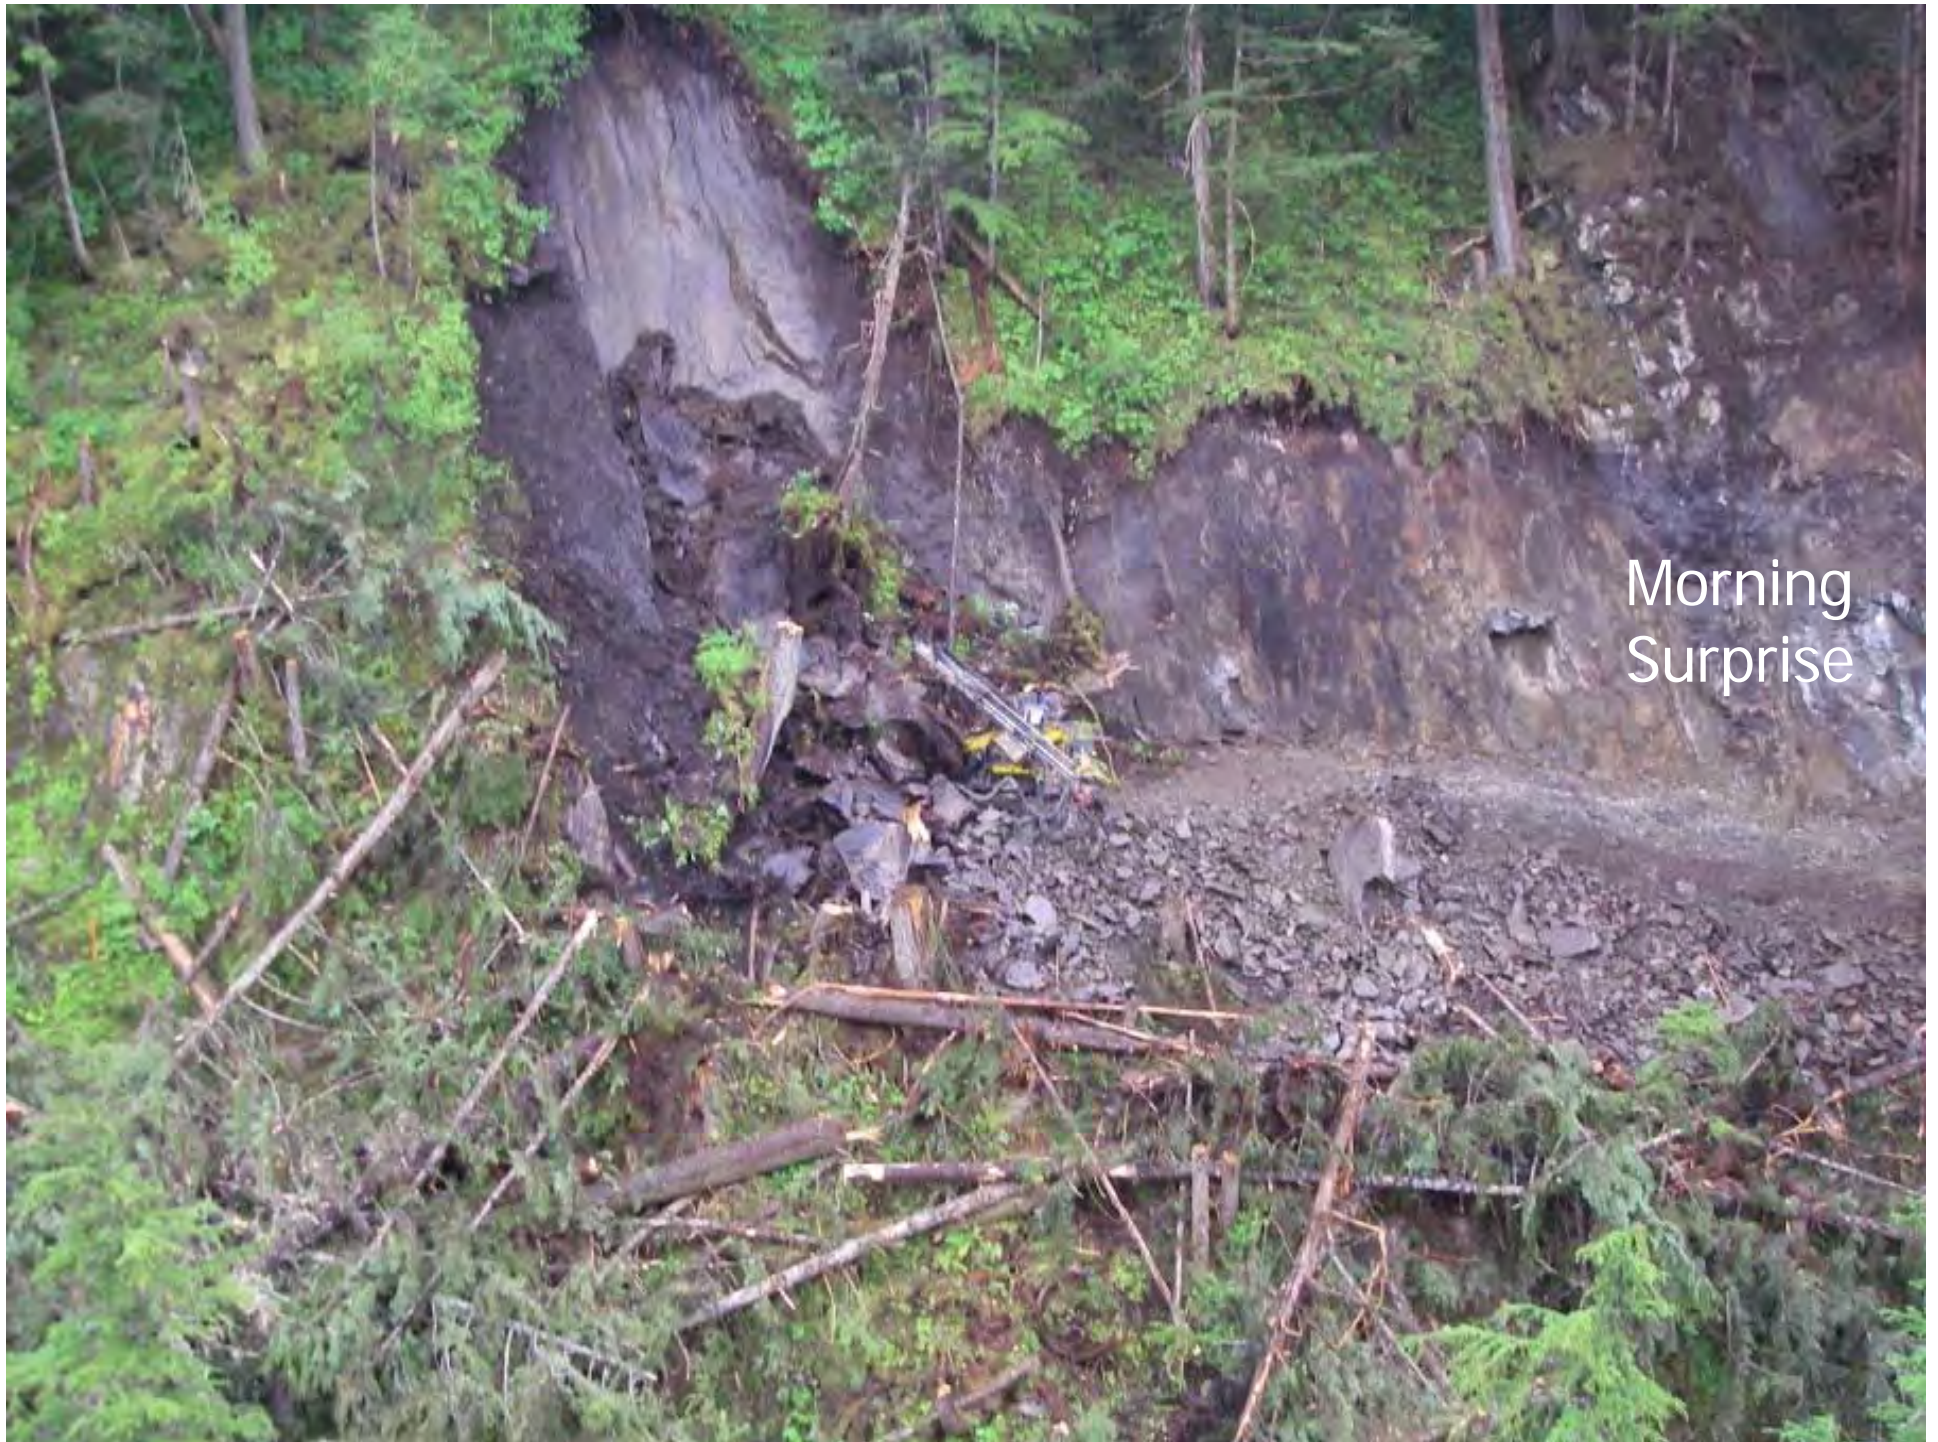
Top Slope Slides
Became a Growing
Problem

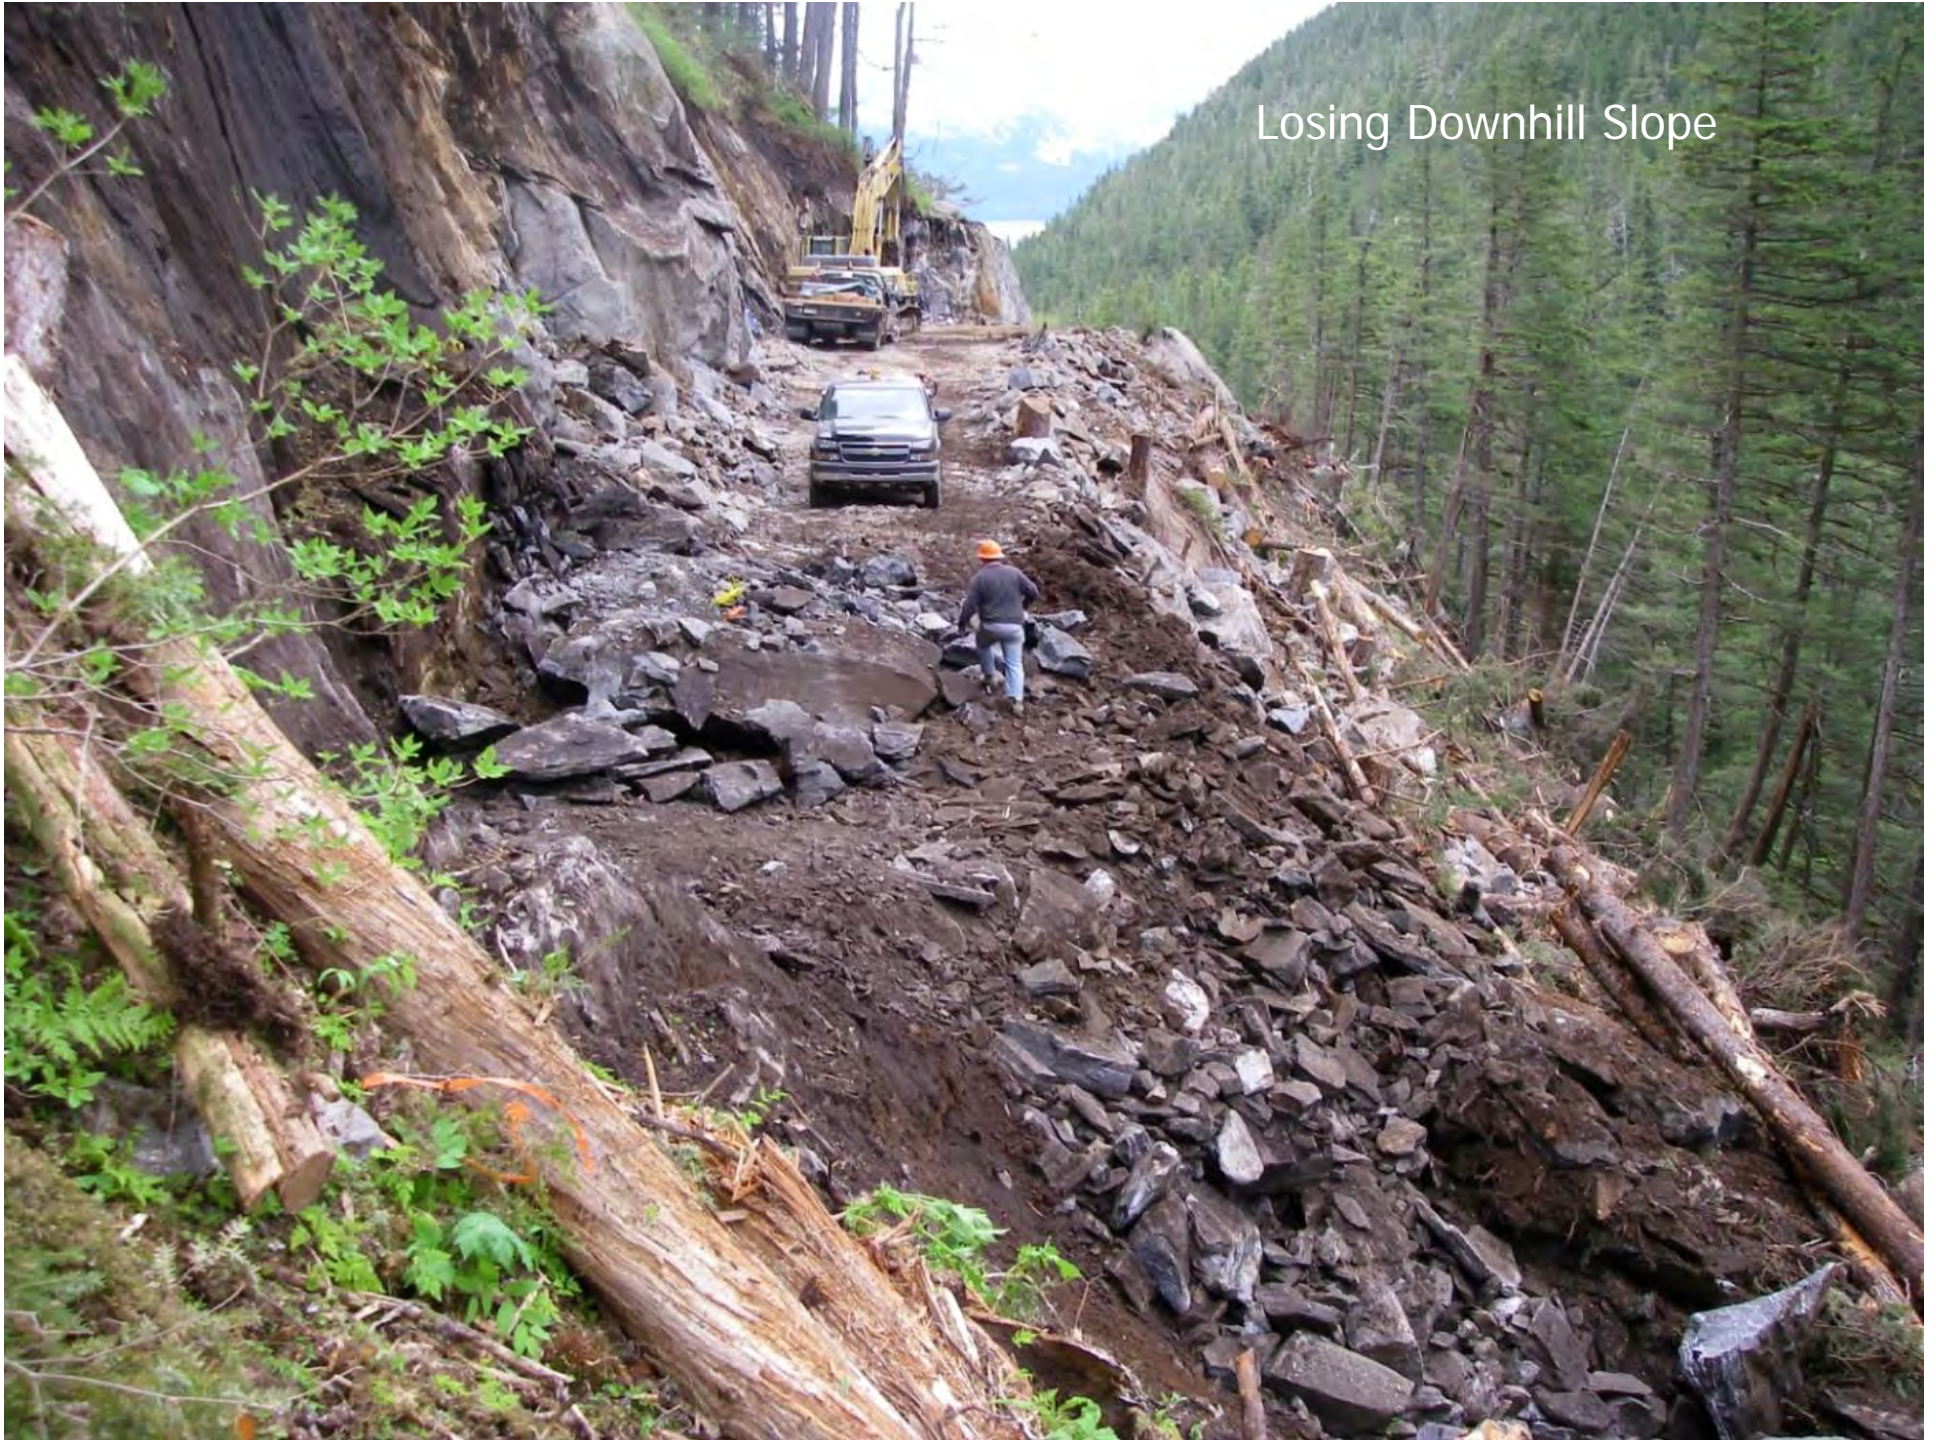
Losing Downhill Slope

Abandon Higher Heading and Drop Alignment

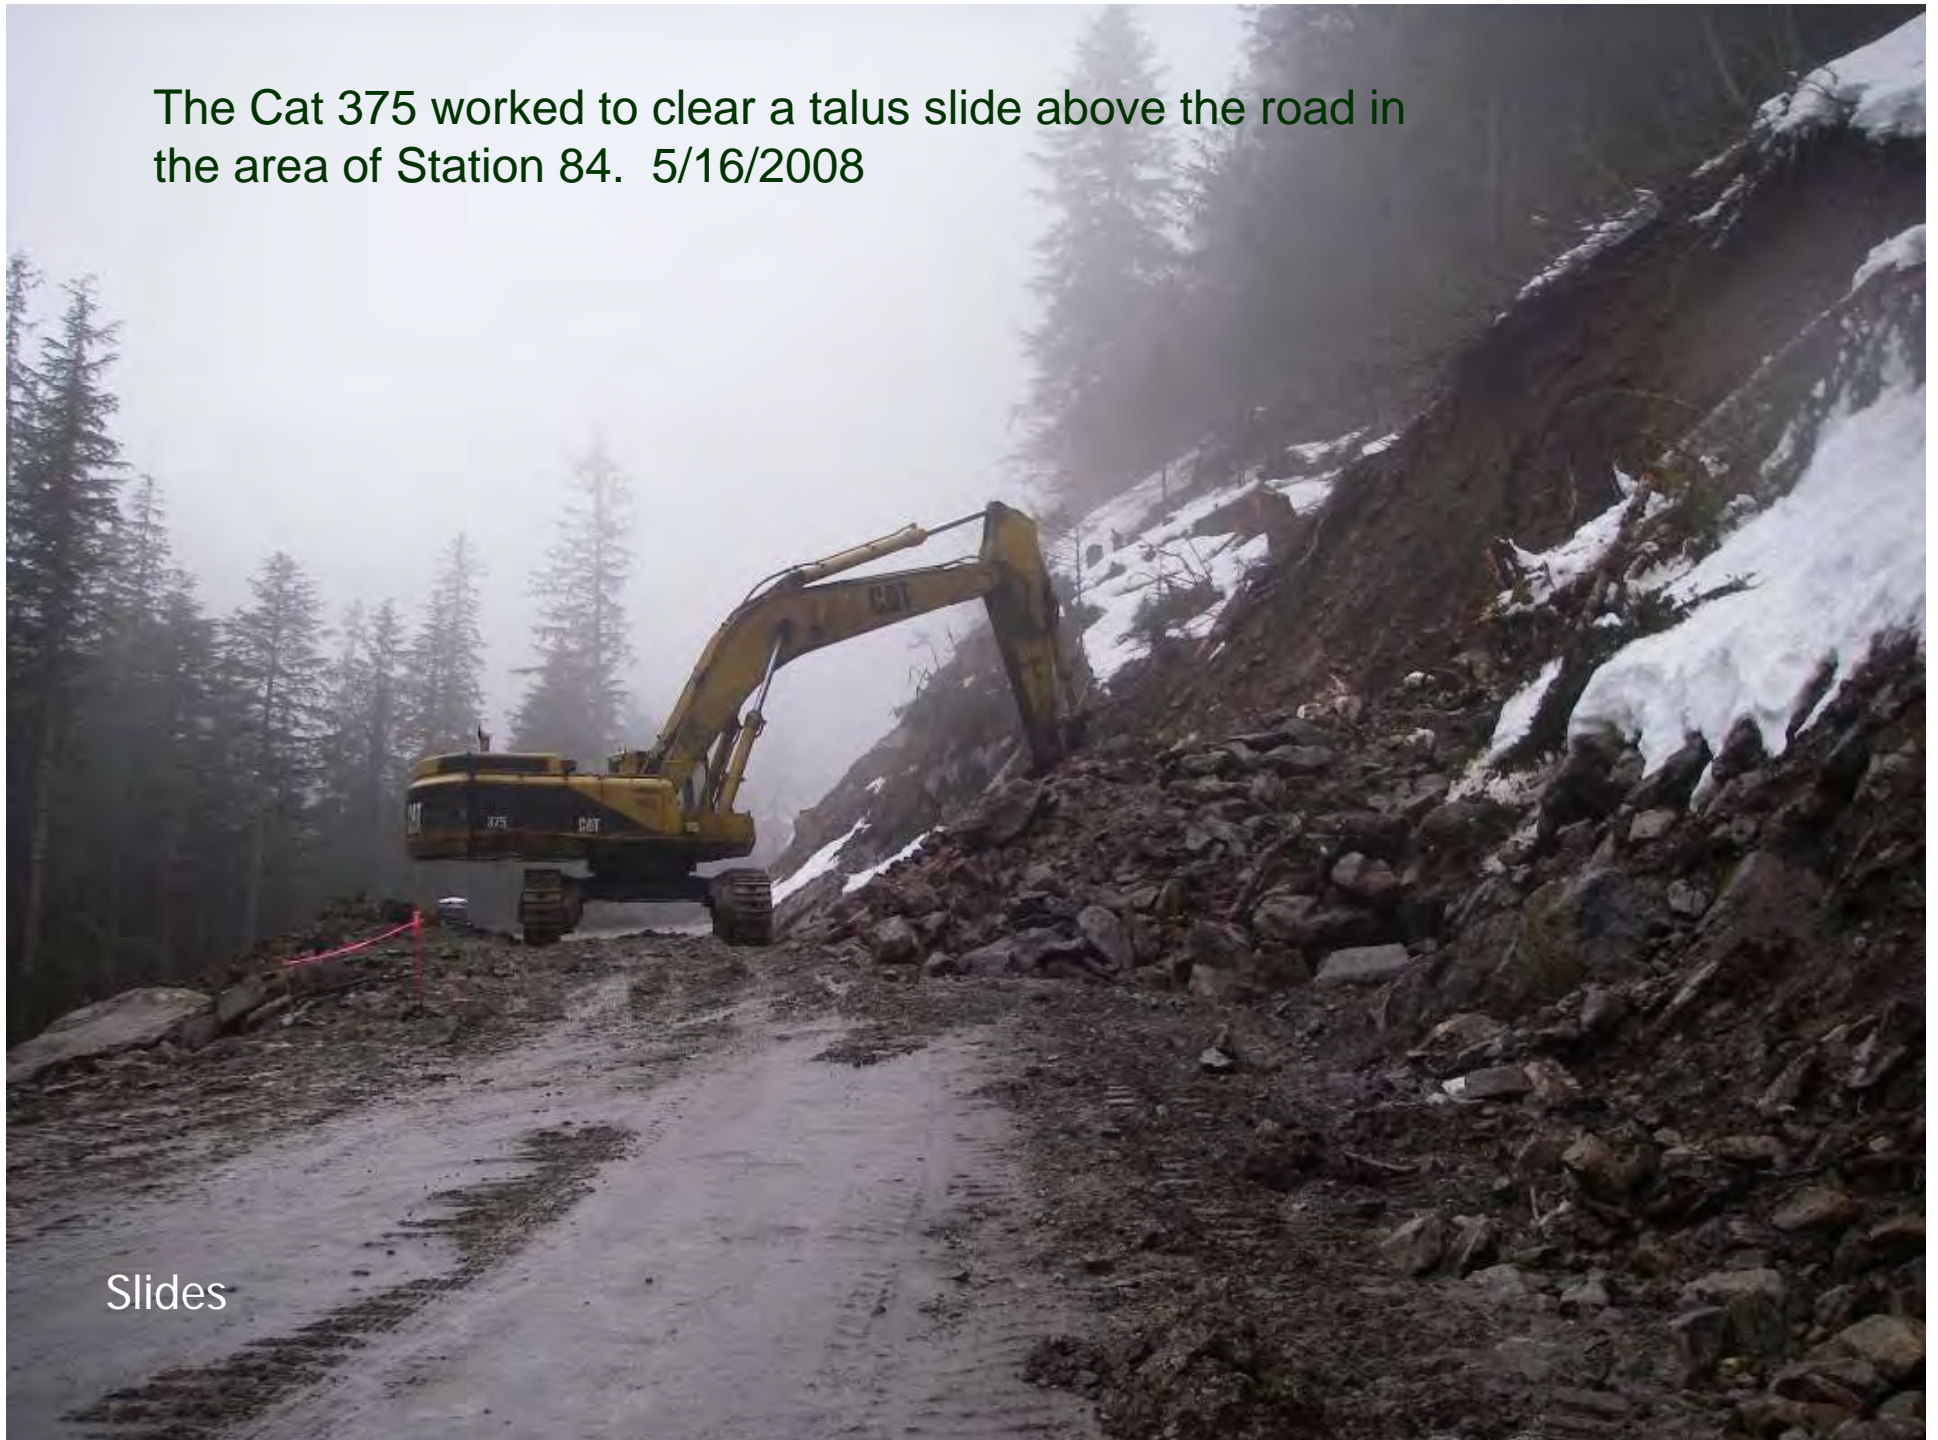
The Cat 375 worked to clear a talus slide above the road in the area of Station 84. 5/16/2008

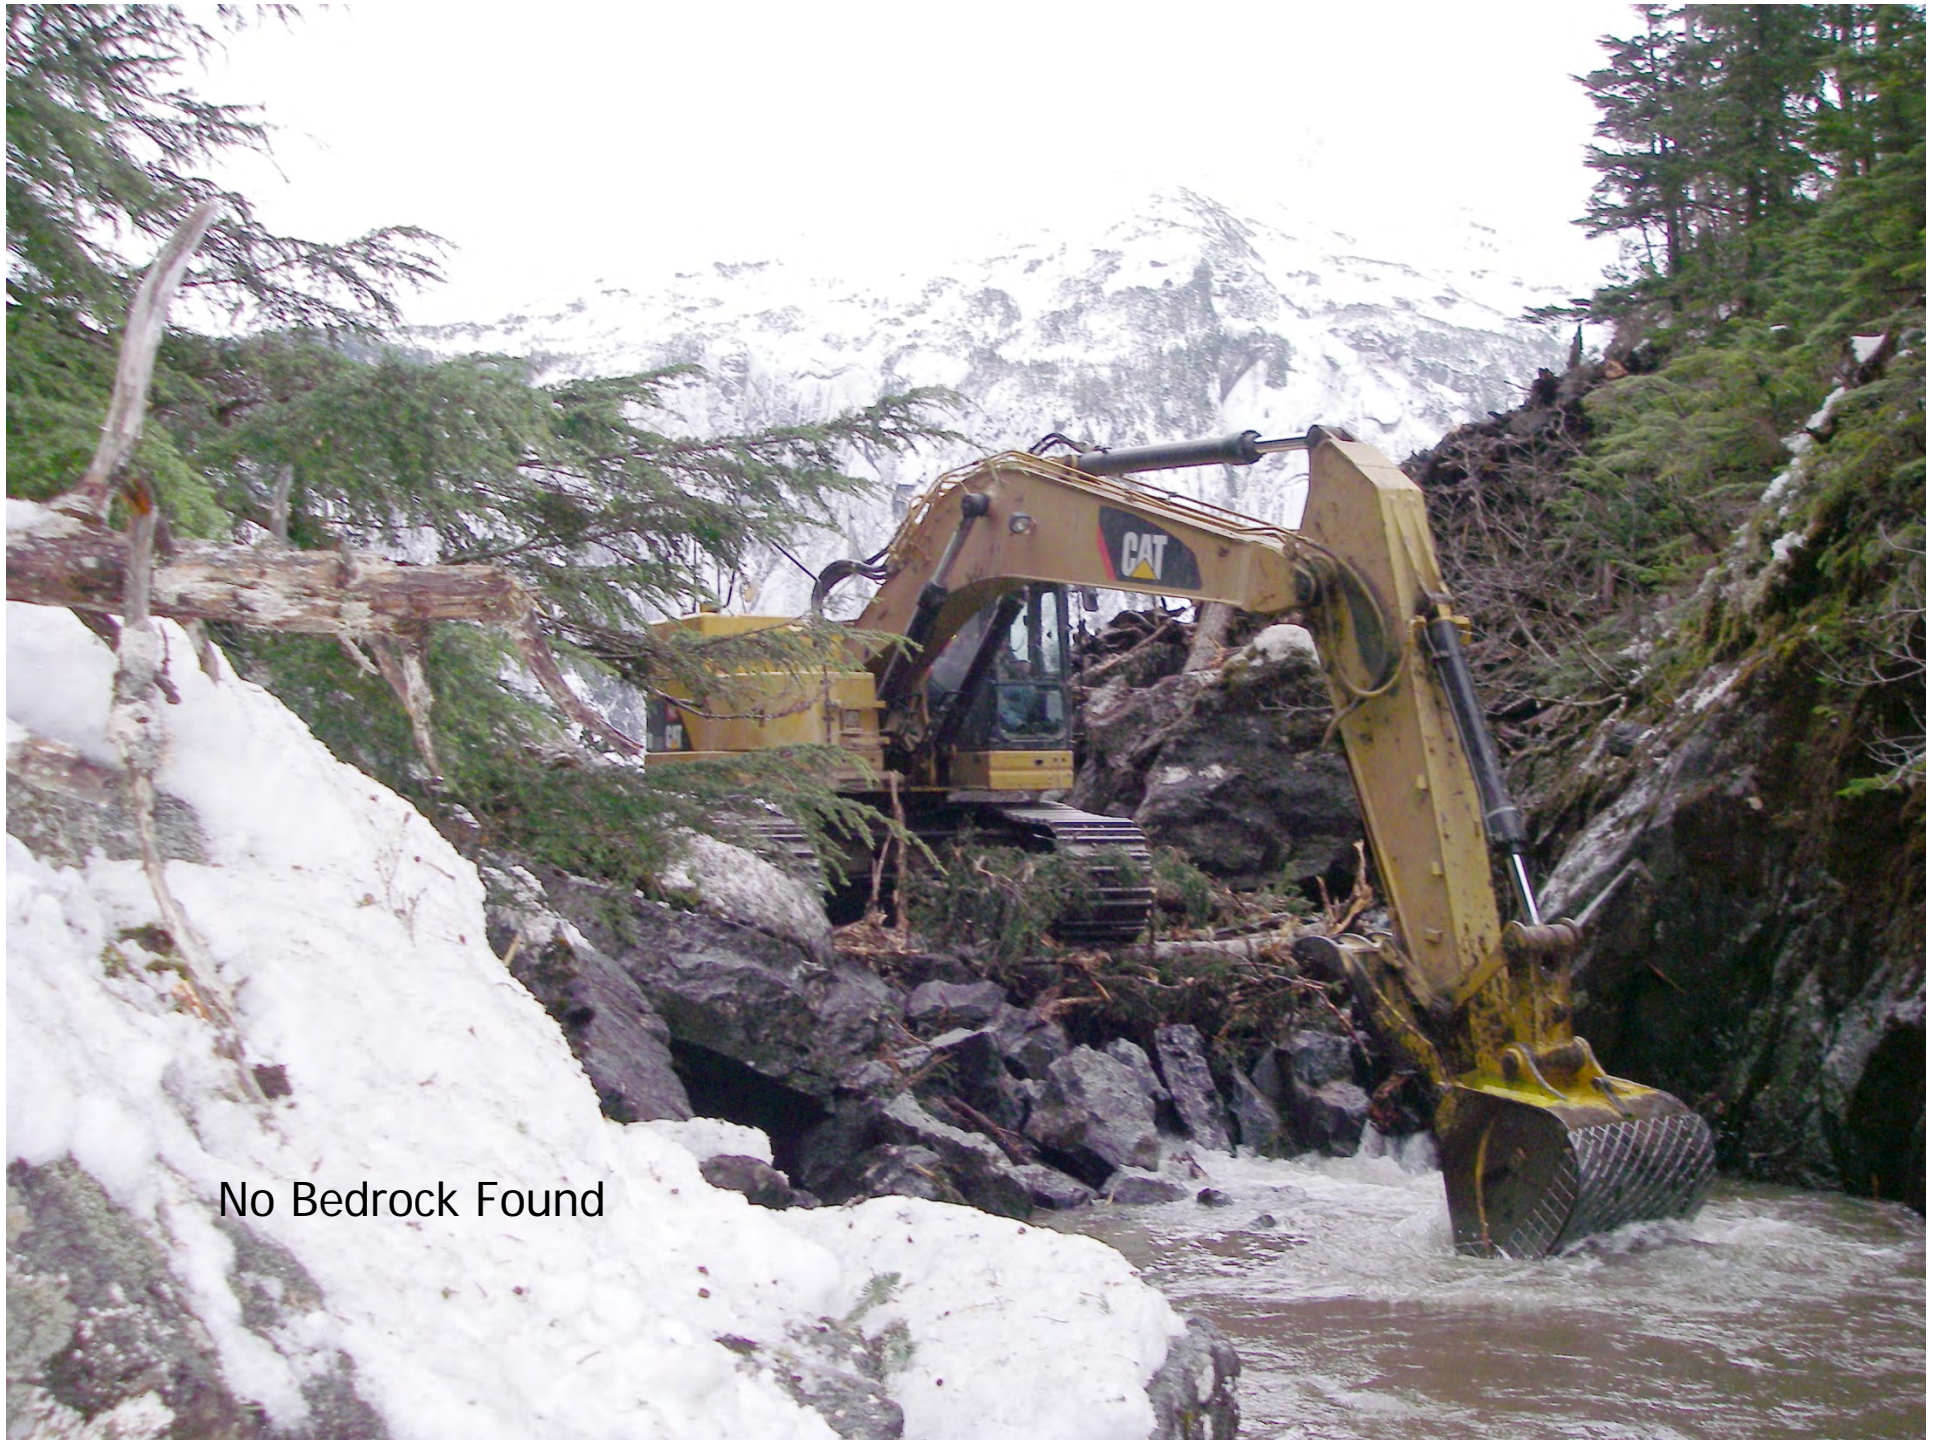
No Bedrock Found

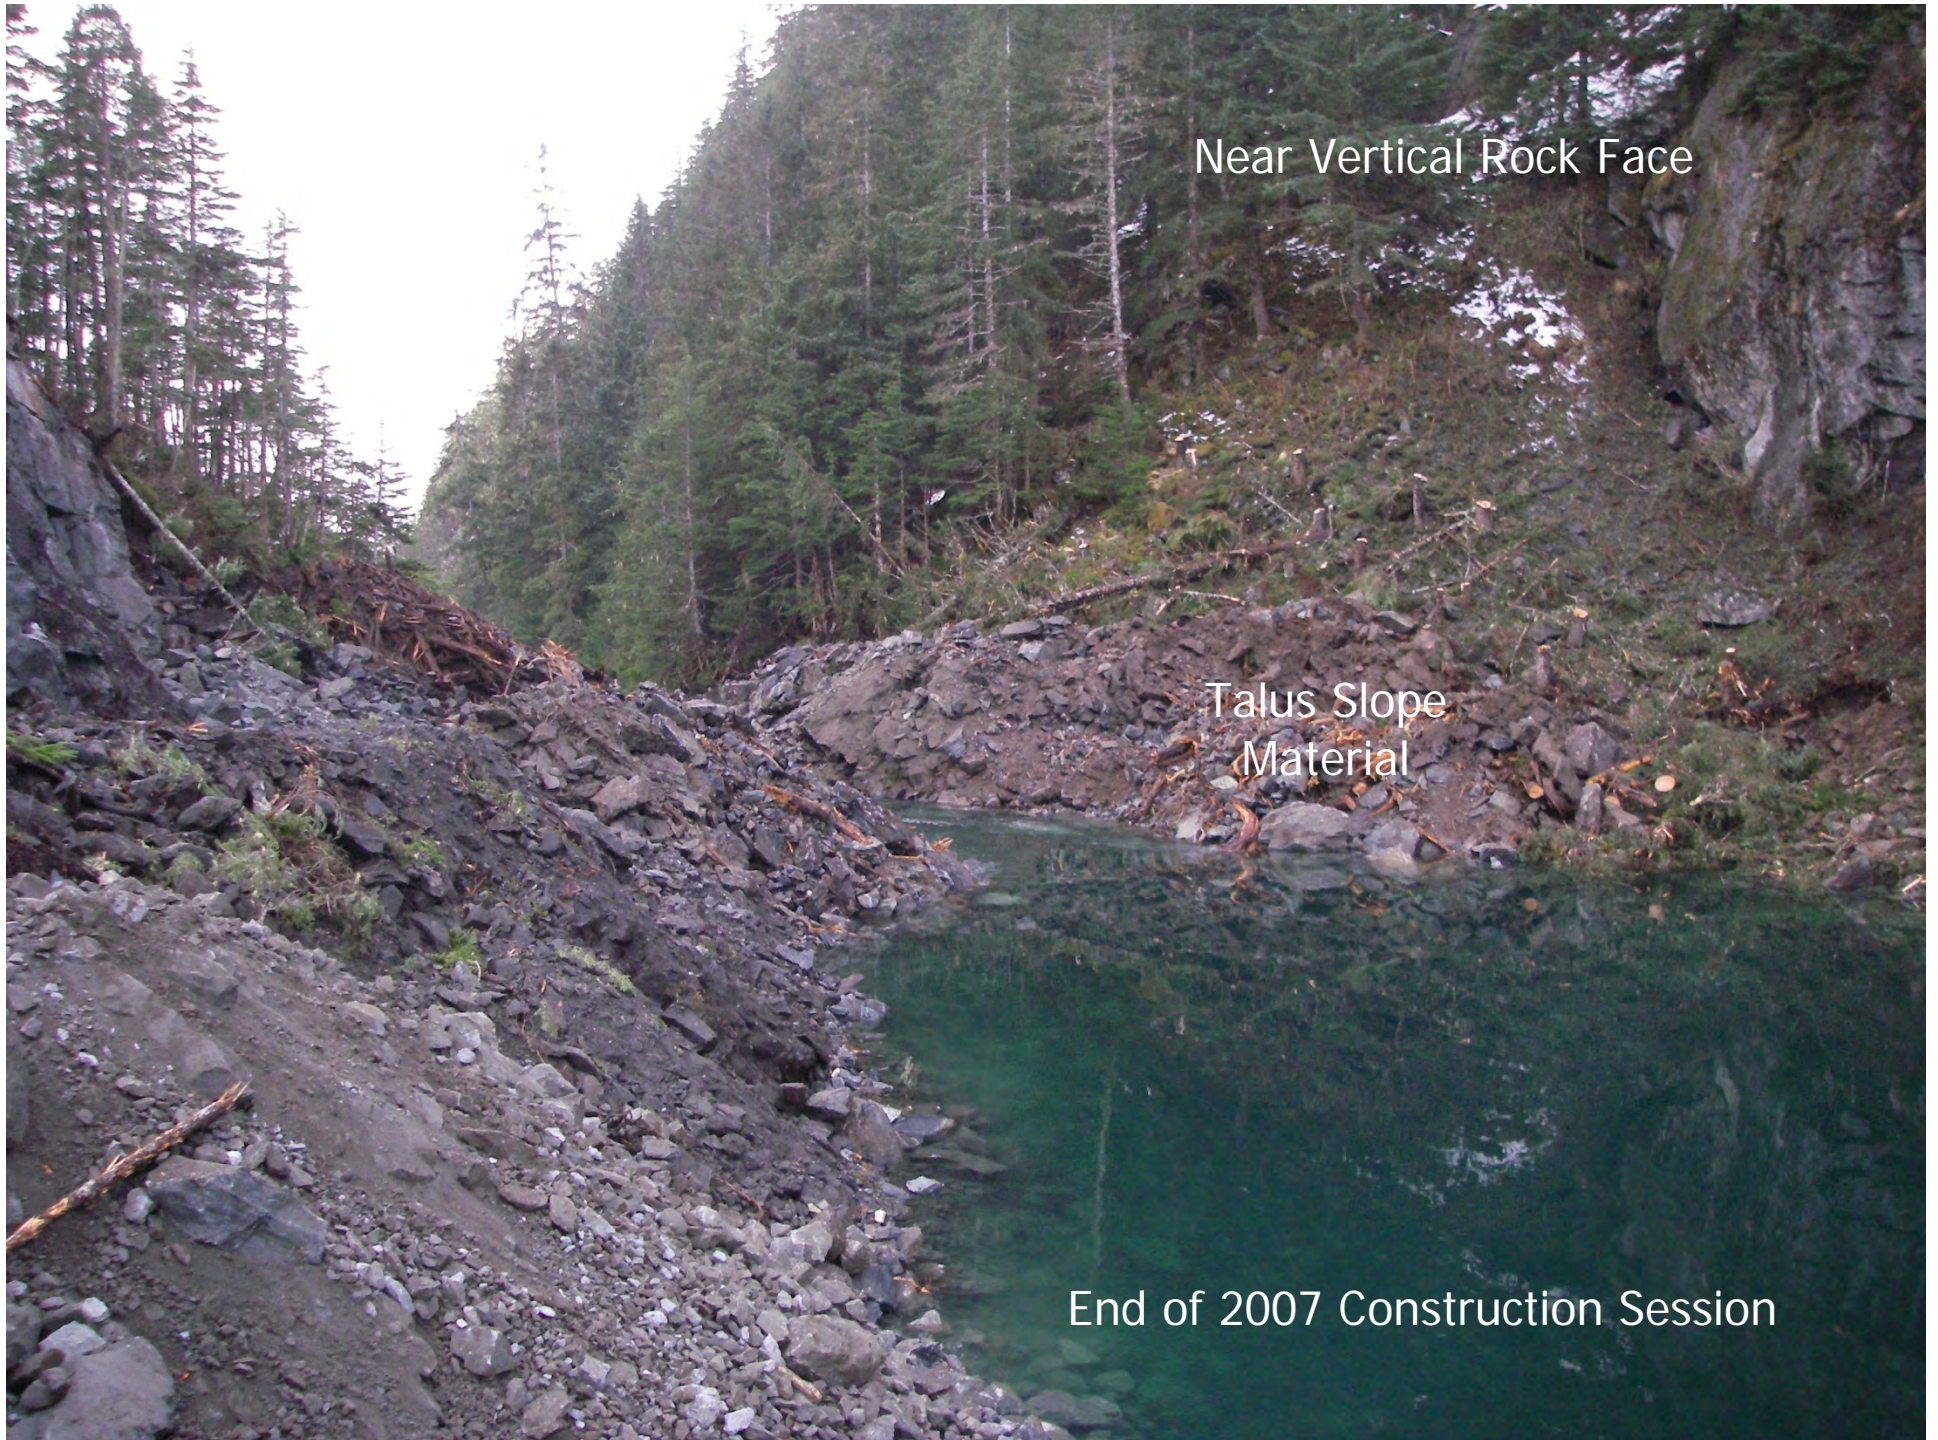
Near Vertical Rock Face

Talus Slope
Material

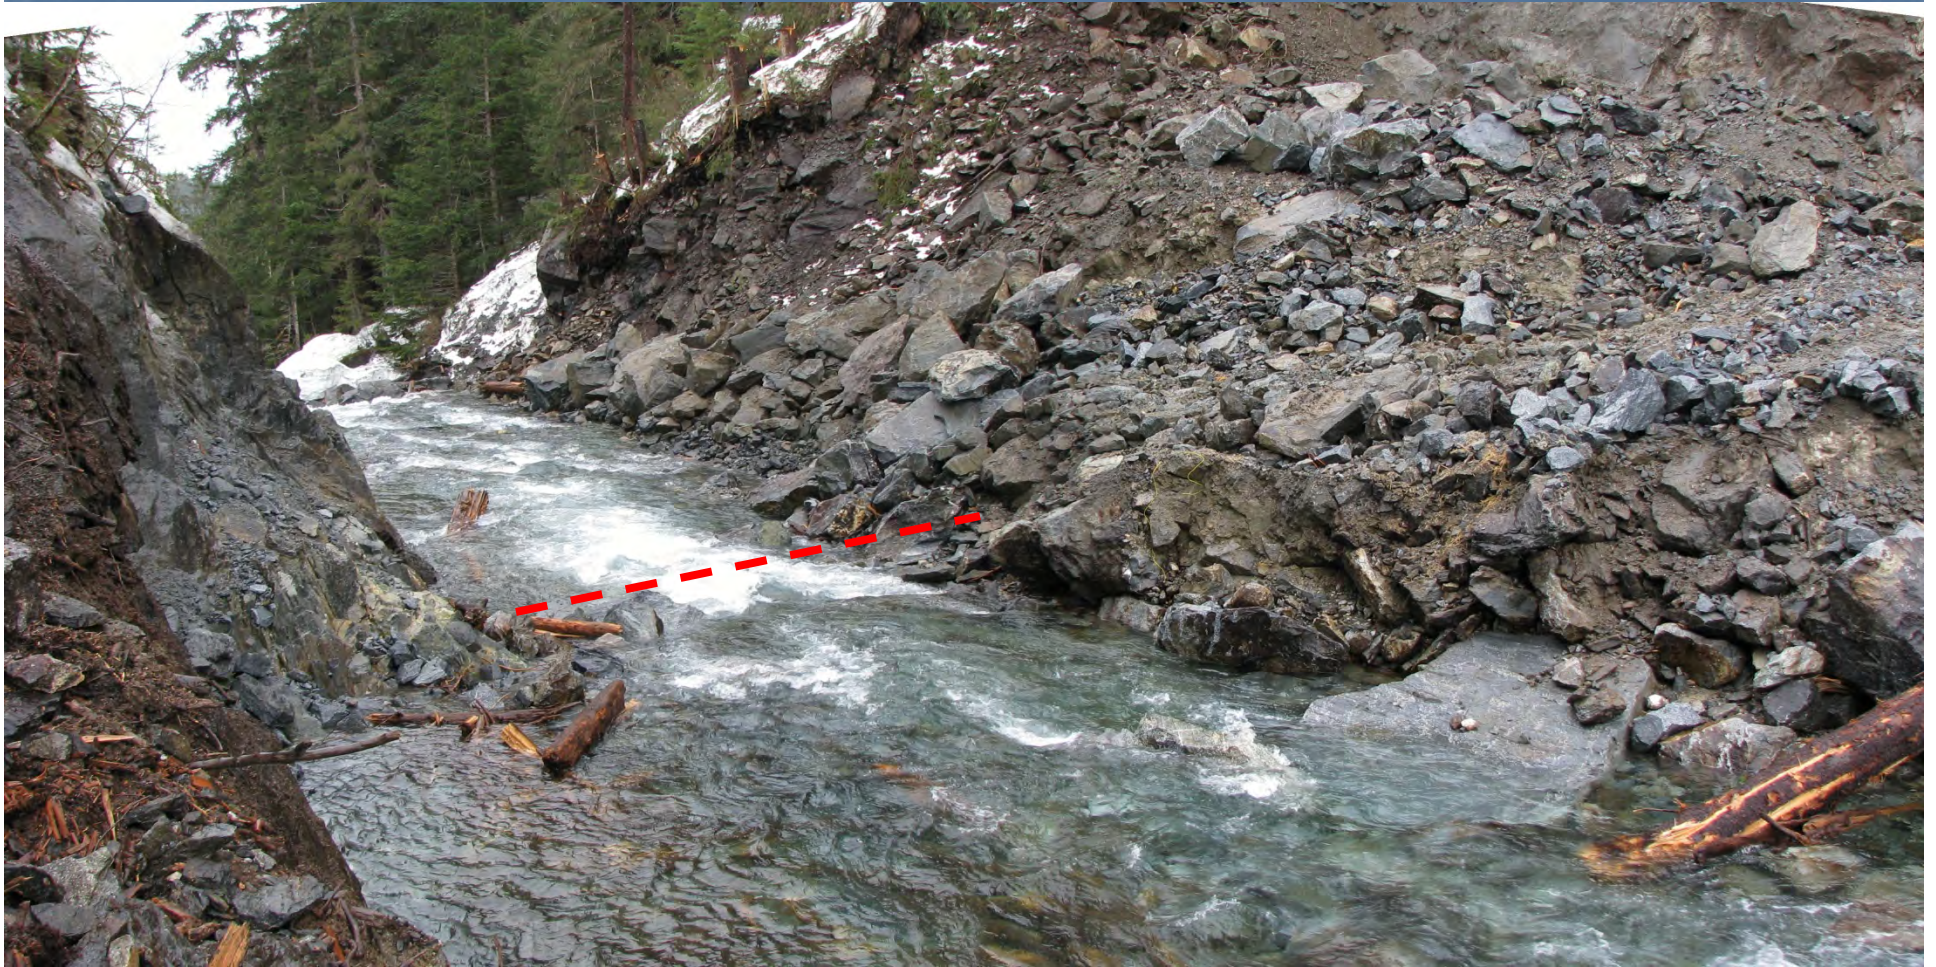
Bedrock much deeper than expected – change design

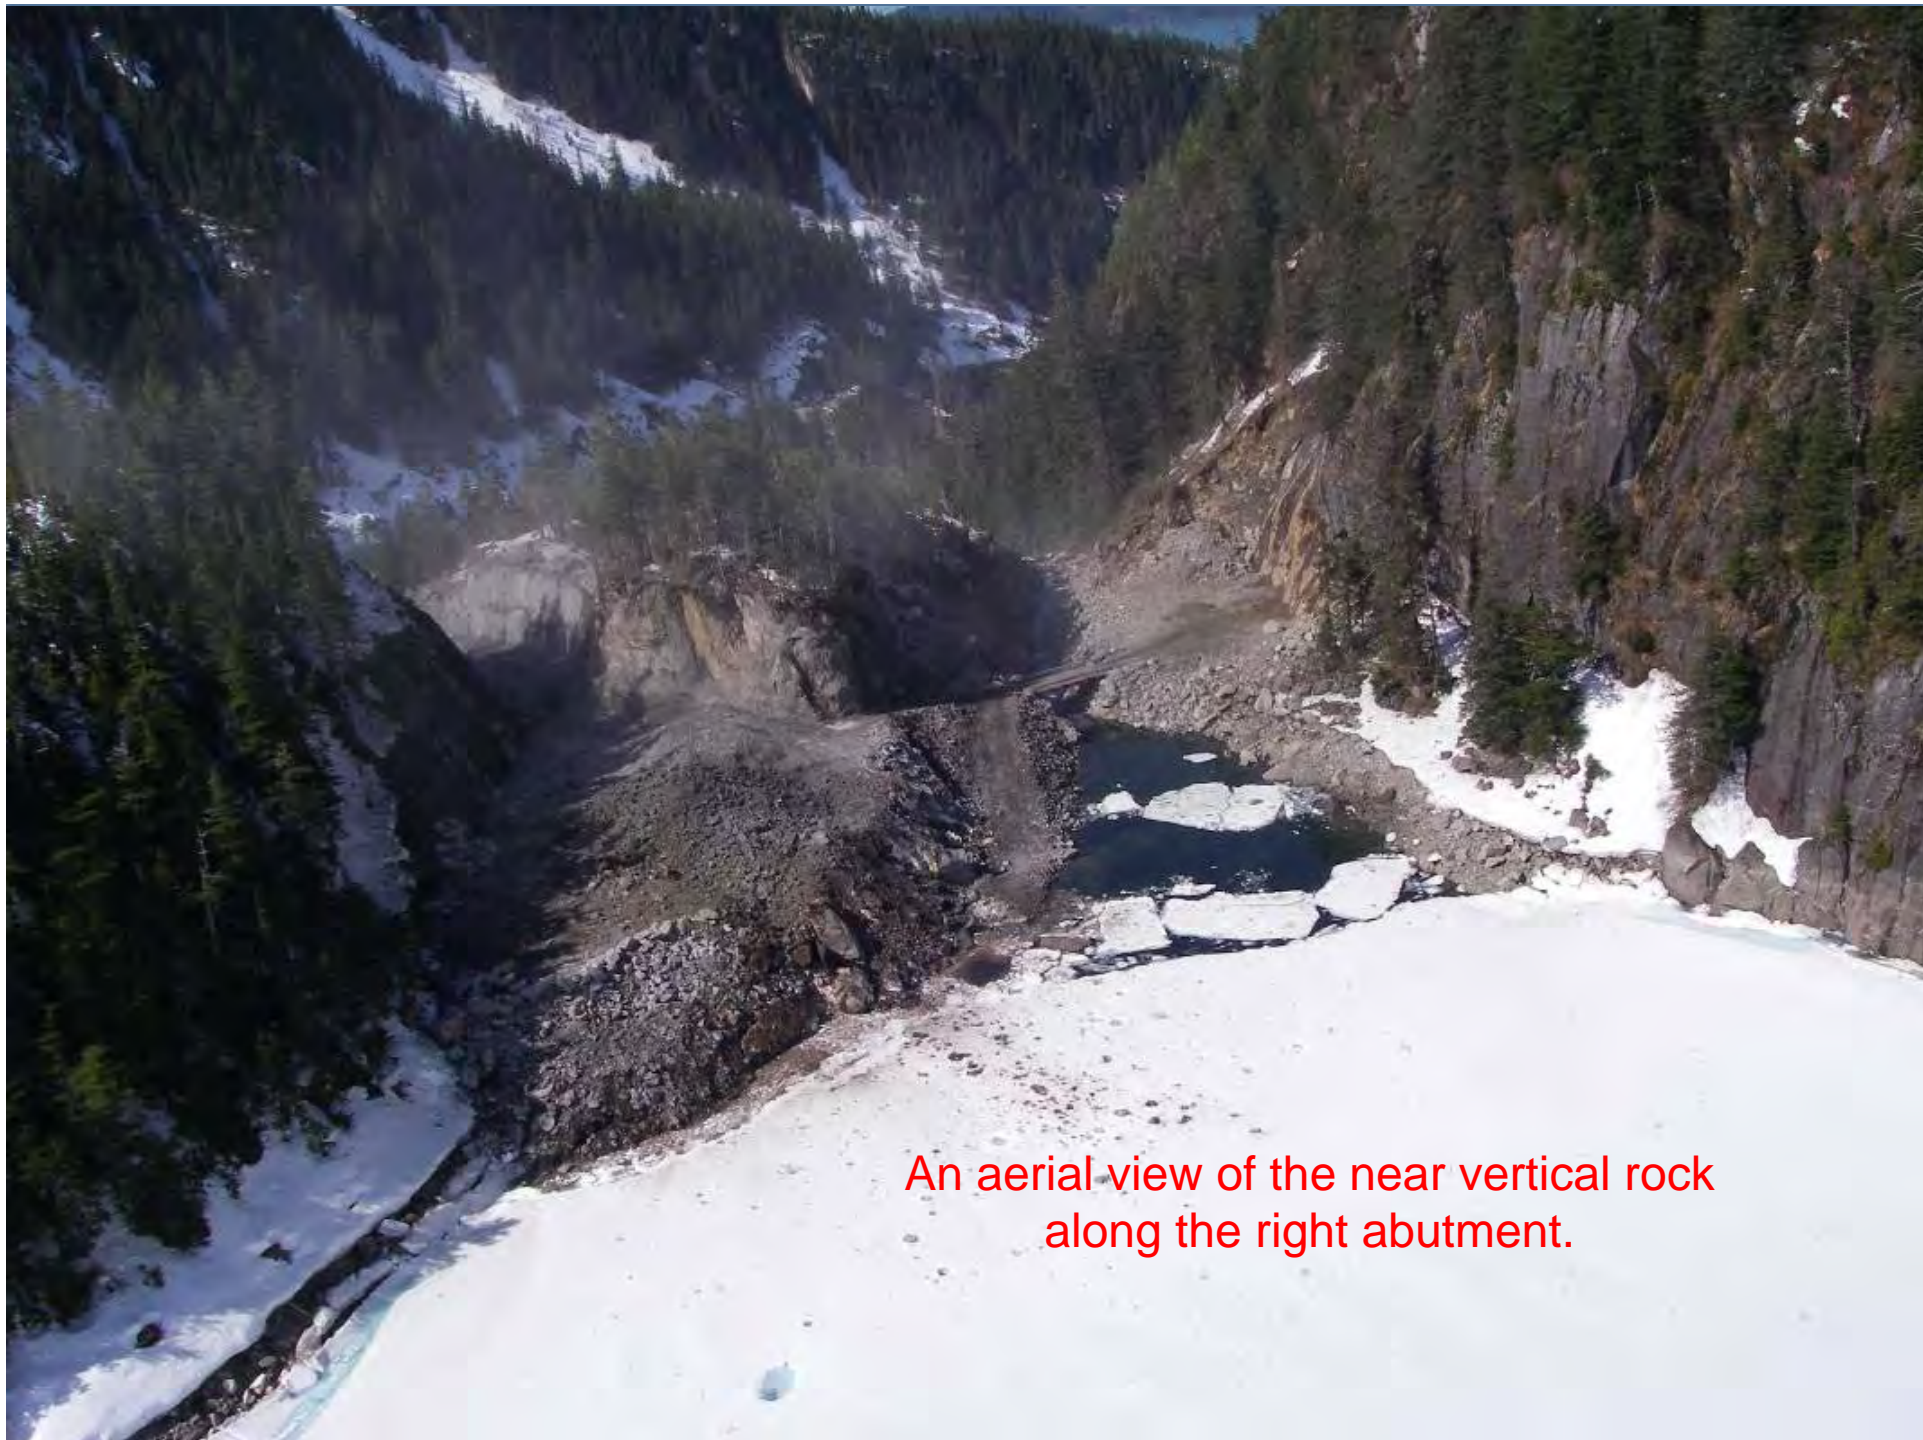
An aerial view of the near vertical rock
along the right abutment.
