The Role of Geology in the Construction of the Lake Dorothy Hydroelectric Project

Ron Wright
Senior Civil Engineer
Federal Energy Regulatory Commission

Lake Dorothy Hydroelectric Project

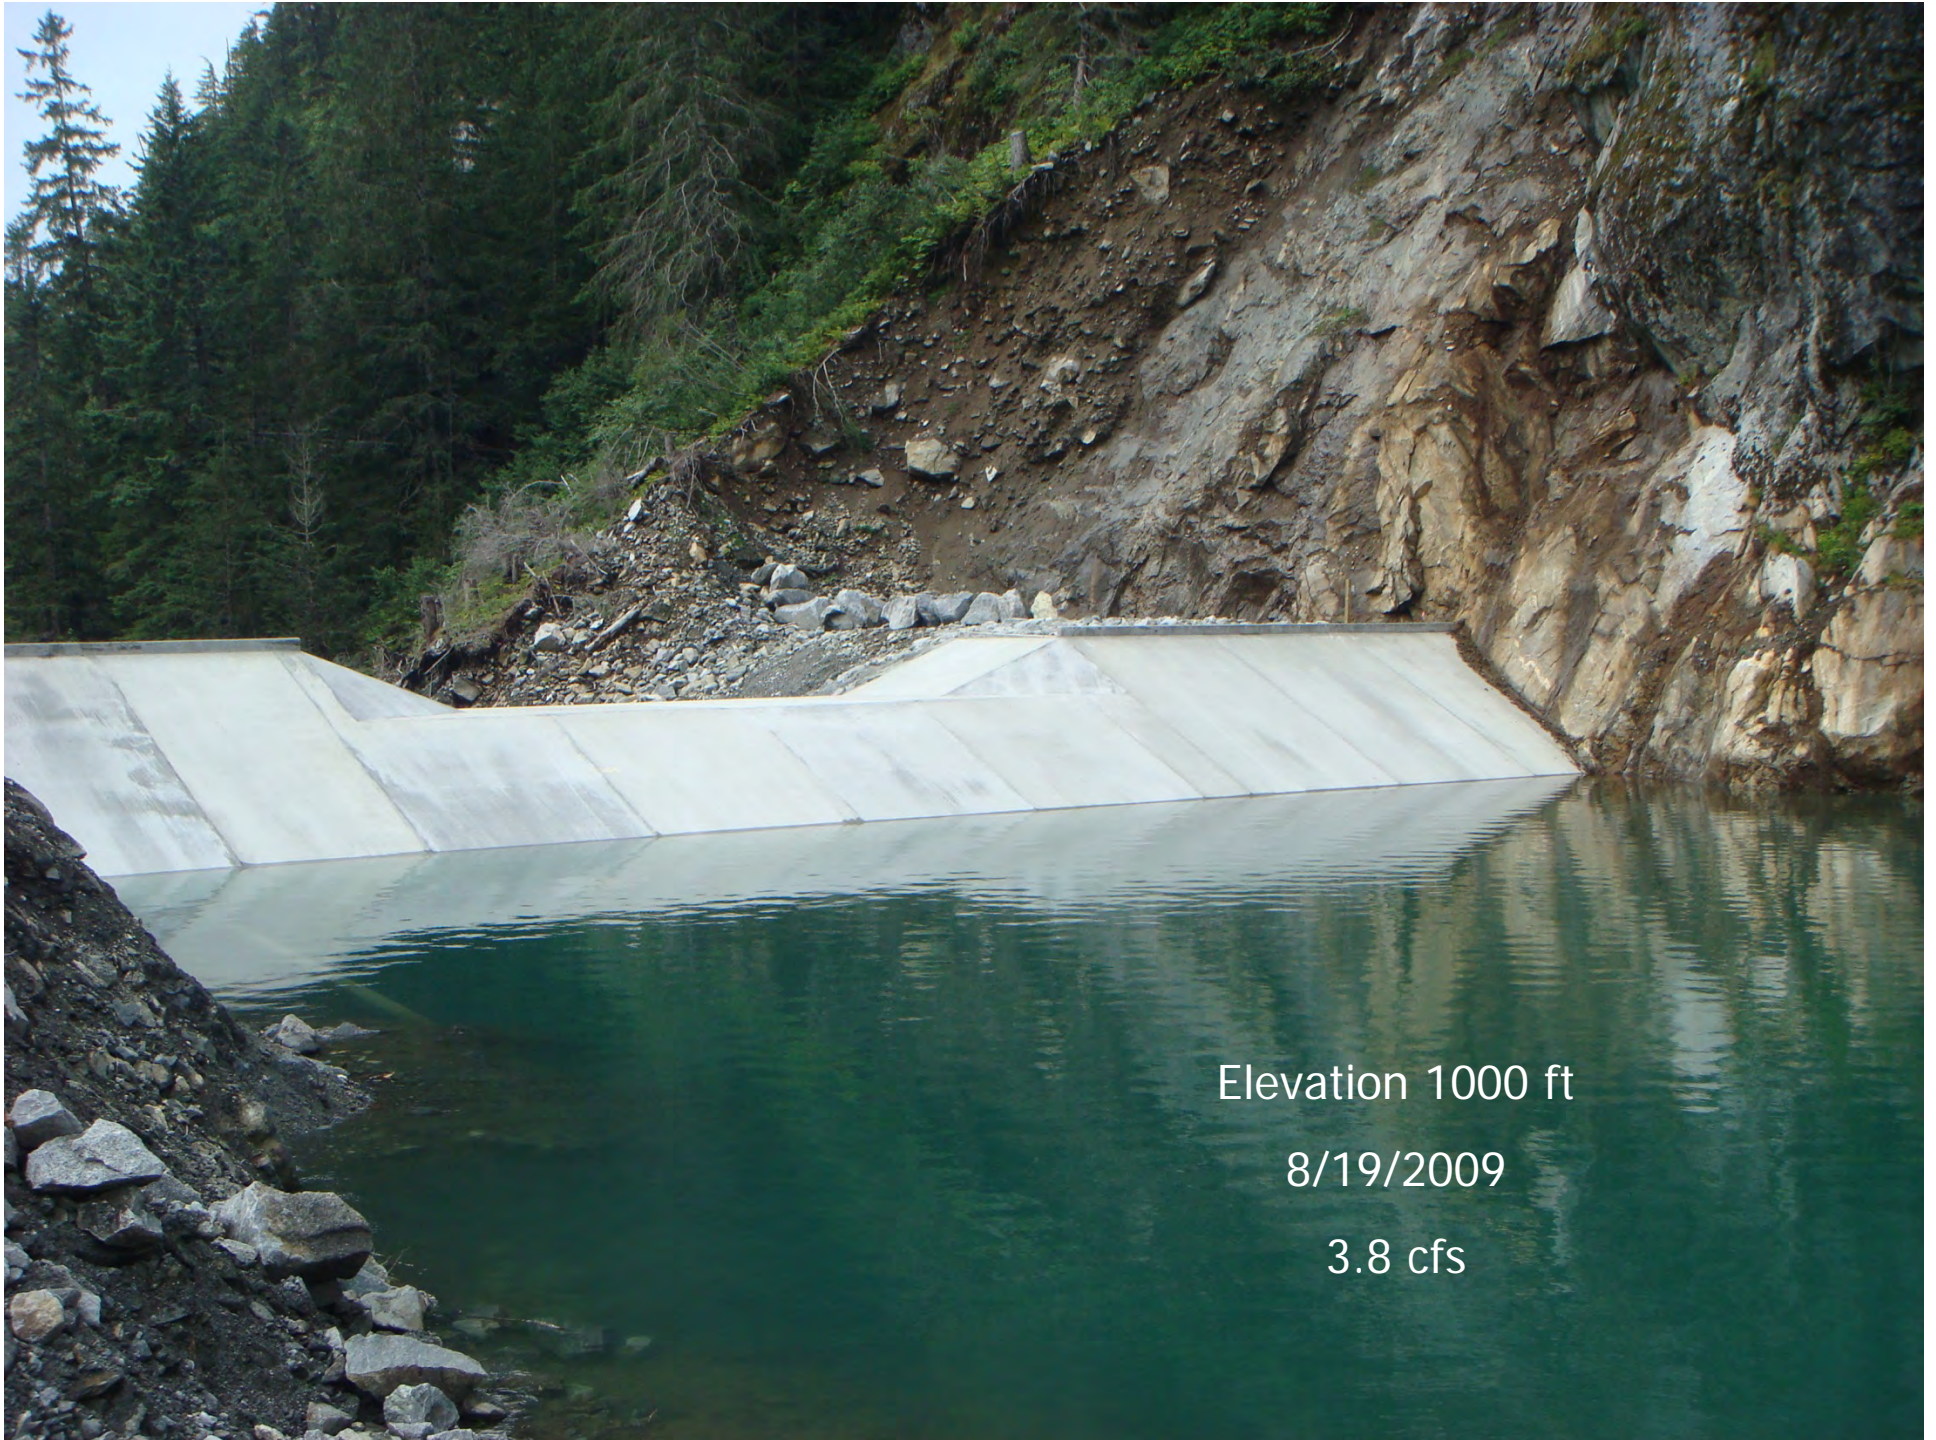
Elevation 1000 ft

8/19/2009

3.8 cfs

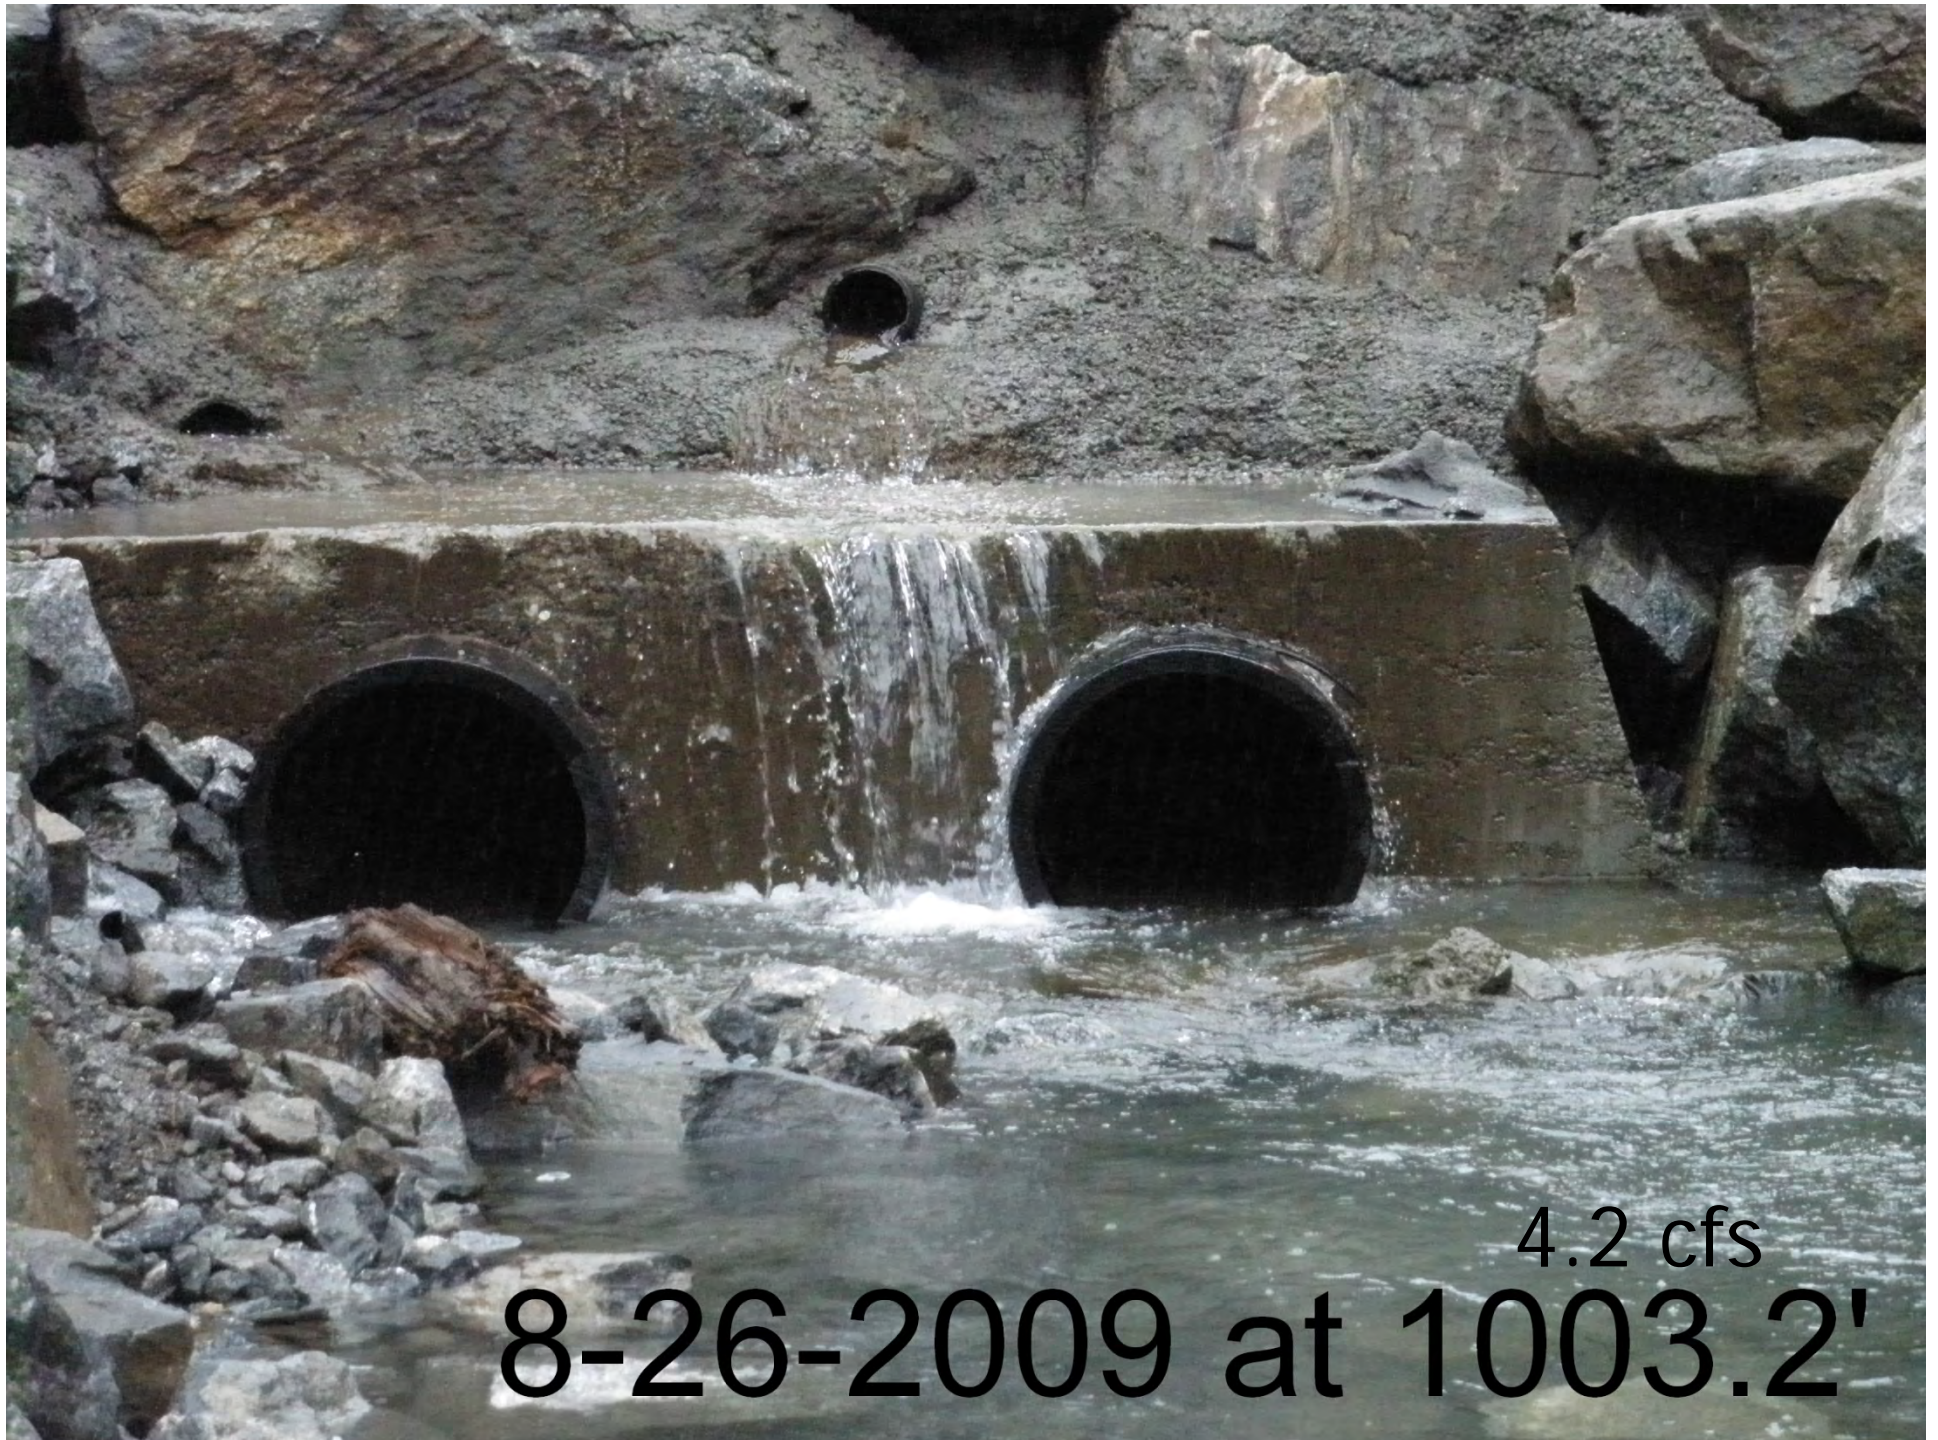
4.2 cfs
8-26-2009 at 1003.2'

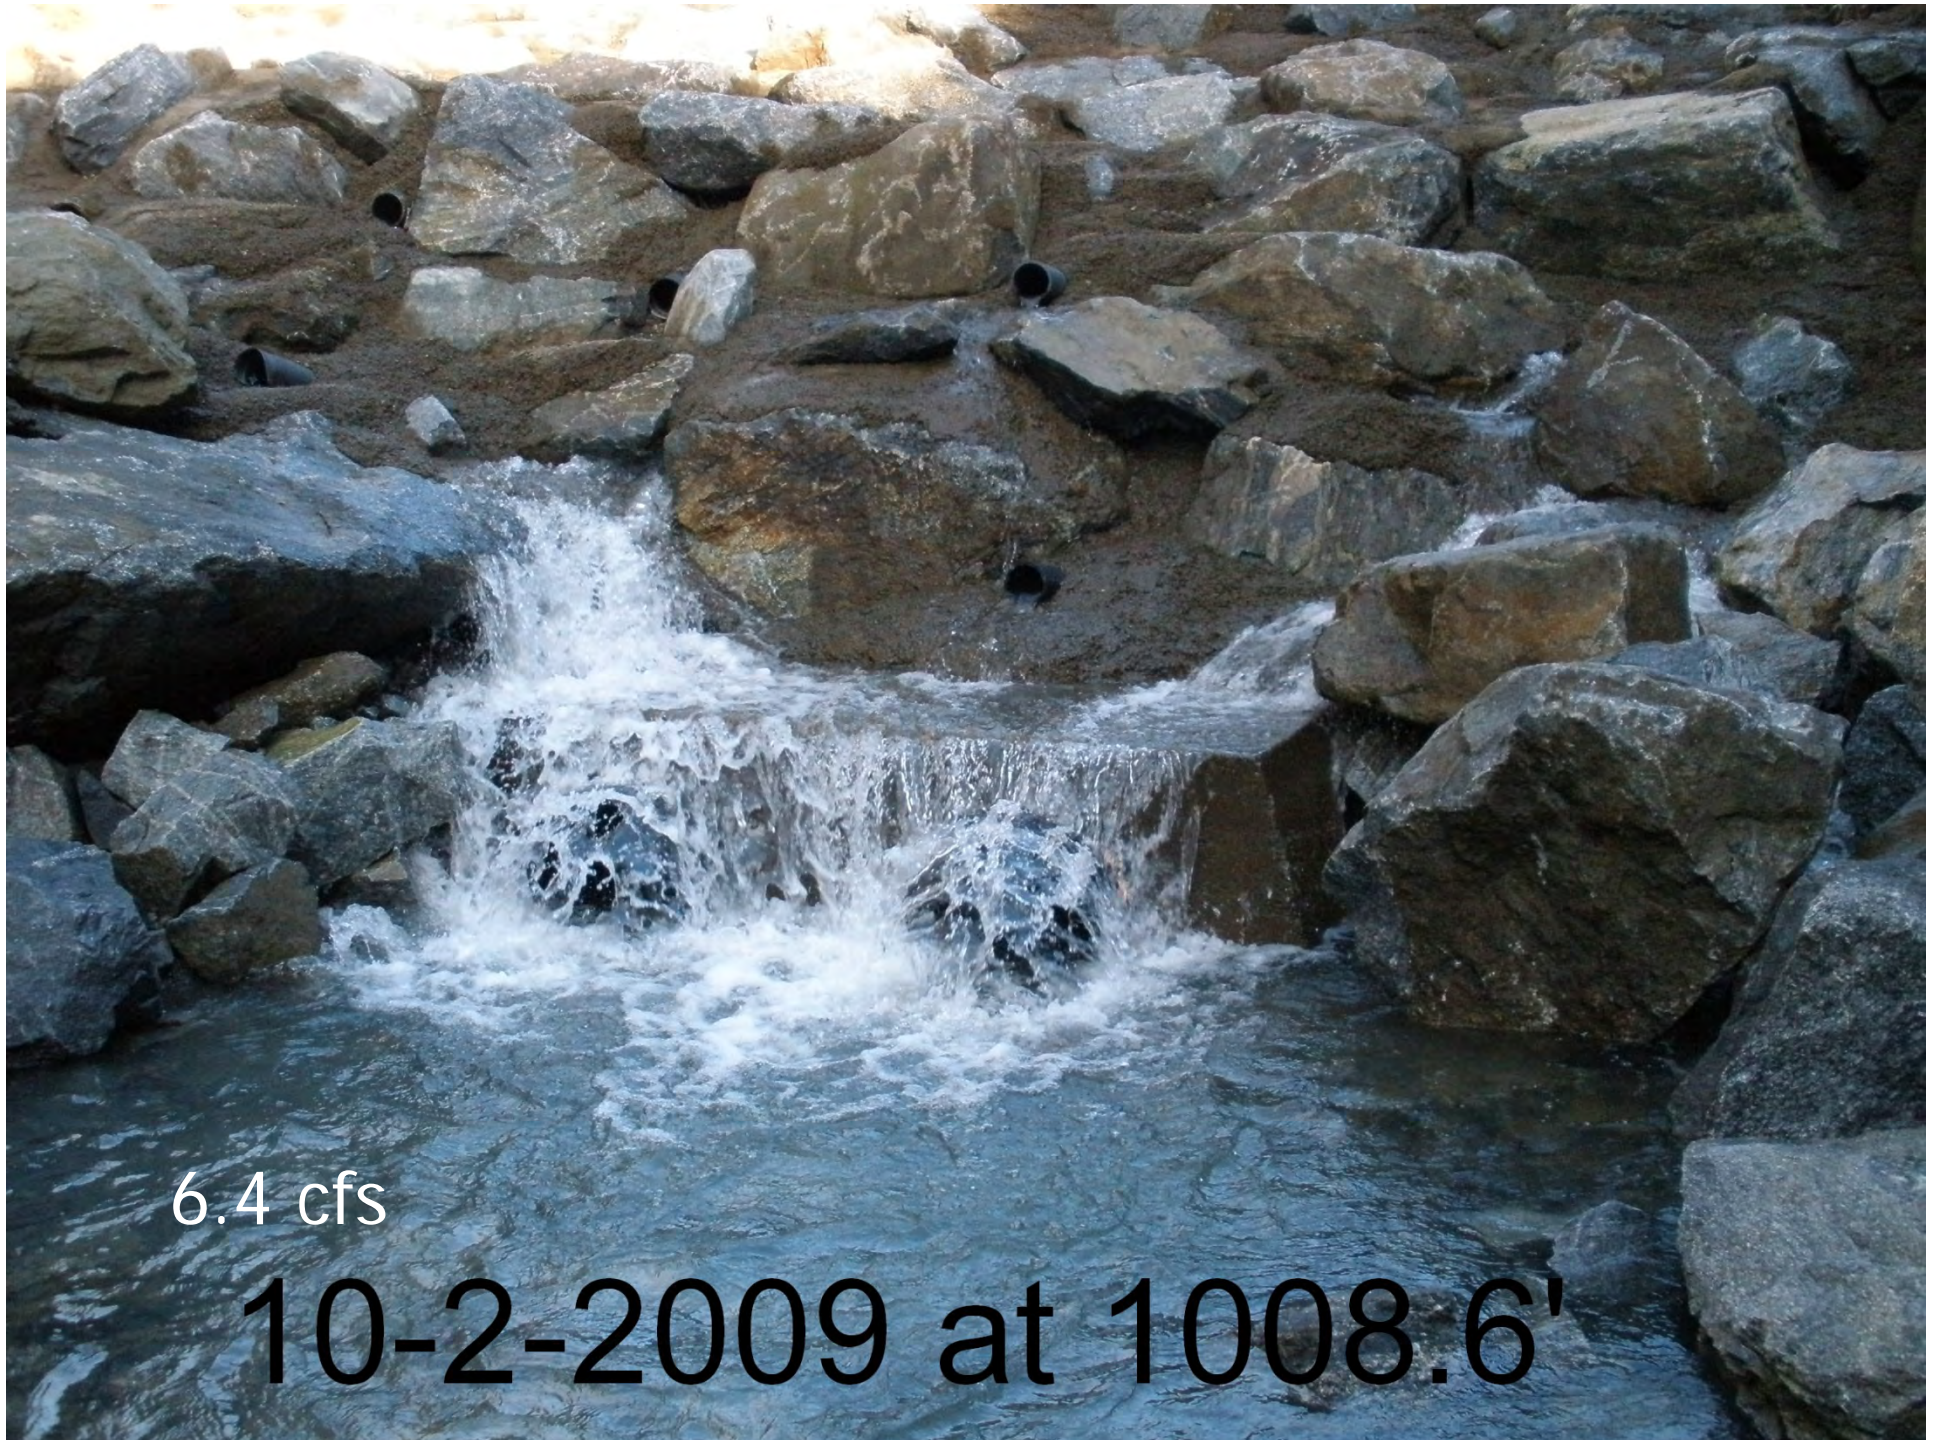
6.4 cfs

10-2-2009 at 1008.6'

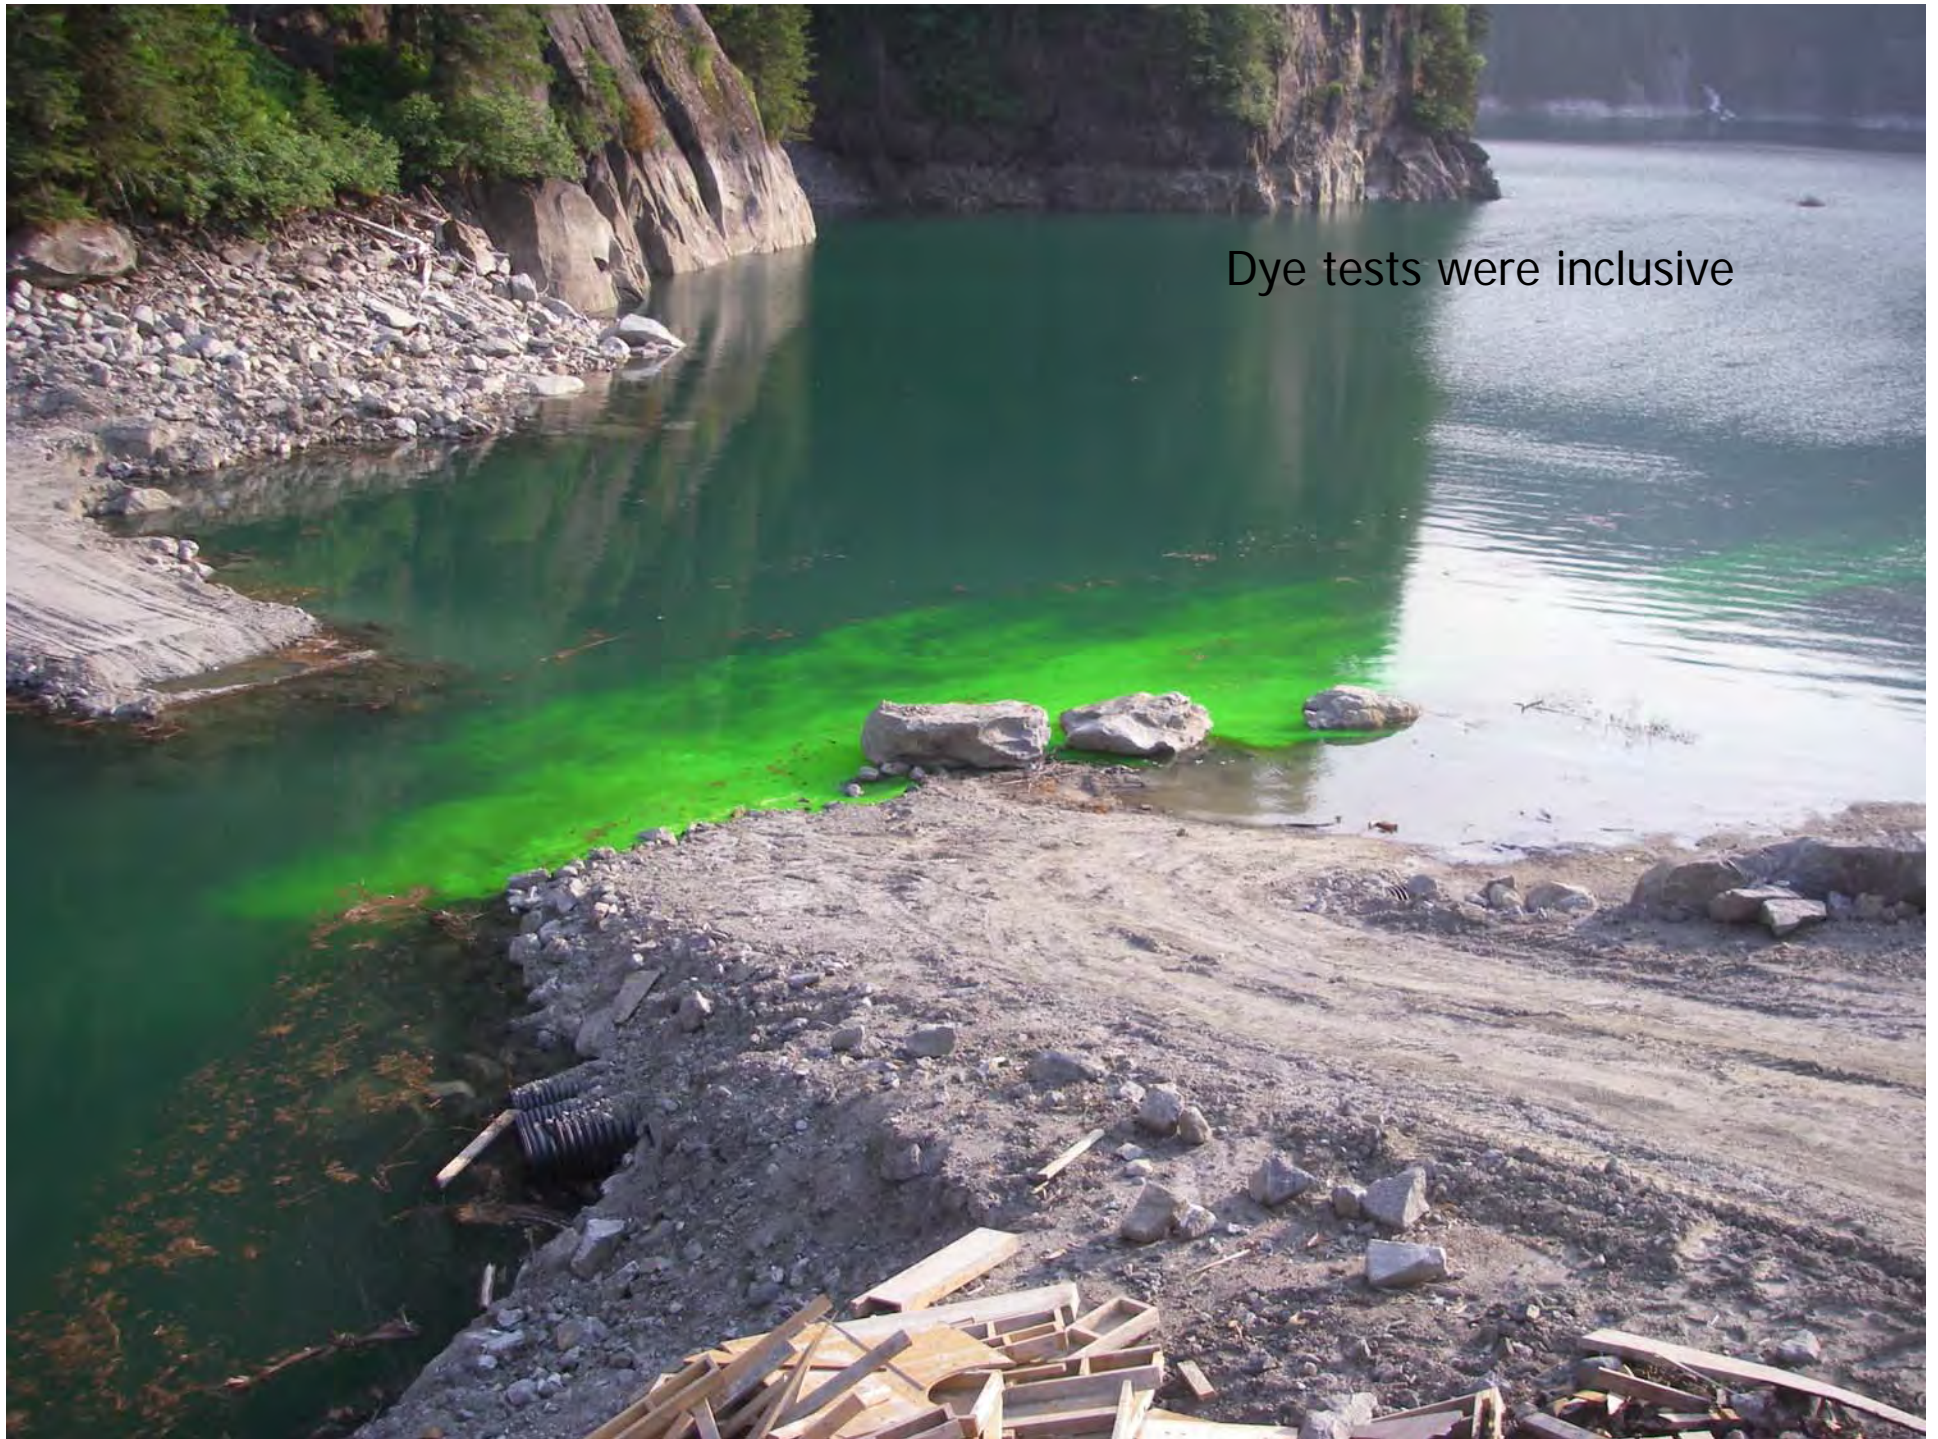
Dye tests were inclusive

Diver inspection looking for signs of leakage in
reservoir. 8/29/2009

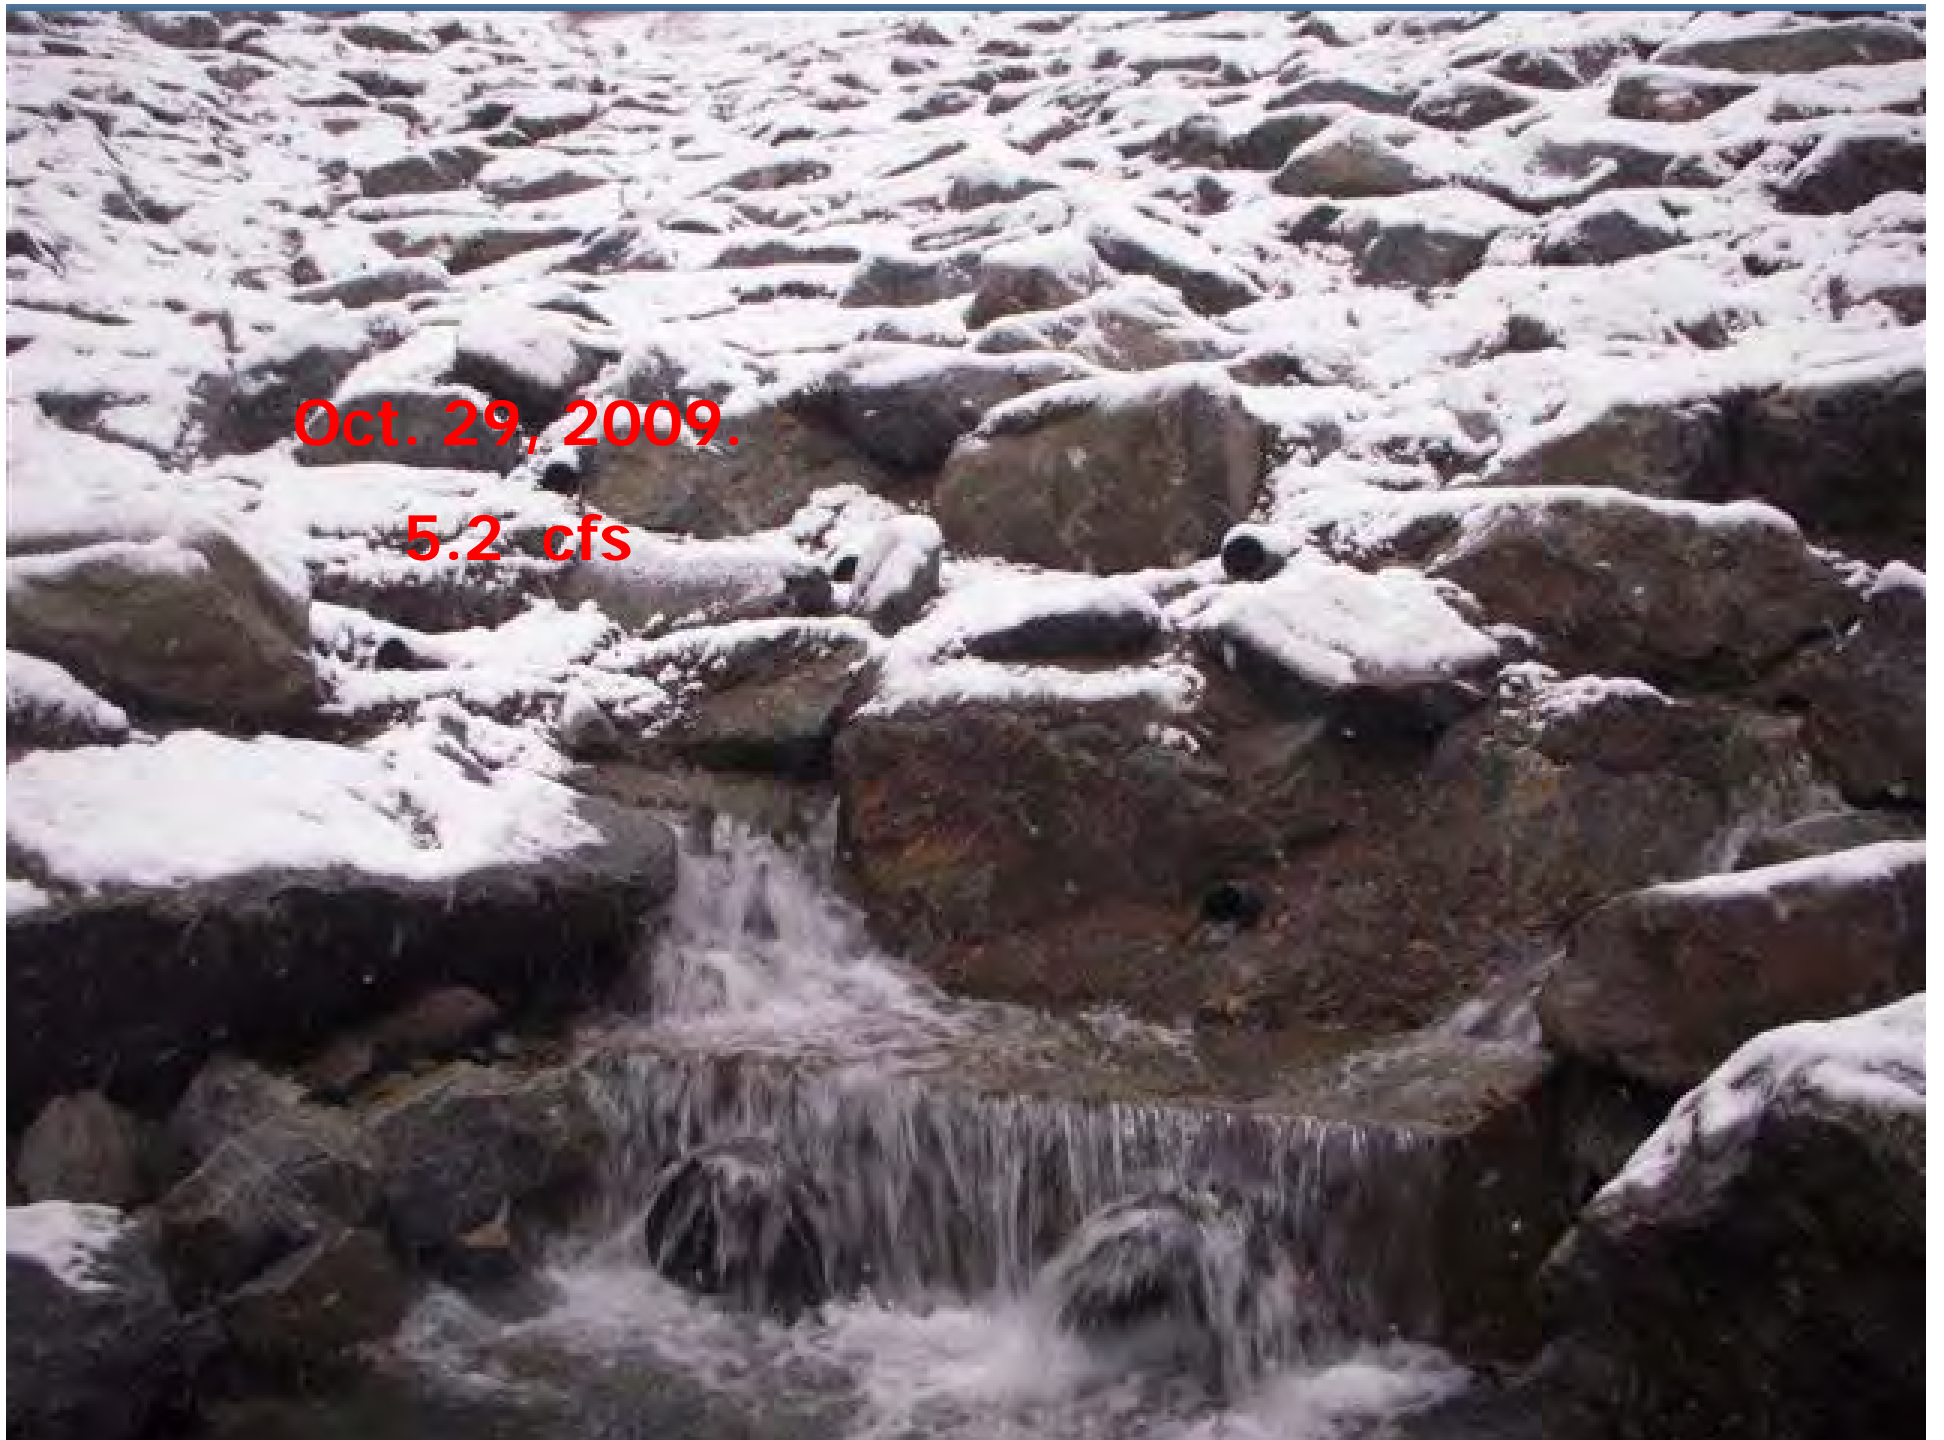
5.2 cfs

Owner Directed to Develop Seepage Remediation Plan

2010 Upstream Blanket Extension

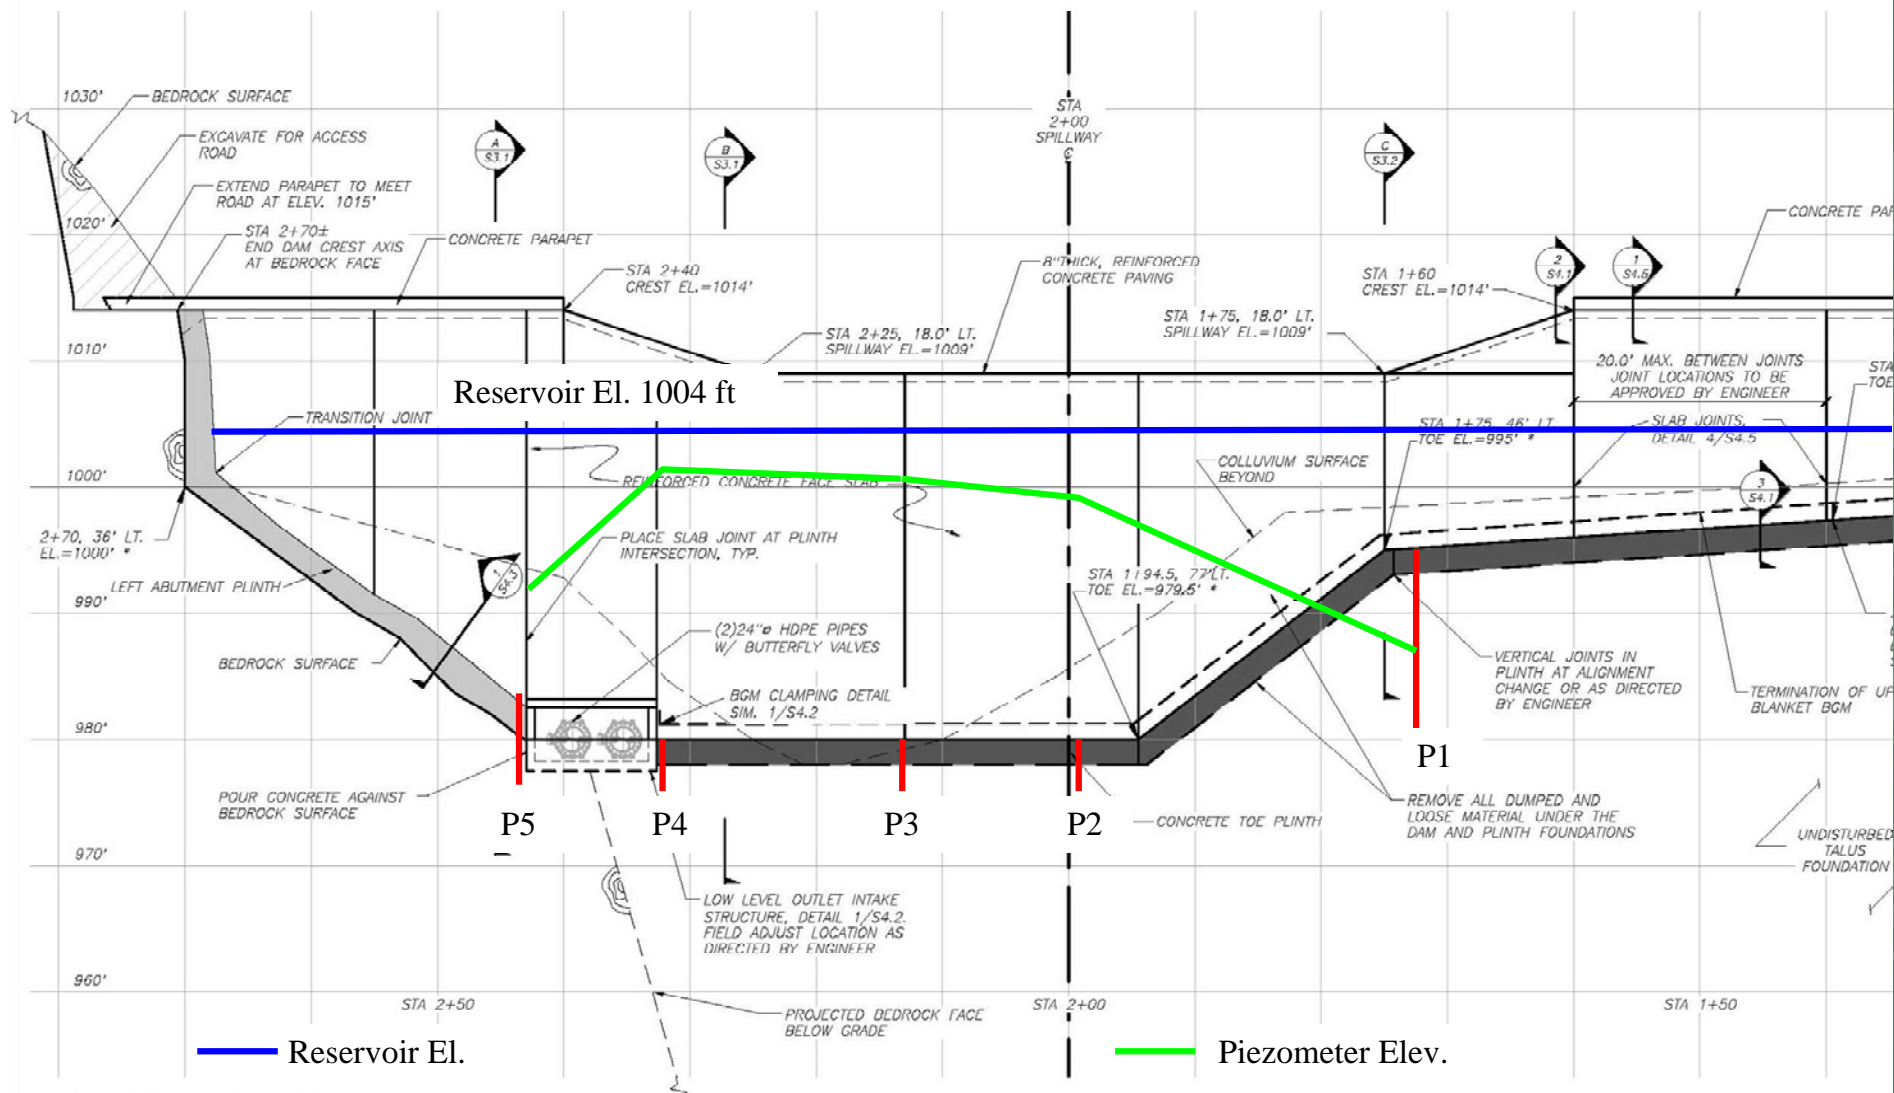
No Change in Seepage

6.9 cfs

7-30-2010 at 1008.2'
