Turning Geologic Data into Knowledge; A summary of dam failure case histories

Pete Shaffner P.G.

Senior Engineering Geologist Risk Management Center US Army Corps of Engineers Denver, Colorado

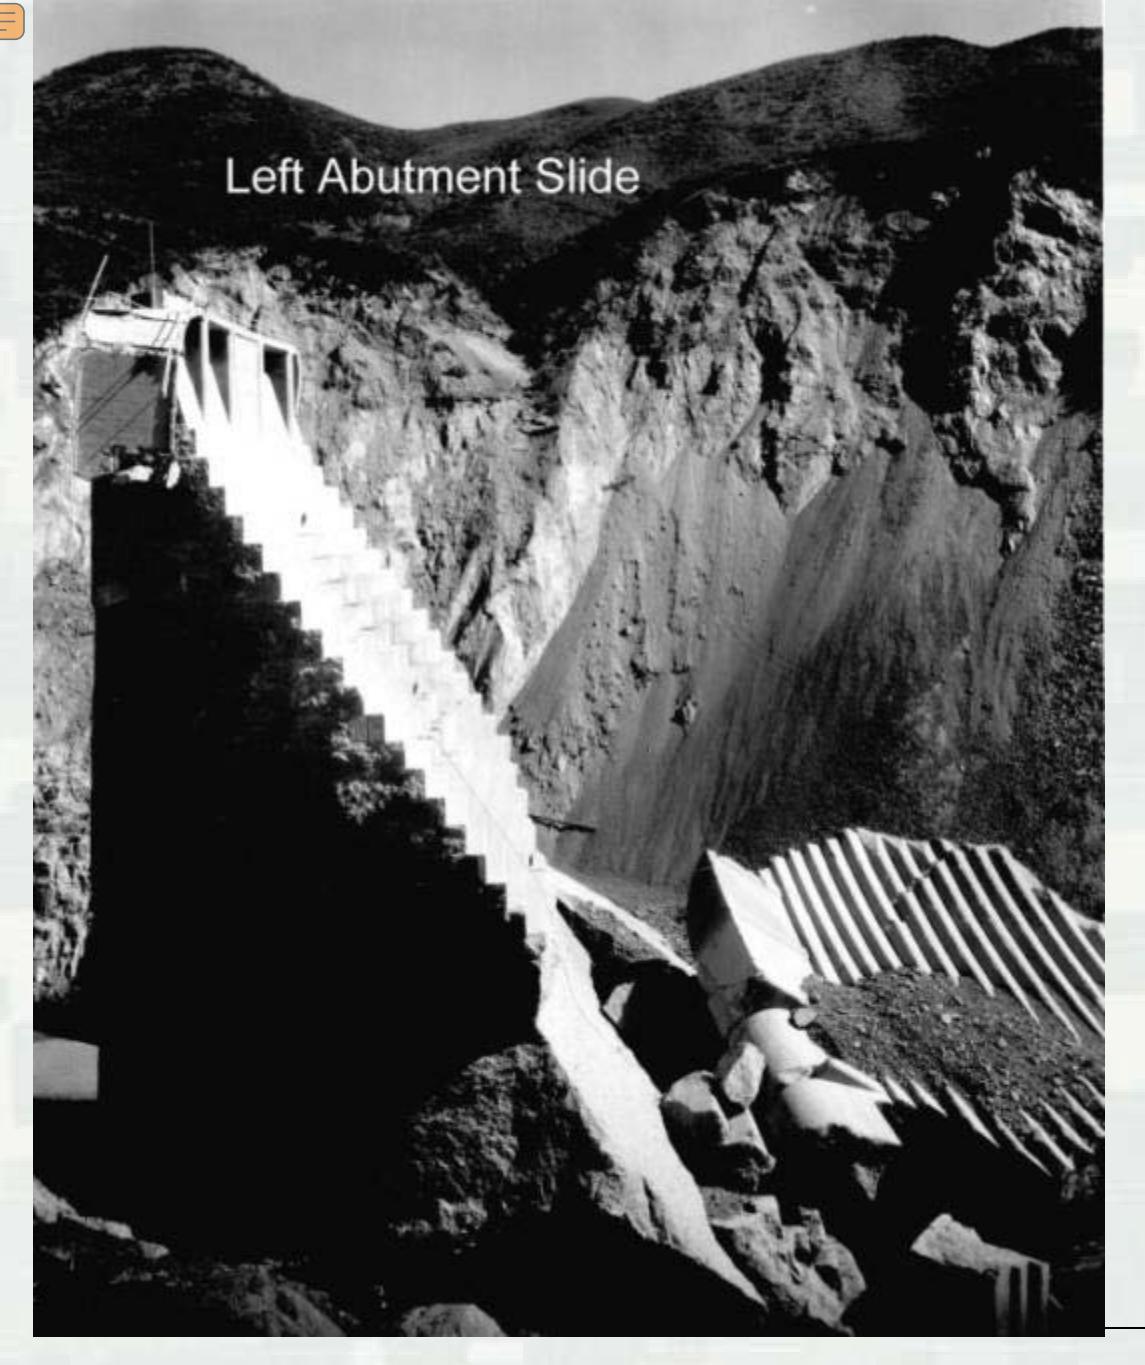
St. Francis Dam 1928

St. Francis Dam • Failure midnight March 12, 1928 450 lives lost Left abutment sliding initiated failure Re-analyzed by J. David Rogers and Karl F. Hasselmann Geology was evaluated and believed adequate Paleo landslides were completely missed

Two of the world's leading geologists at the time, John C. Branner of Stanford University and Carl E. Grunsky, found NO major problems with the foundation.

After failure Bailey Willis recognized paleo landslides.

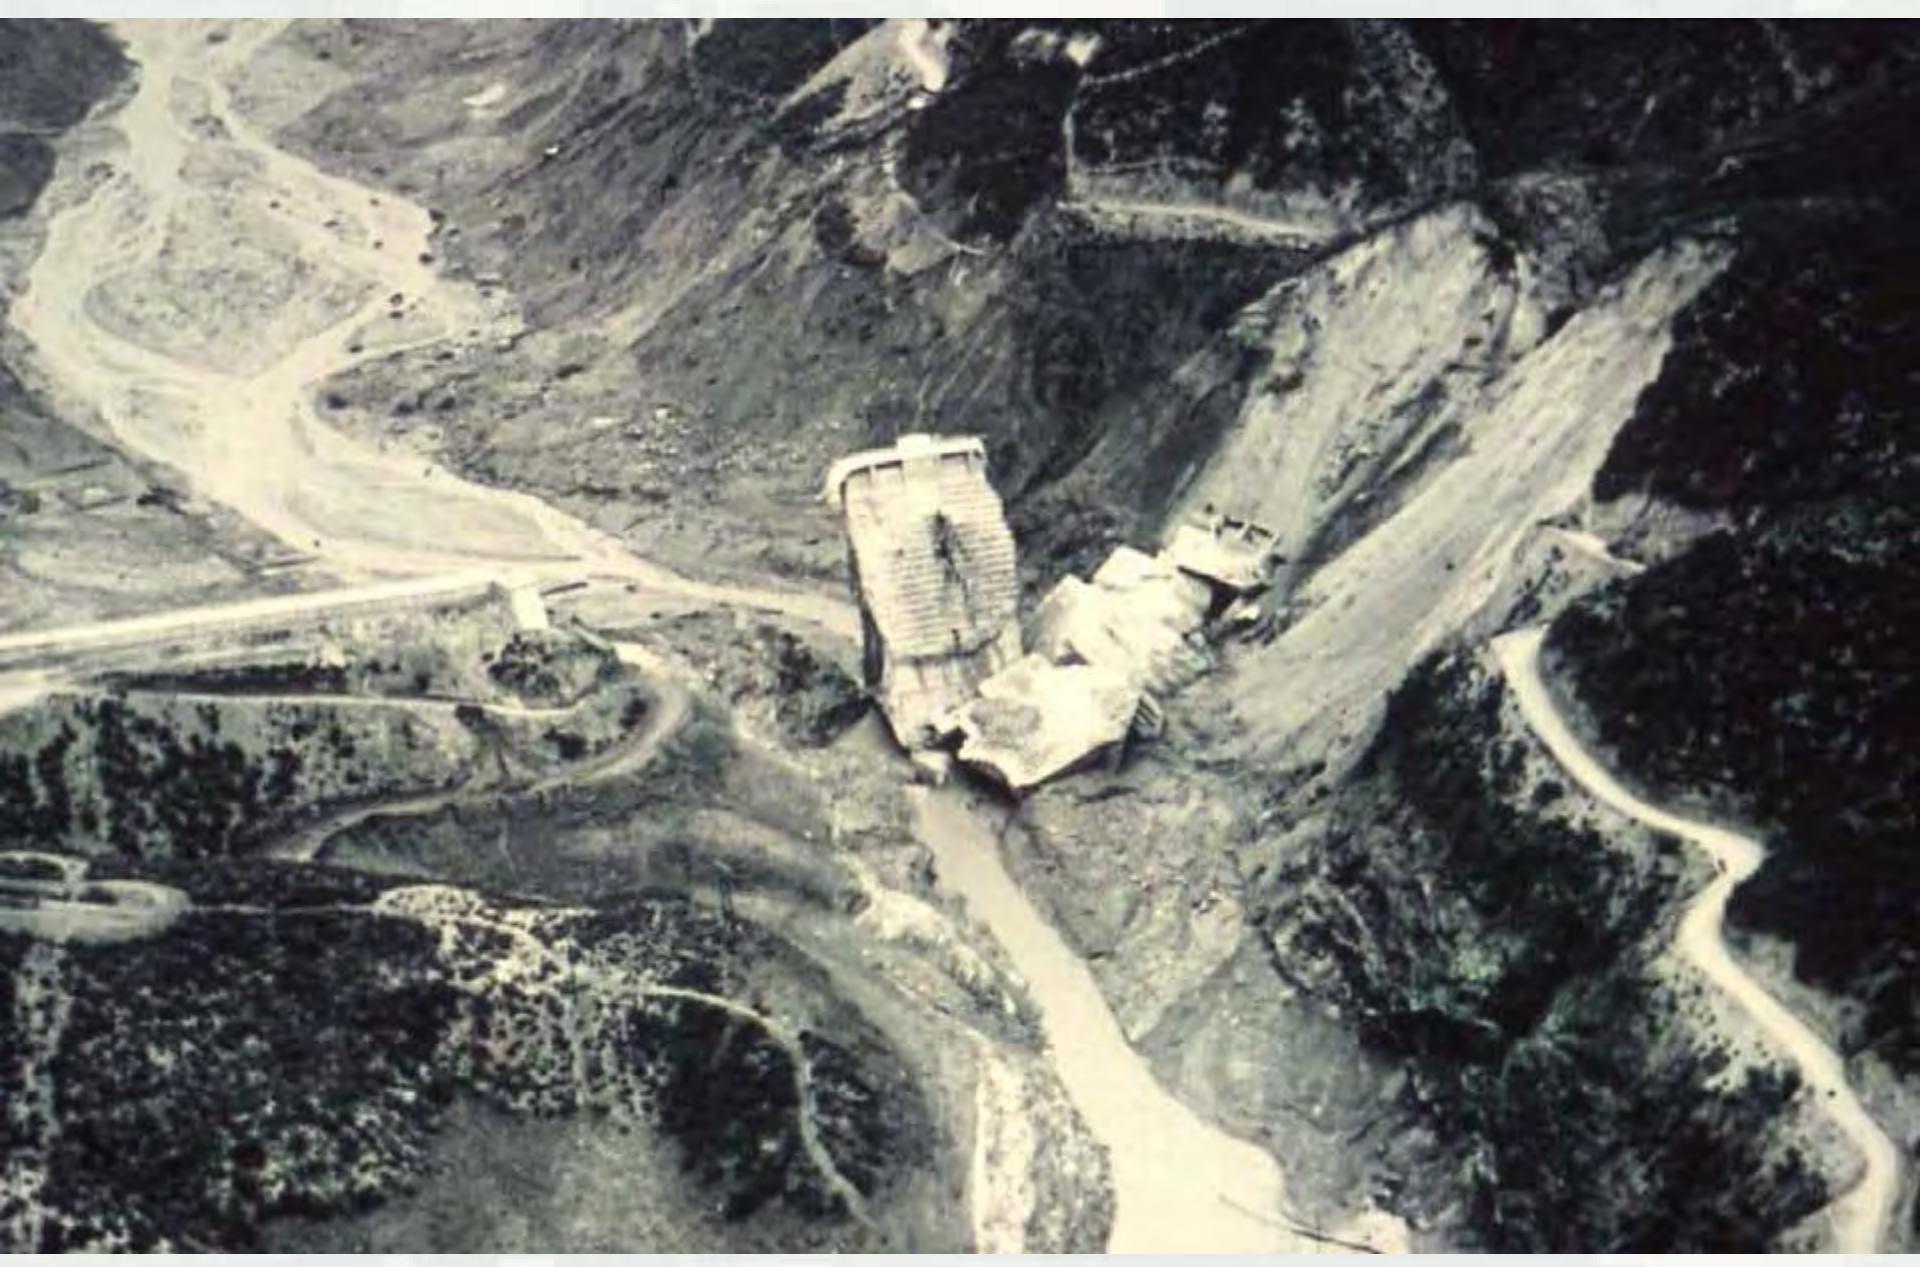
No Drains on abutment

MUDDY DISCHARGE

Scour Line

Concrete Blocks Carried Downstream

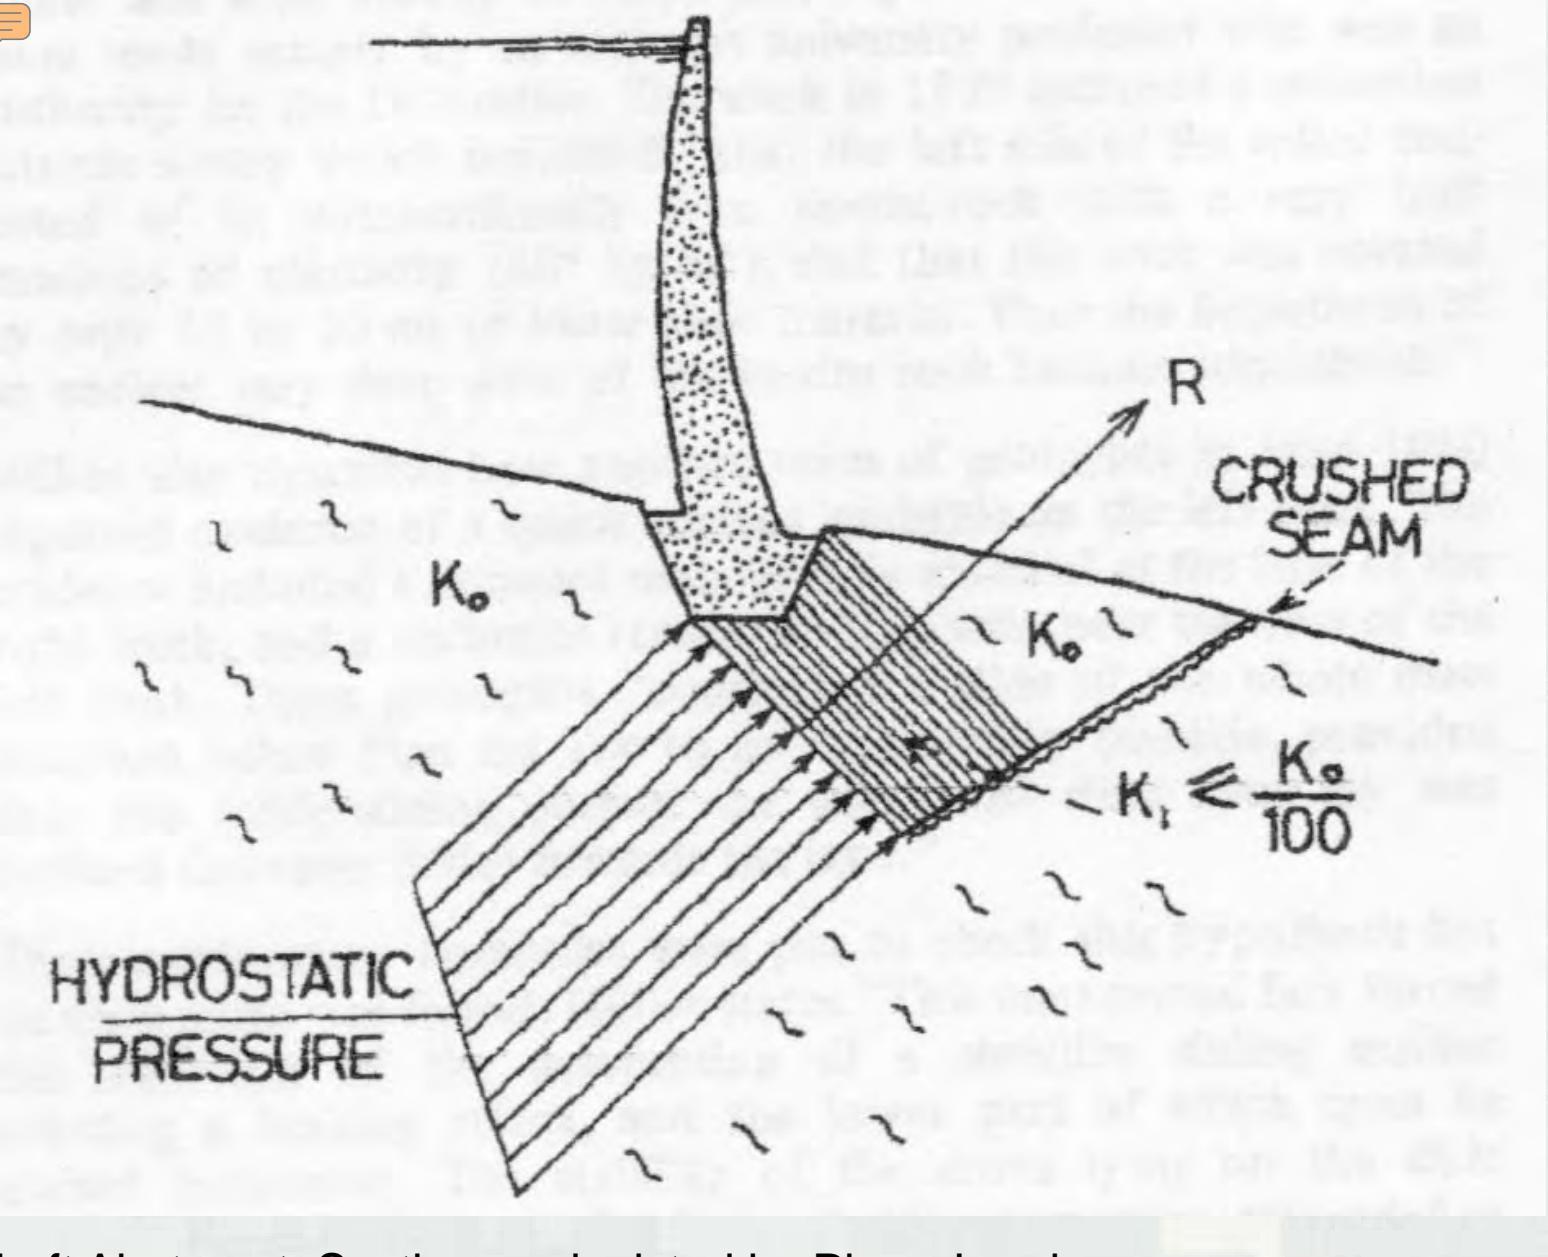
Left Abutment Section as depicted by Pierre Londe

• Failure was caused by hydraulic uplift of a large rock wedge lying beneath the dam's left abutment

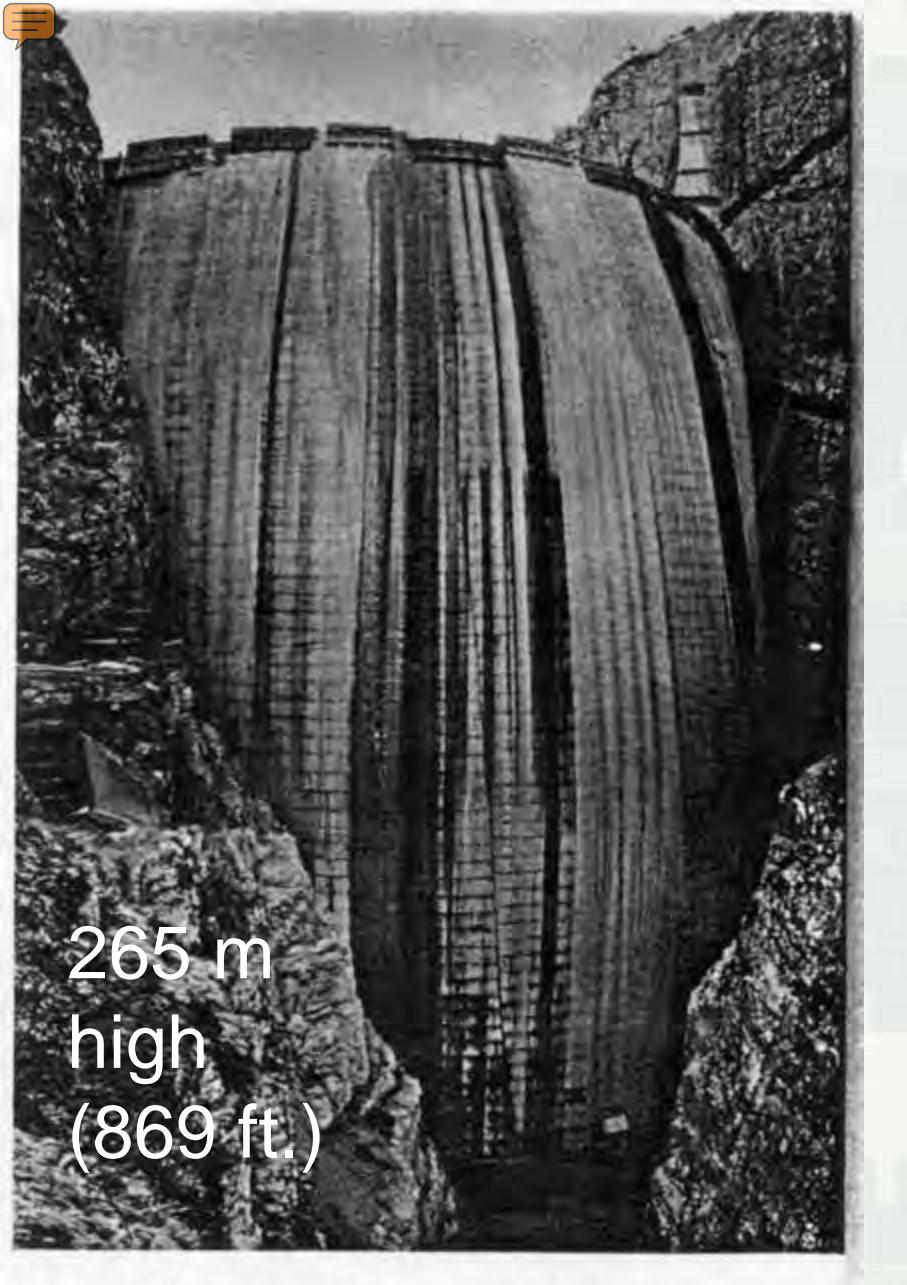
Vaiont Dam nearing completion as seen from upstream.

The dam itself and the foundation was not the issue

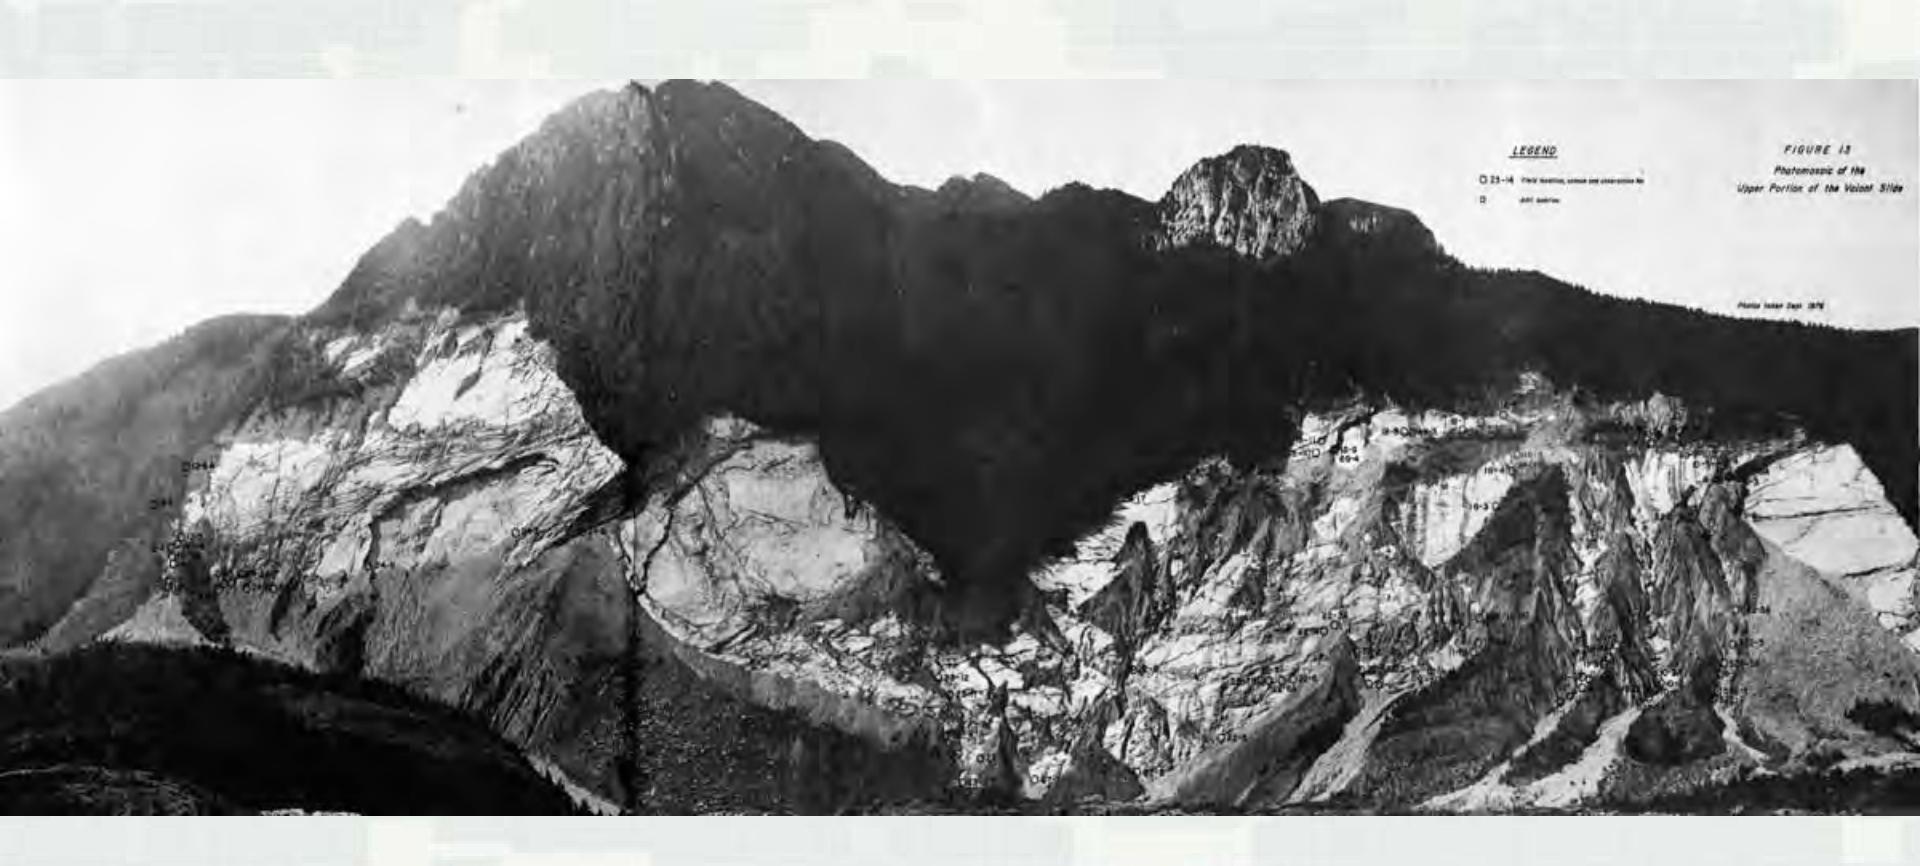
Enormous landslide scarp in limestone on left side of Vaoint Reservoir.

Volume estimated to be 340 million cu. yds

Resulted in a wave approximately 328 feet tall overtopping the dam.

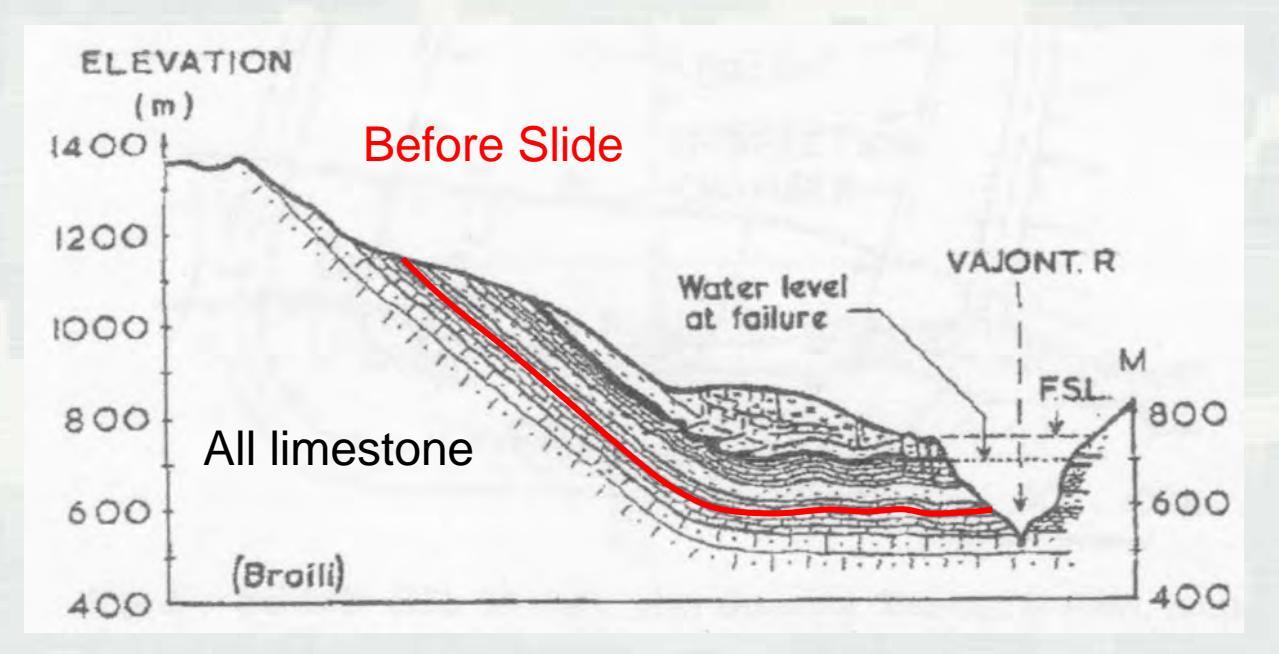
Vaoint Landslide

View of left bank, looking downstream

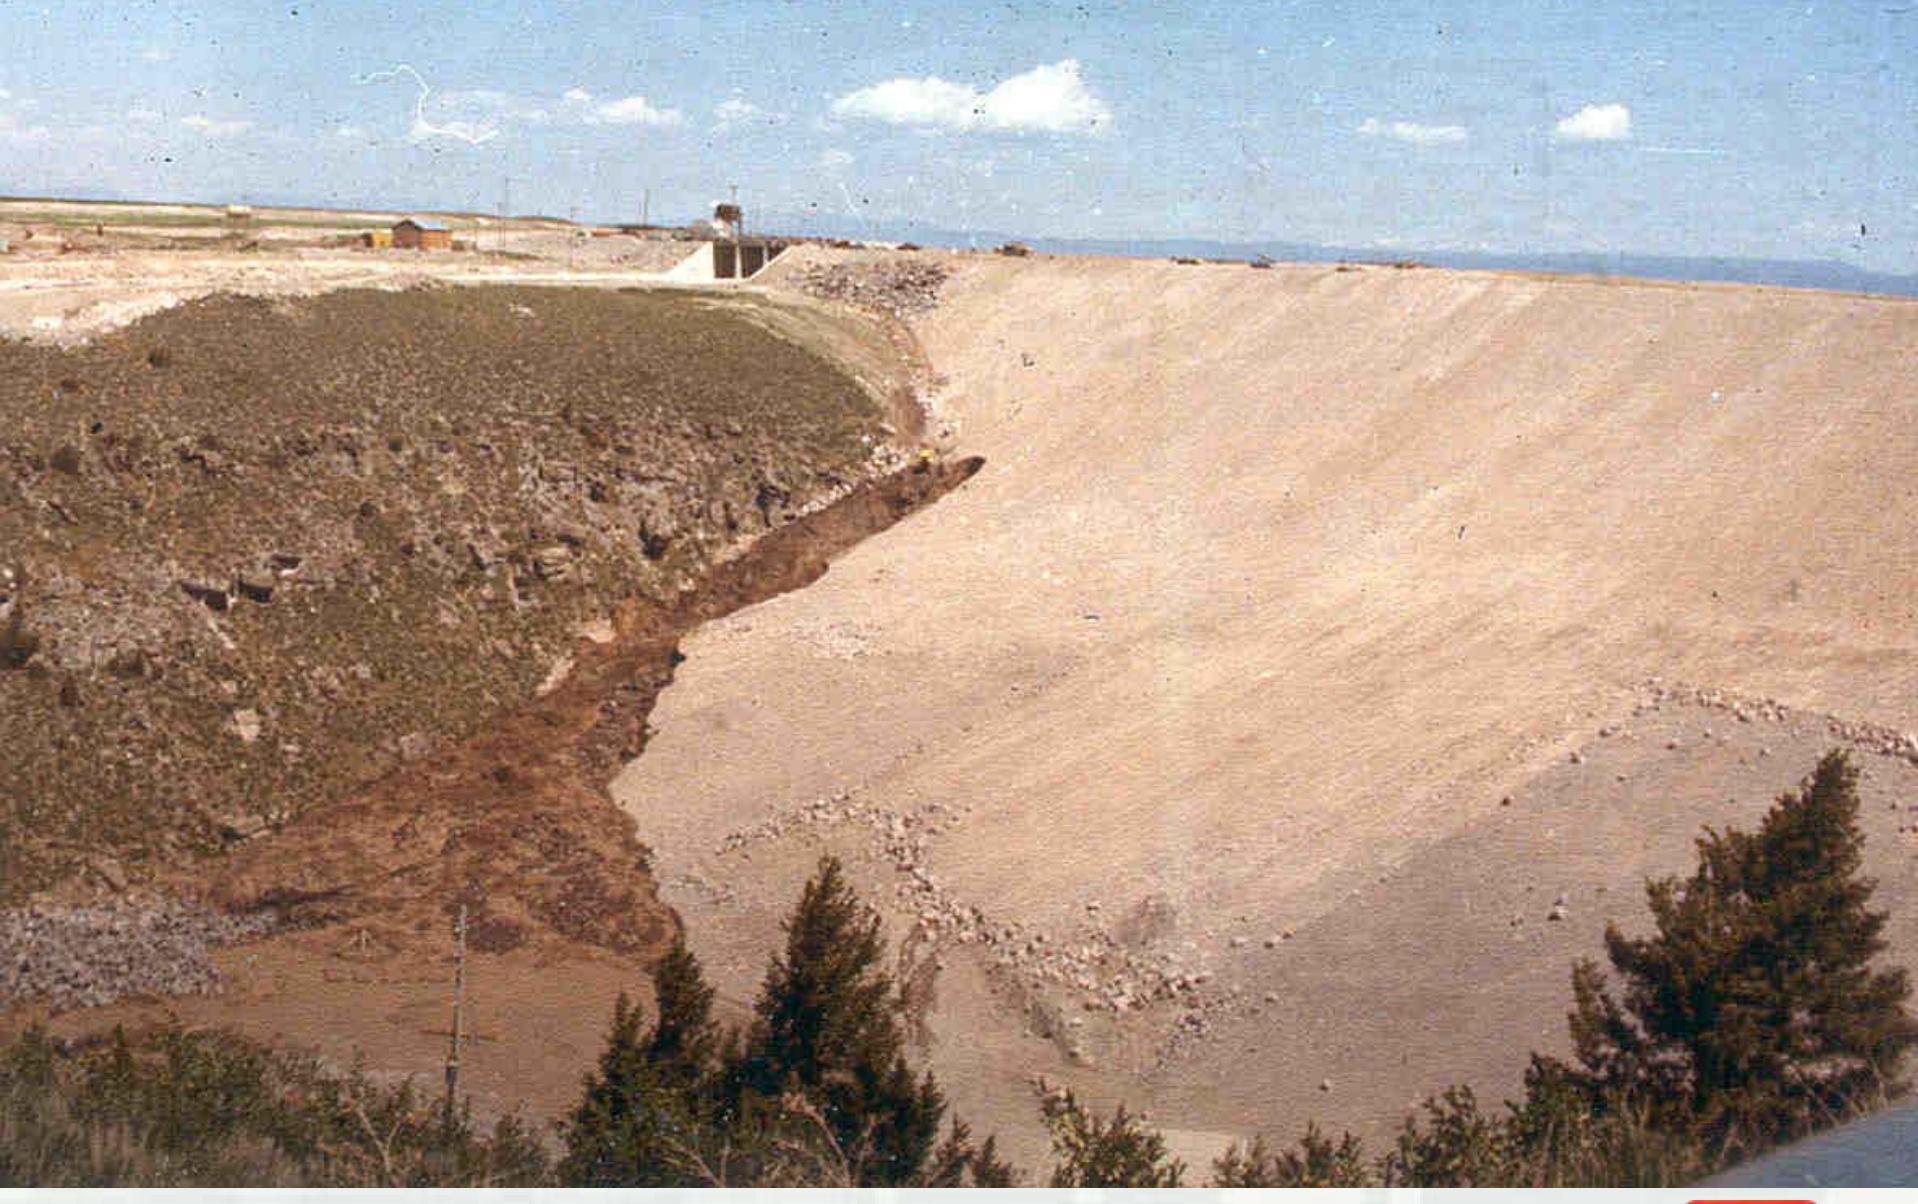
Dozers Lost In Hole About 11:20 am

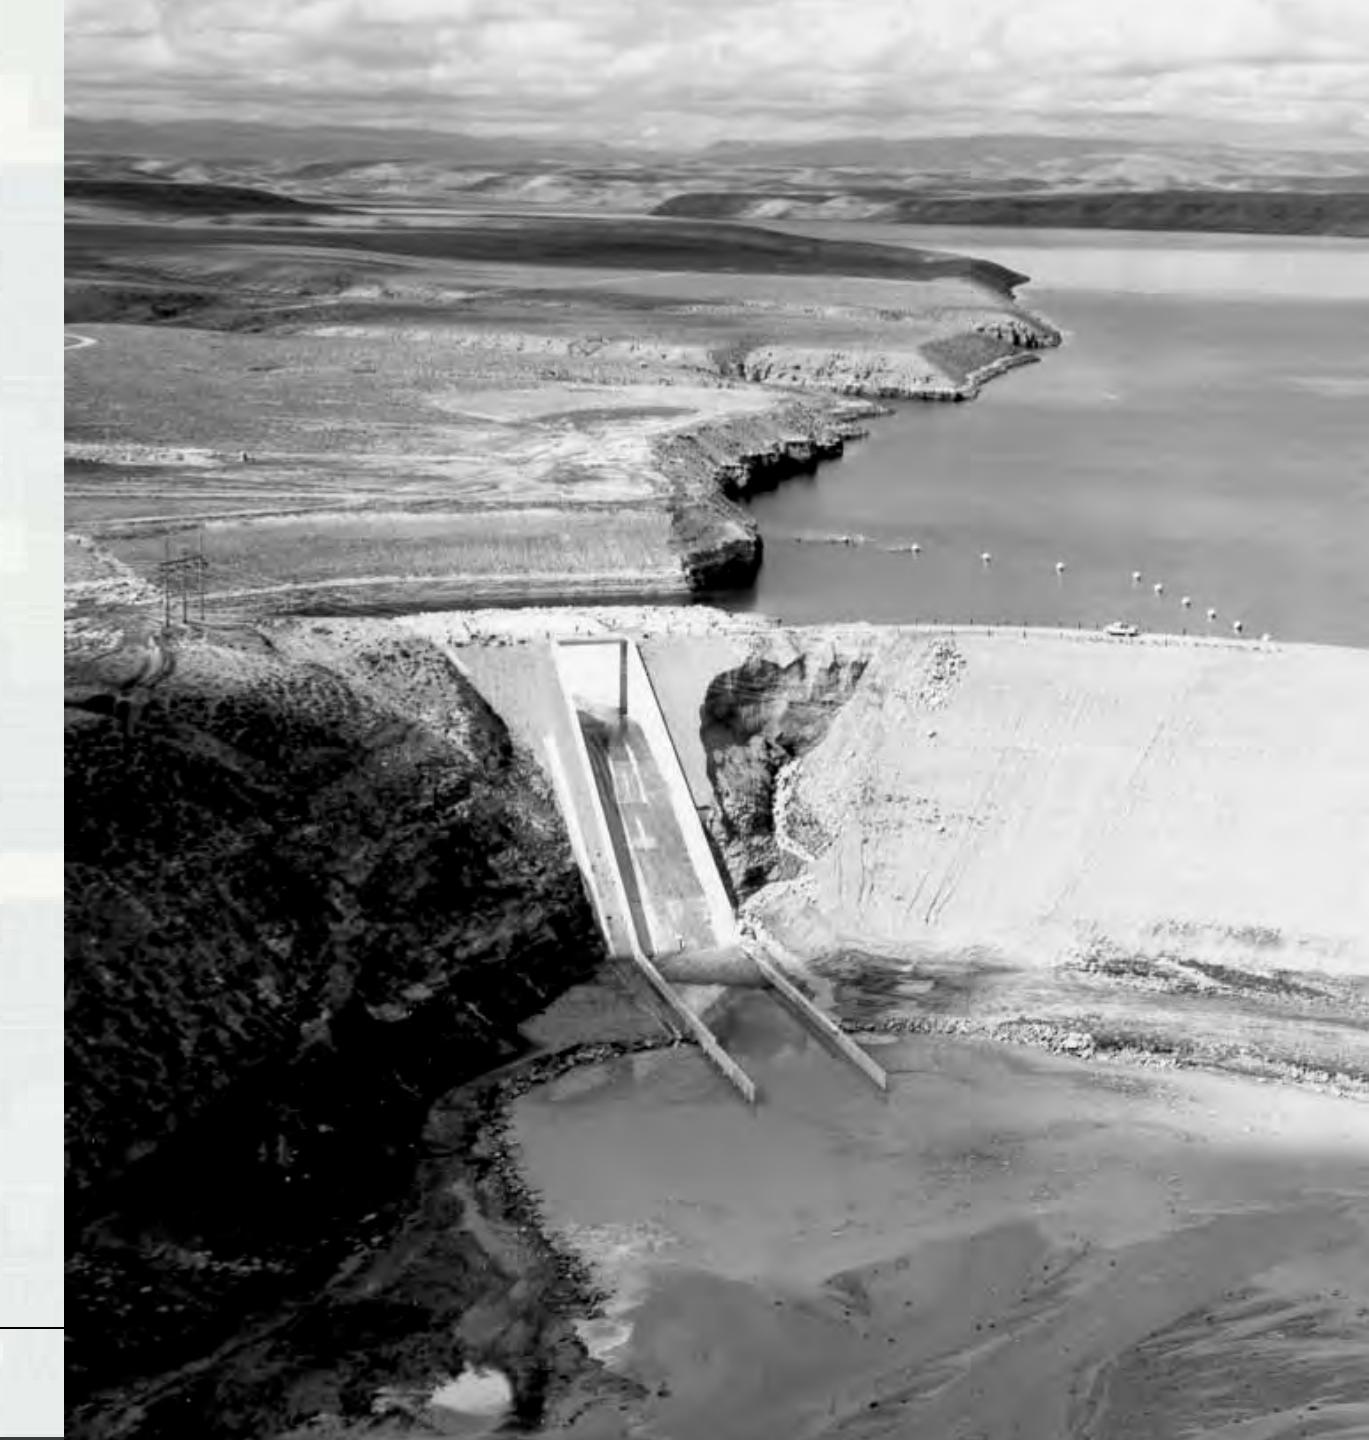
9-5-65

See detailed notes on slides
Piping Erosion Conduit 9-9-65

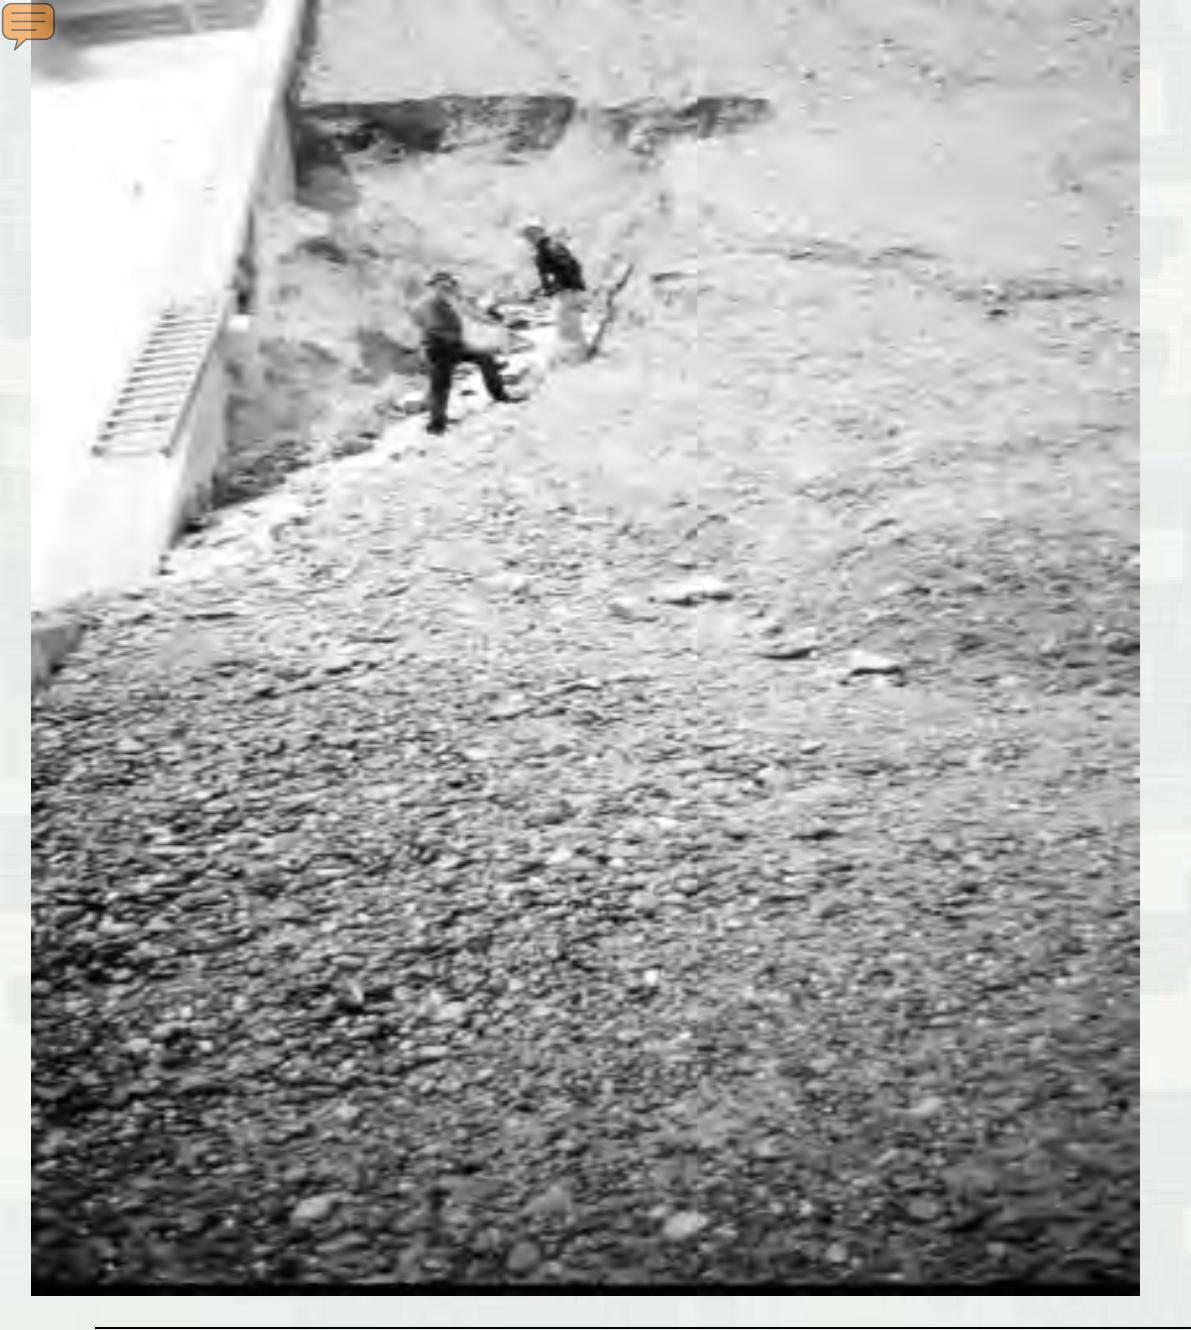
This erosion incident several months earlier was labeled as a "slope stability failure" and backfilled with more permeable material.

There were two of these "incidents" prior to the main problem, but engineers failed to comprehend the seriousness of the problem

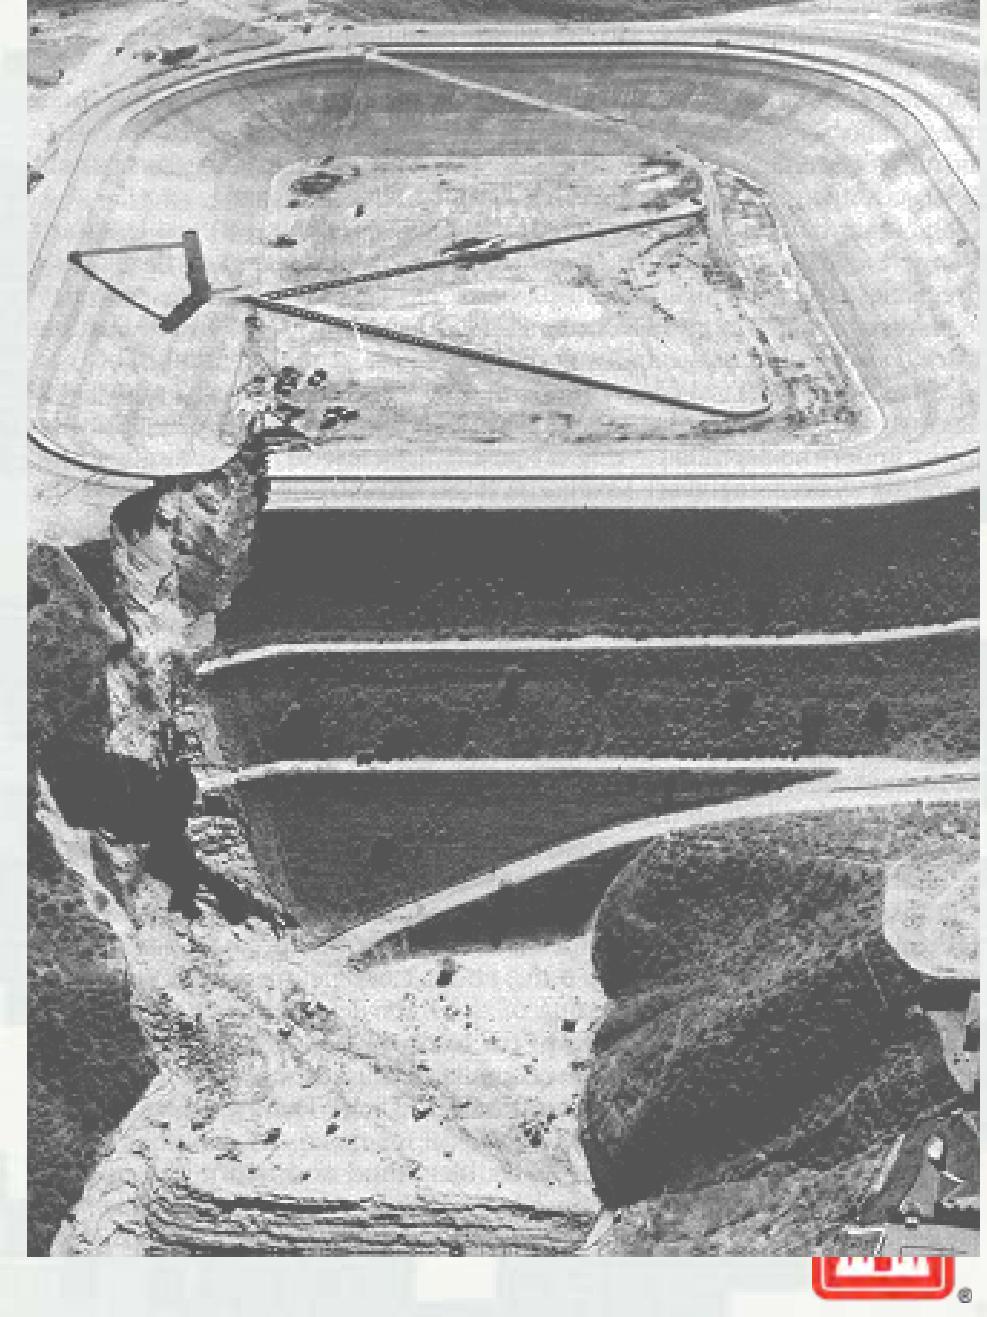
Note Population at risk: Evacuation saved many lives

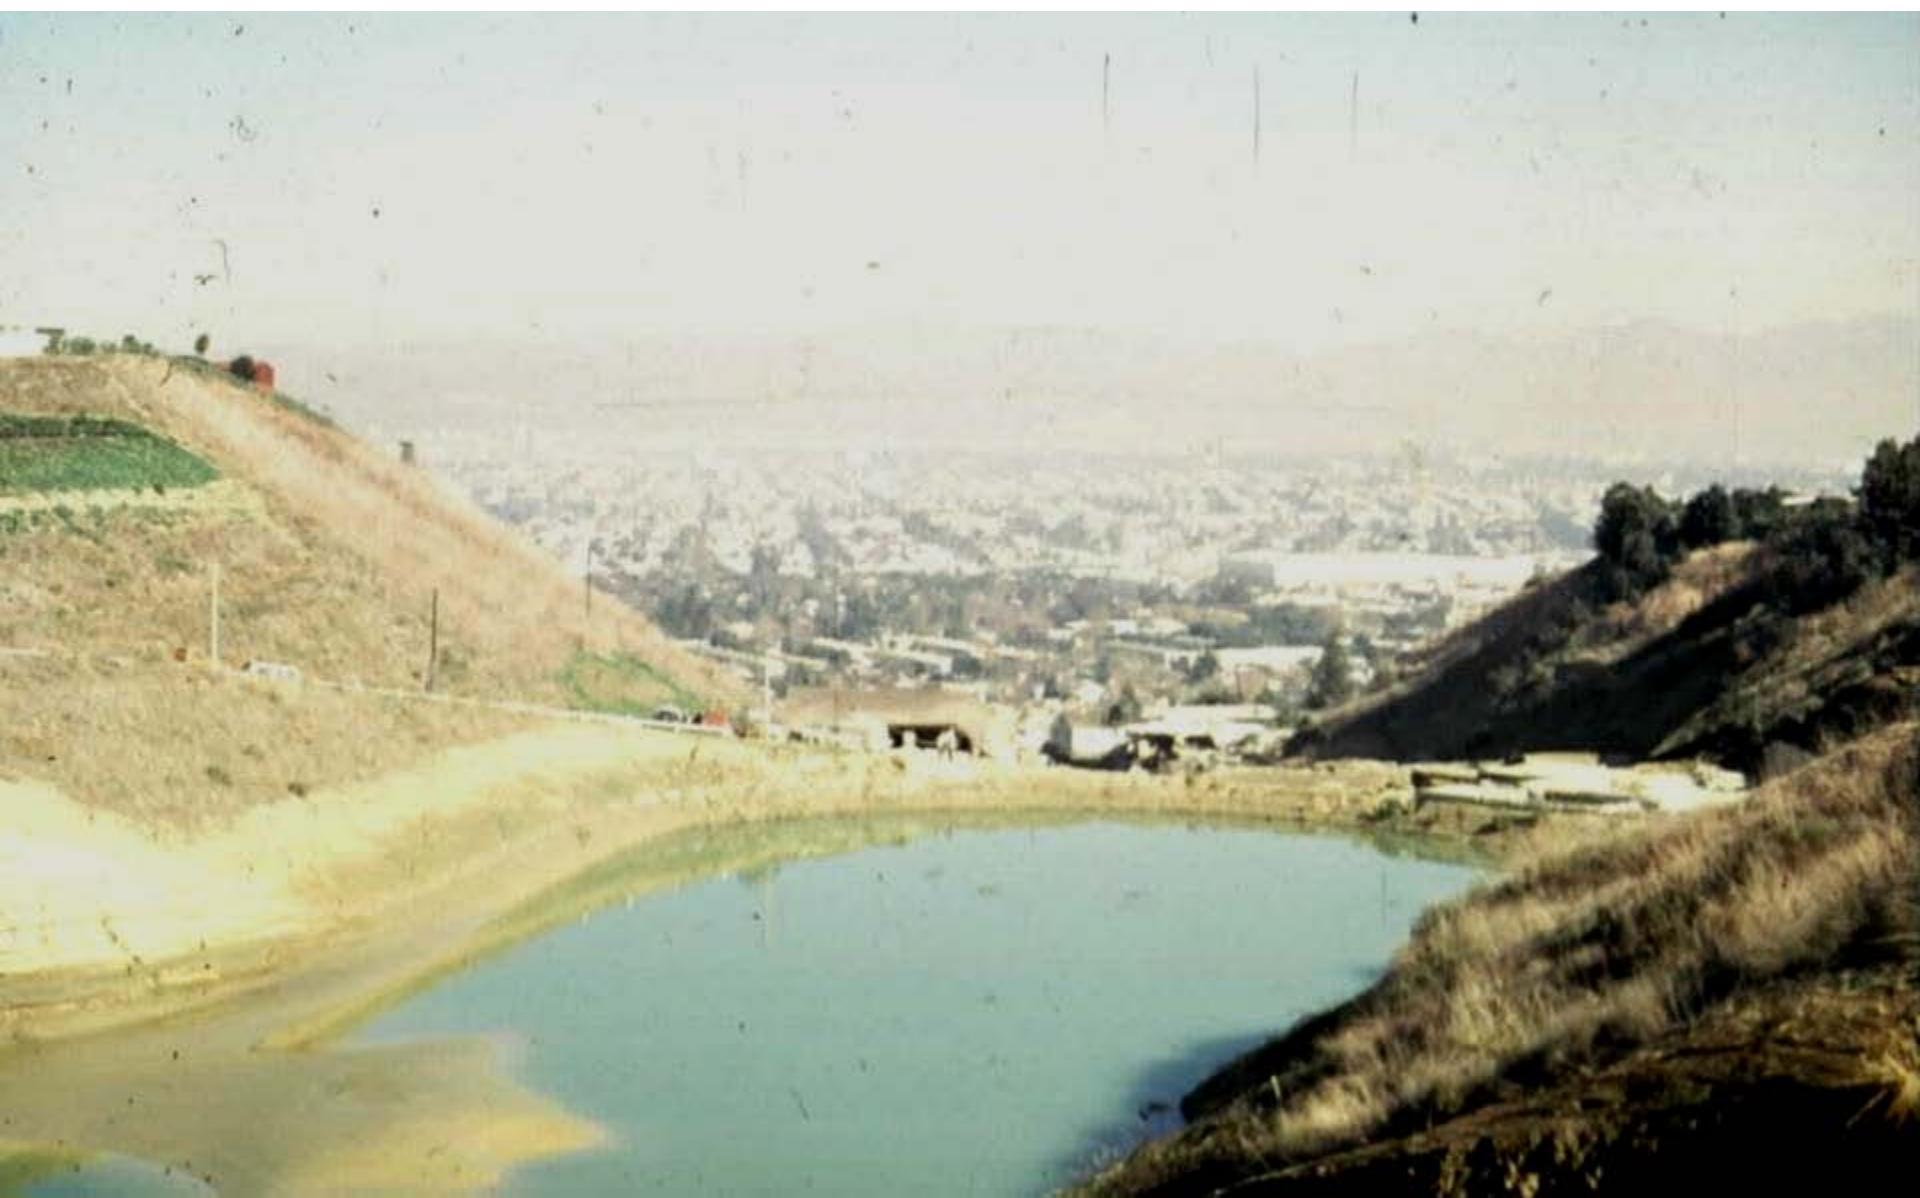
Note Oil Field

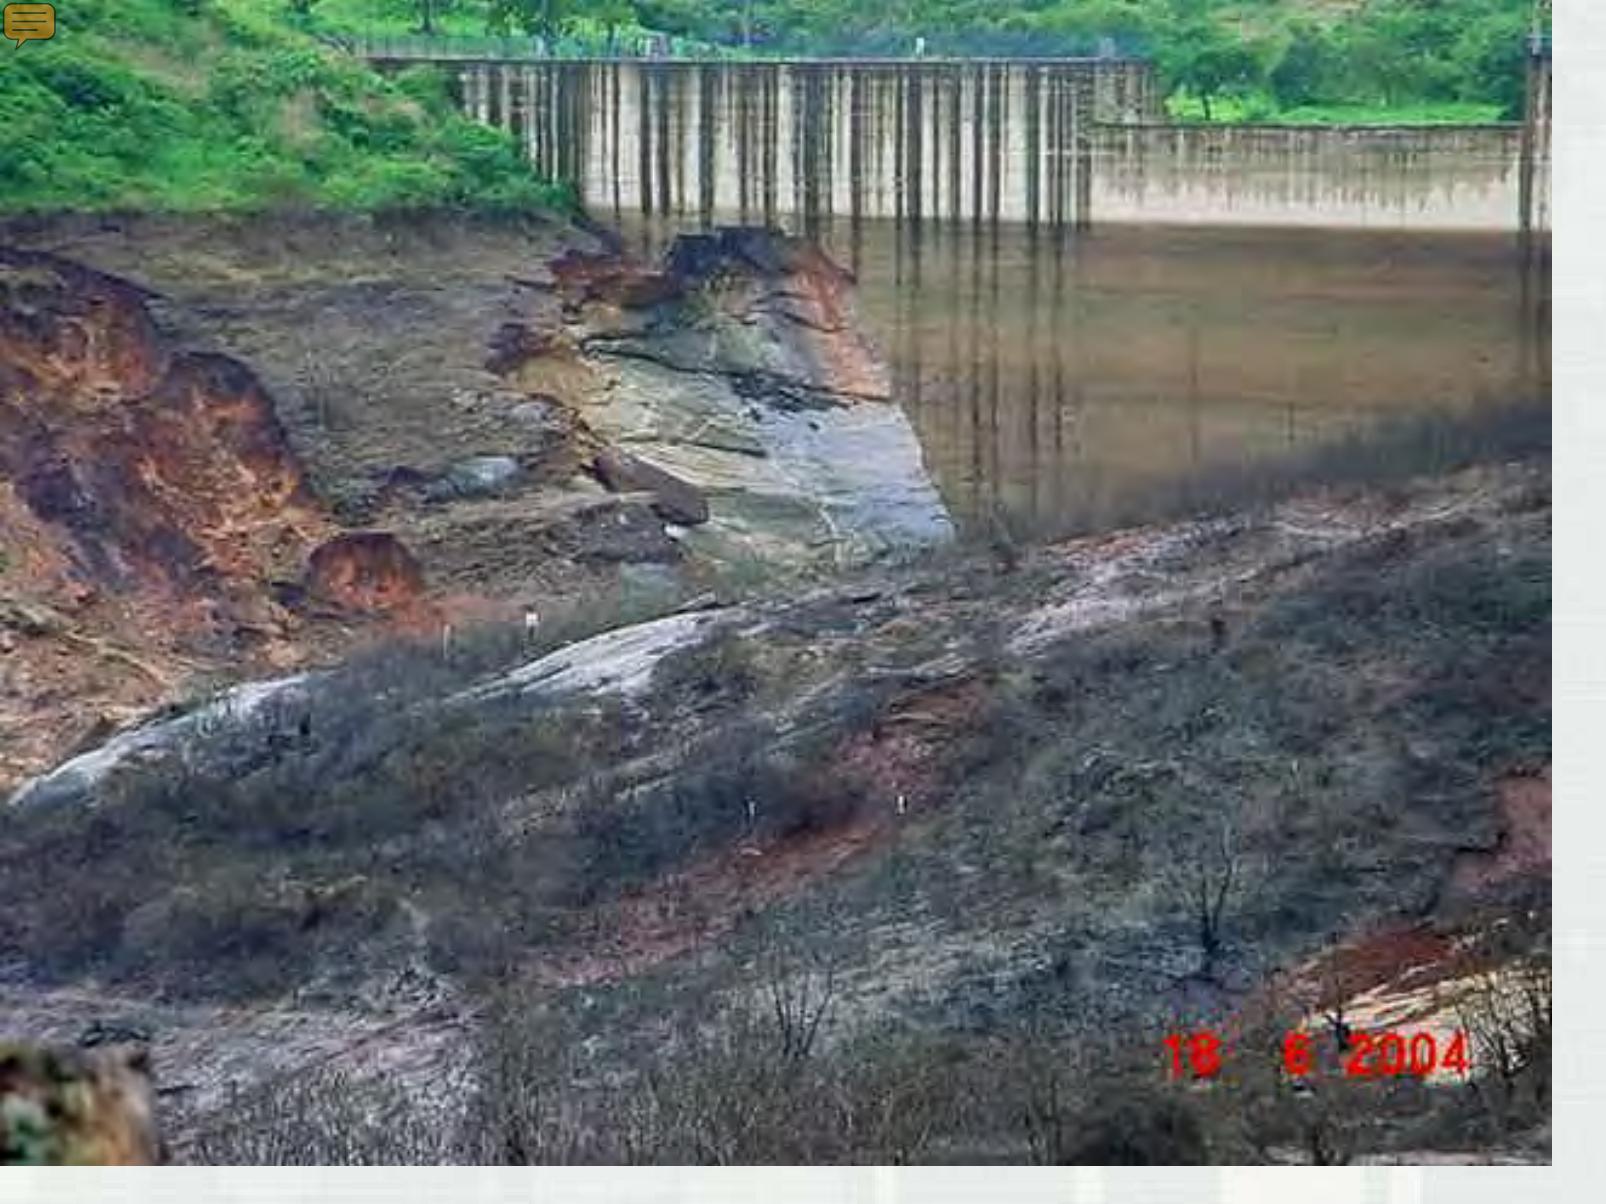
Two days after first filling and failure
