Turning Geologic Data into Knowledge; A summary of dam failure case histories

Pete Shaffner P.G.

Senior Engineering Geologist Risk Management Center US Army Corps of Engineers Denver, Colorado

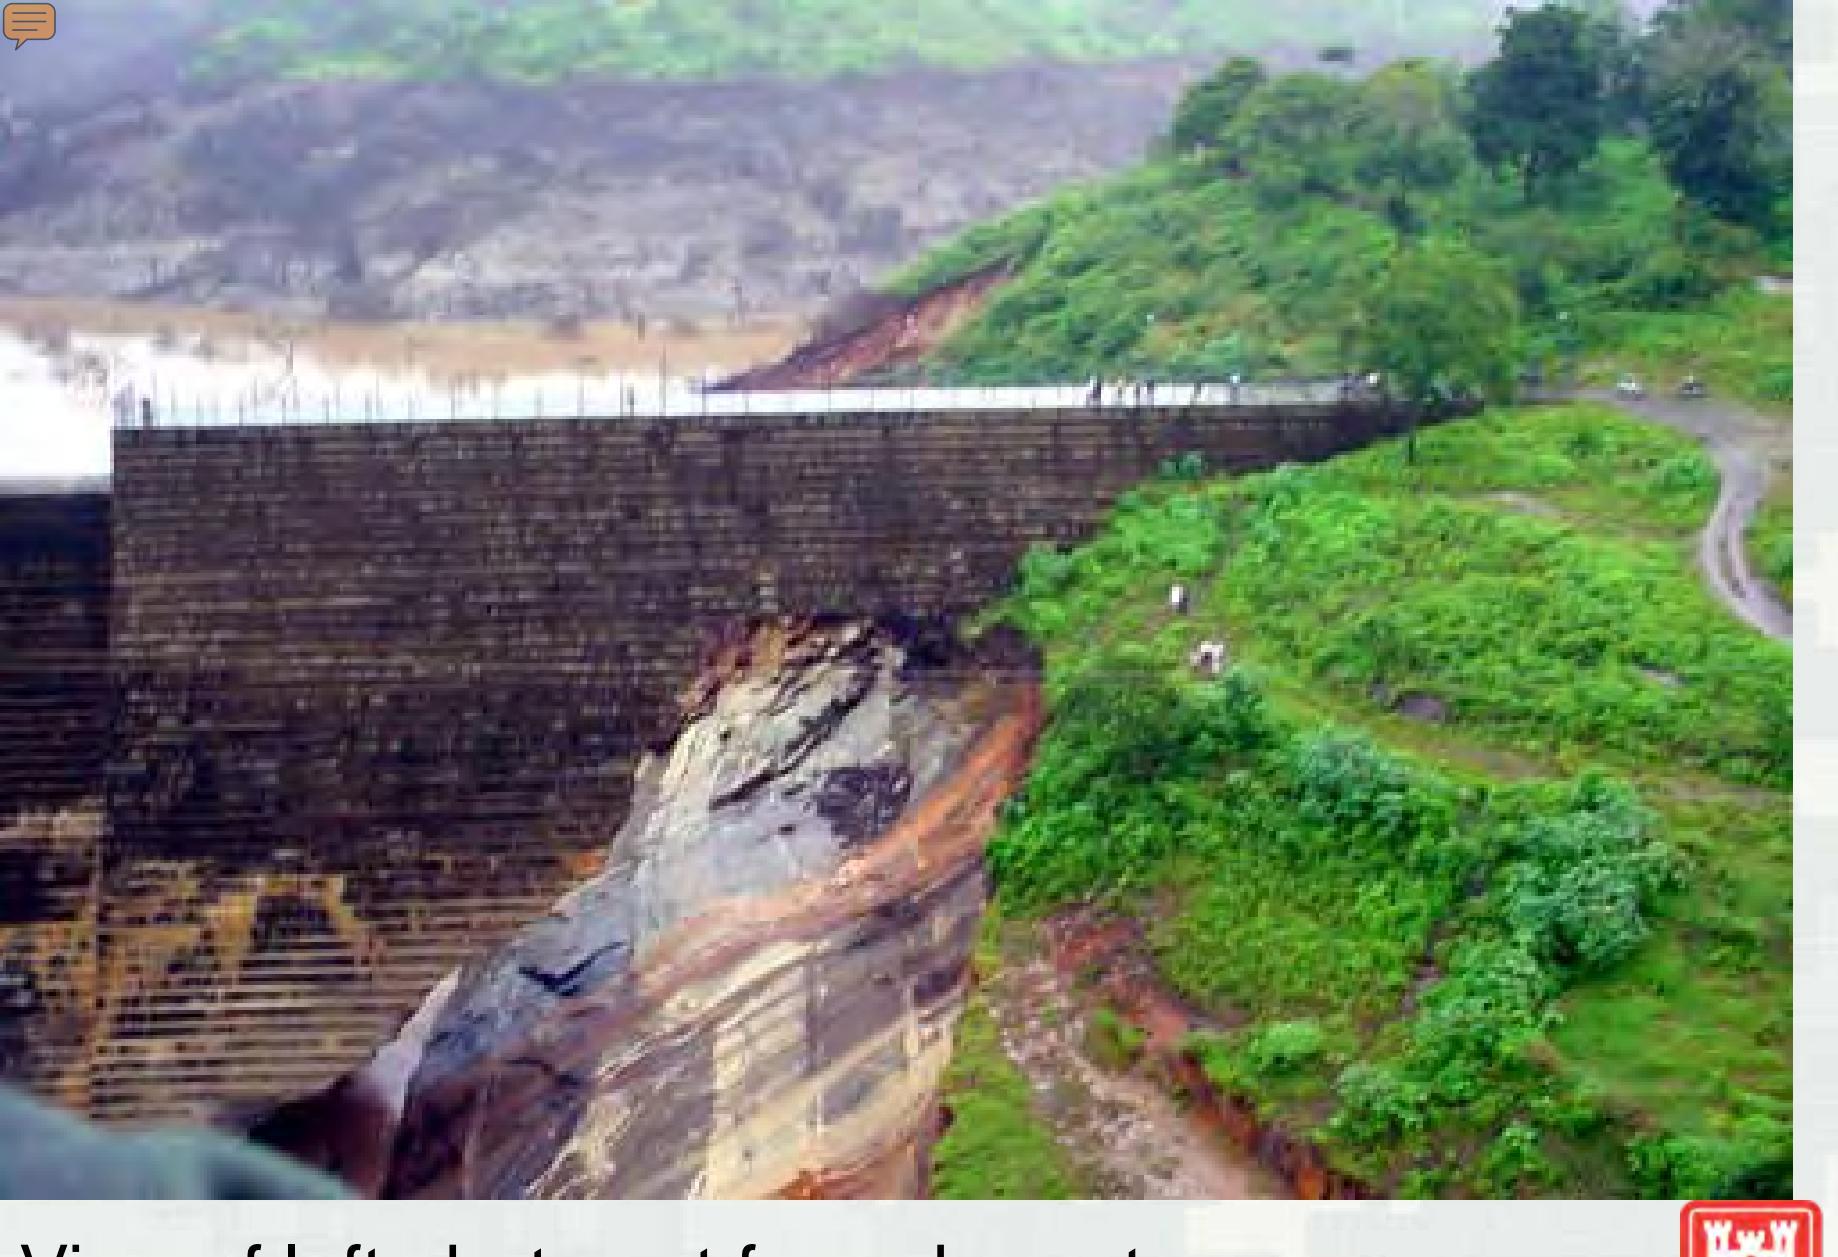
View of left abutment from downstream

View along crest showing failed bridge and continuous infilled fracture plane at left abutment

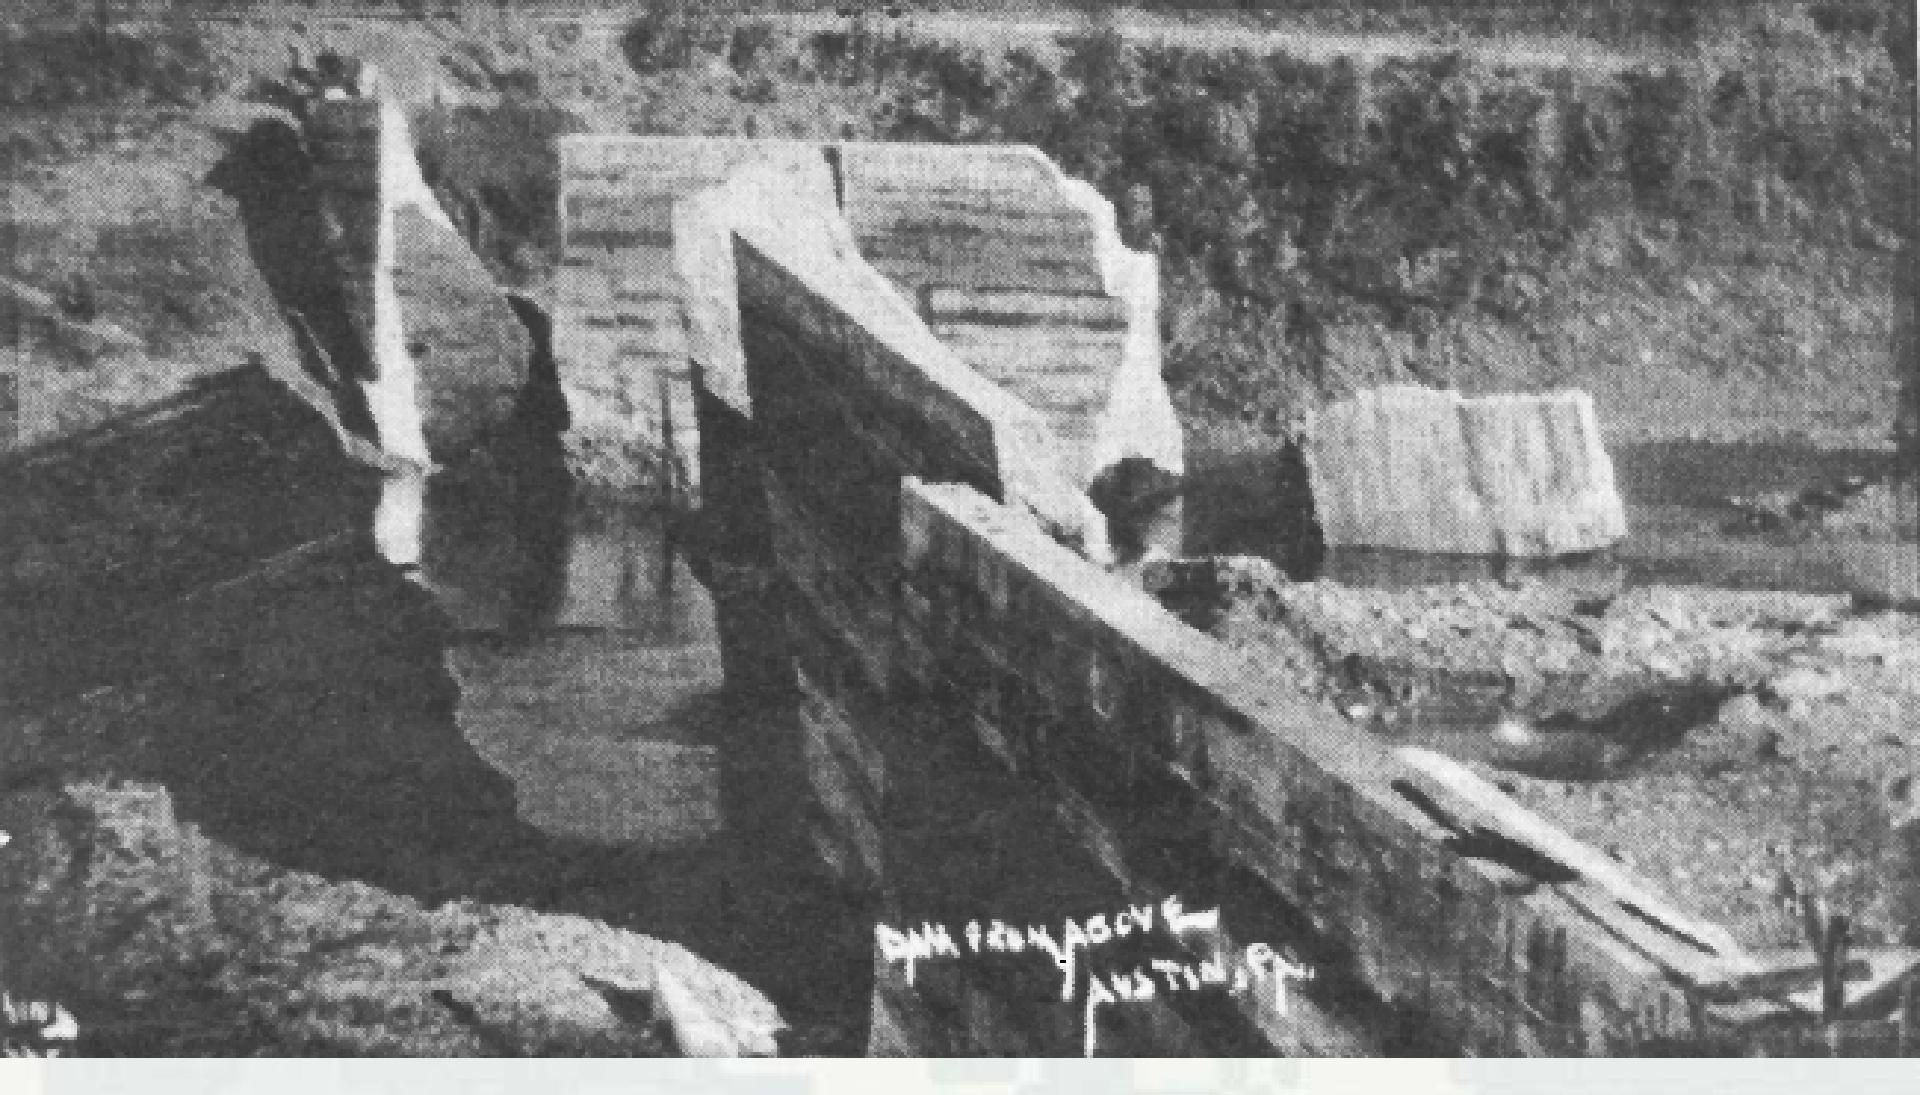
Bayless Dam Failure: September 30, 1911

The dam collapsed suddenly. A review of the failure indication that the dam failed by sliding on weak shale layers in the strong BUILDING STRONG®
