1 **Factors Contributing to Landslide Susceptibility of the Kope Formation,**
2 **Cincinnati, Ohio**
3

10 **ABSTRACT**
11

12 The objective of this study was to evaluate the factors that contribute to the high
13 frequency of landslides in the Kope Formation and the overlying colluvial soil present in the
14 Cincinnati area, southwestern Ohio. The Kope Formation consists of approximately 80% shale
15 inter-bedded with 20% limestone. The colluvium that forms from the weathering of the shale
16 bedrock consists of a low plasticity clay. Based on field observations, liDAR (light detection and
17 ranging) data, and information gathered from city and county agencies, we created a landslide
18 inventory map for the Cincinnati area, identifying 842 landslides. From the inventory map, we
19 selected ten landslides for detailed investigations that included seven rotational and three
20 translational slides. Representative samples were collected from the landslide sites for
21 determining natural water content, Atterberg limits, grain size distribution, shear strength

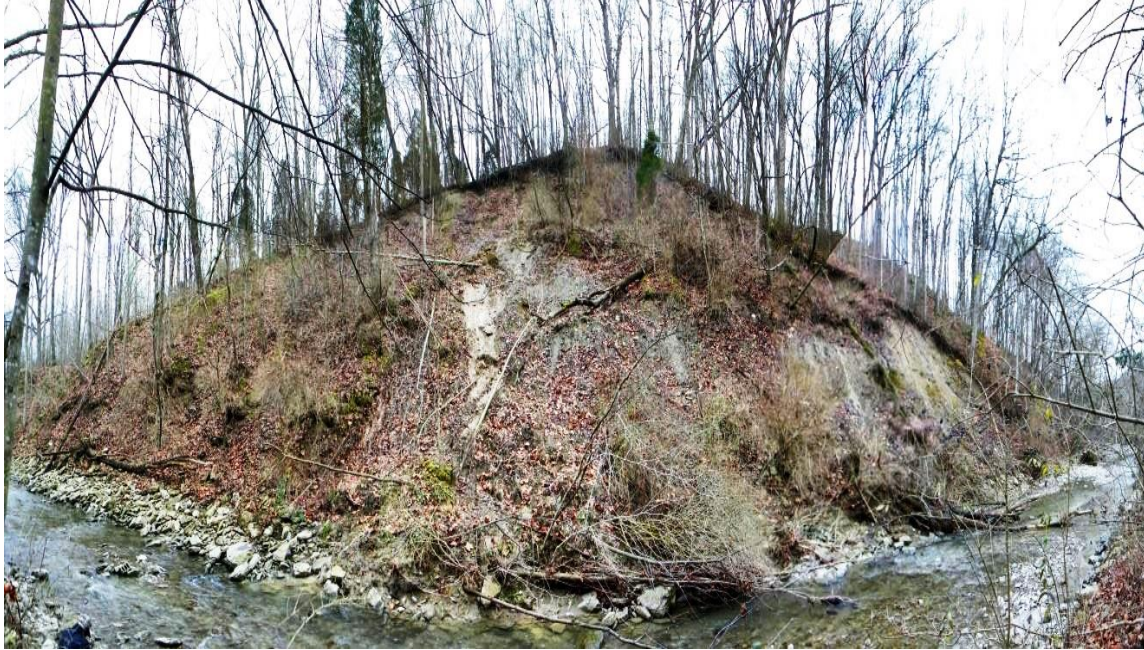
Figure 5: The Ten Mile Road landslide with well-developed head scarp. Notice the undercutting of the toe by a stream.

308 Many slopes in the Cincinnati area are subject to undercutting of the slope toe by stream
309 erosion (Figure 5). This removes the lateral support, thereby reducing the resisting forces.
310 Undercutting of the slope toe, facilitated by the low durability of the Kope Formation, is a very

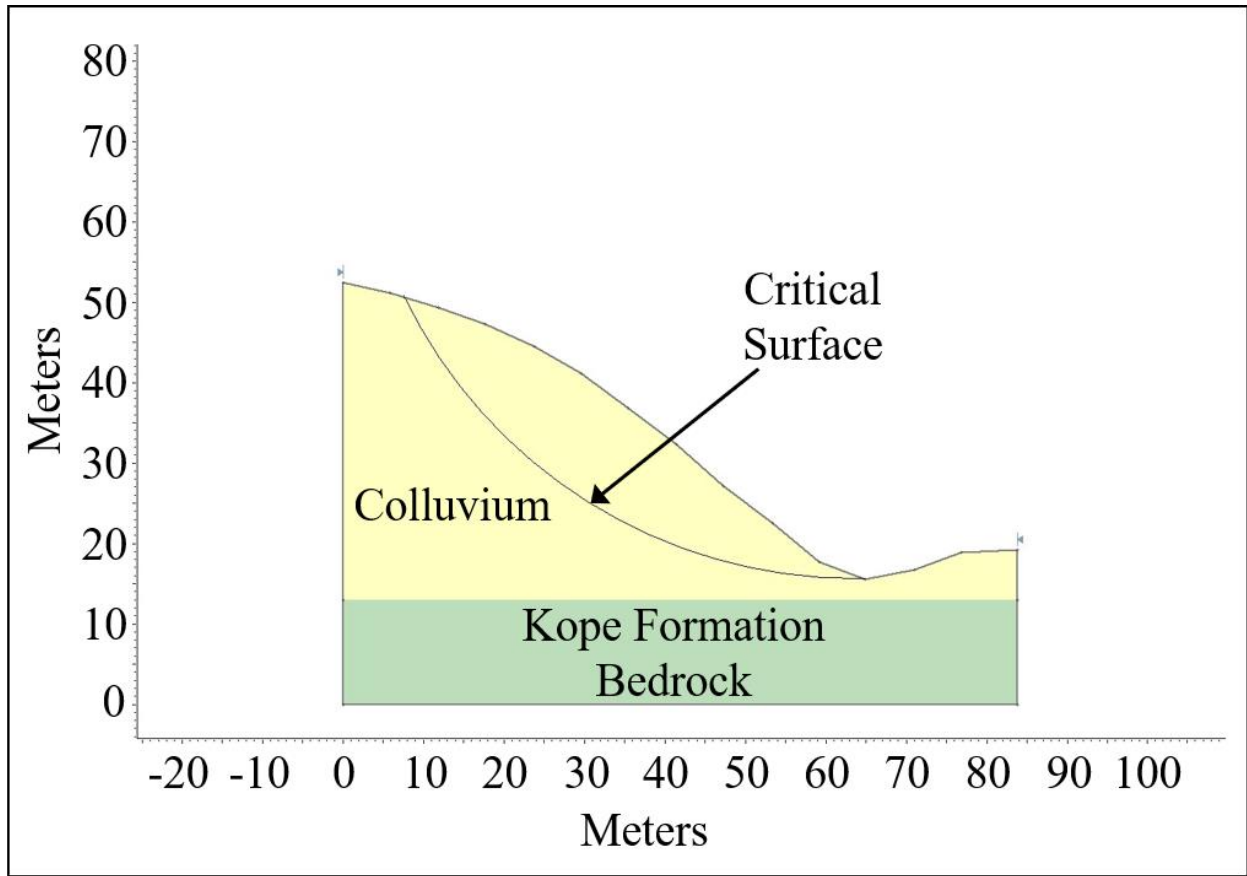
Figure 6: Critical surface for the minimum factor of safety for dry and saturated conditions for the Ten Mile Road landslide, as determined by the Slide program.

229 For the sake of brevity, we present stability analysis for one rotational landslide (Ten
230 Mile Road landslide) and one translational landslide (Columbia Parkway landslide). For stability
231 analyses for all ten landslides, see Glassmeyer (2014). The software program Slide (Rocscience,
232 2012) was used to perform the stability analysis, using residual strength parameters. For the Ten
233 Mile Road landslide (Figure 5), the critical surface with the lowest factor of safety (FS) is shown
234 in Figure 6, which matches the failure surface location observed in the field (Figure 5). The Slide
235 program resulted in a FS of 0.83 for the dry condition and 0.79 for the saturated condition. The
236 stability analysis indicated that for the FS to be >1, the cohesion of the soil should be > 61.2 kPa
237 (instead of 22.5 kPa) if the friction angle were to remain constant at 15.6°, or the friction angle

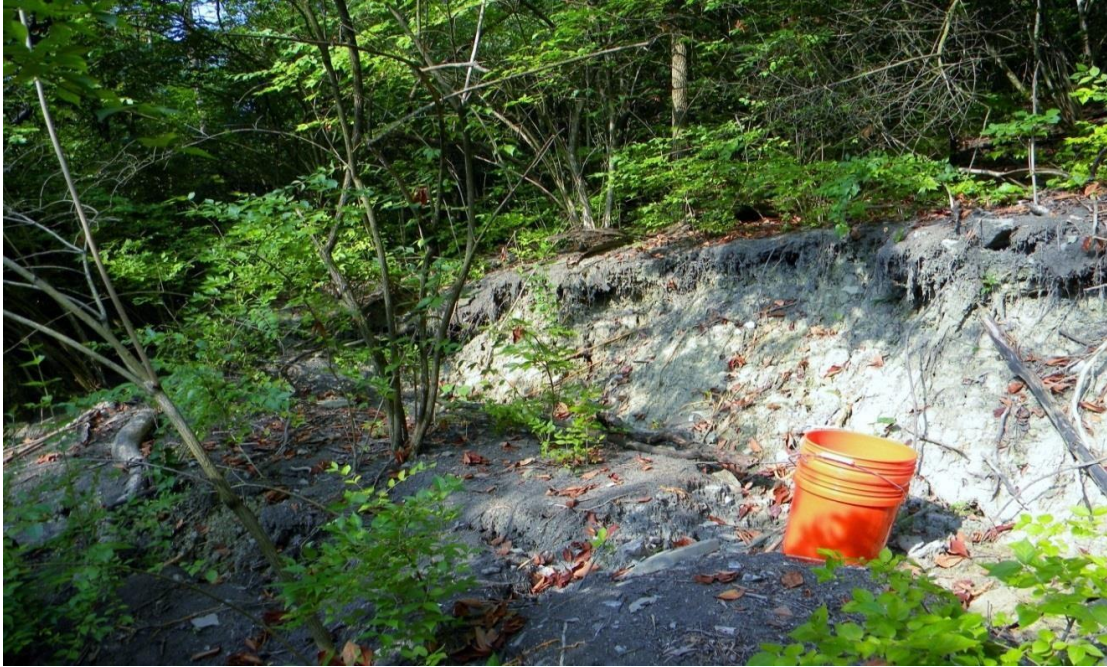
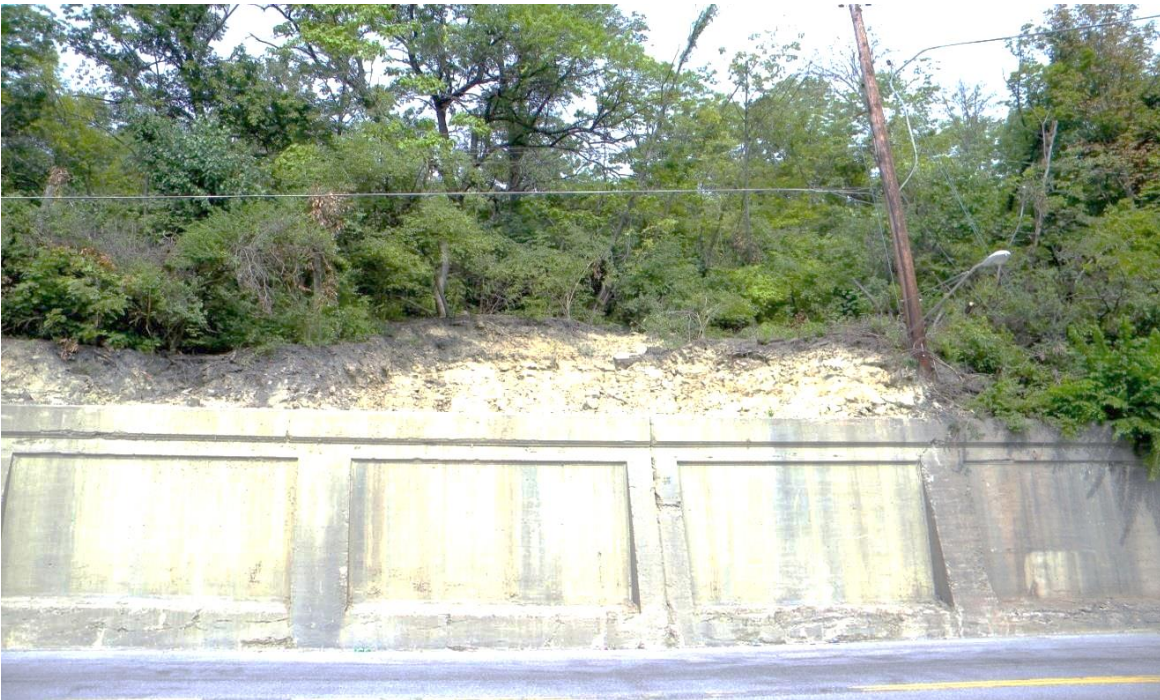
Figure 7: (a) Head scarp of the Columbia Parkway landslide and (b) toe of the Columbia Parkway landslide, emerging on the top of the retaining wall.

239 For the Columbia Parkway landslide (Figure 7), the critical surface, as determined by the

240 Slide program, is located along the contact between the colluvial soil and the underlying bedrock
241 (Figure 8). It initiates at the top of the slope and emerges at the top of the retaining wall at the
242 base of the slope (Figure 7). It should be noted that soil-bedrock contact may not be perfectly
243 planar (Figure 8) but we assumed it to be planar for the purpose of stability analysis. Also, we
244 assumed a uniform, average colluvium thickness. Locally, the landslide may change into
245 earthflow/mudflow. The minimum FS for the dry condition is 1.04, when the colluvium is dry,
246 and 0.68 when saturated. Stability analysis results show that the soil-rock friction angle needs to
247 be $>18^\circ$ instead of 14.8° (Table 4) for the FS to be >1 , if the cohesion were to remain constant at
248 6.8 kPa, or the cohesion should be >8.9 kPa if the friction angle remains constant (14.8°) (Table

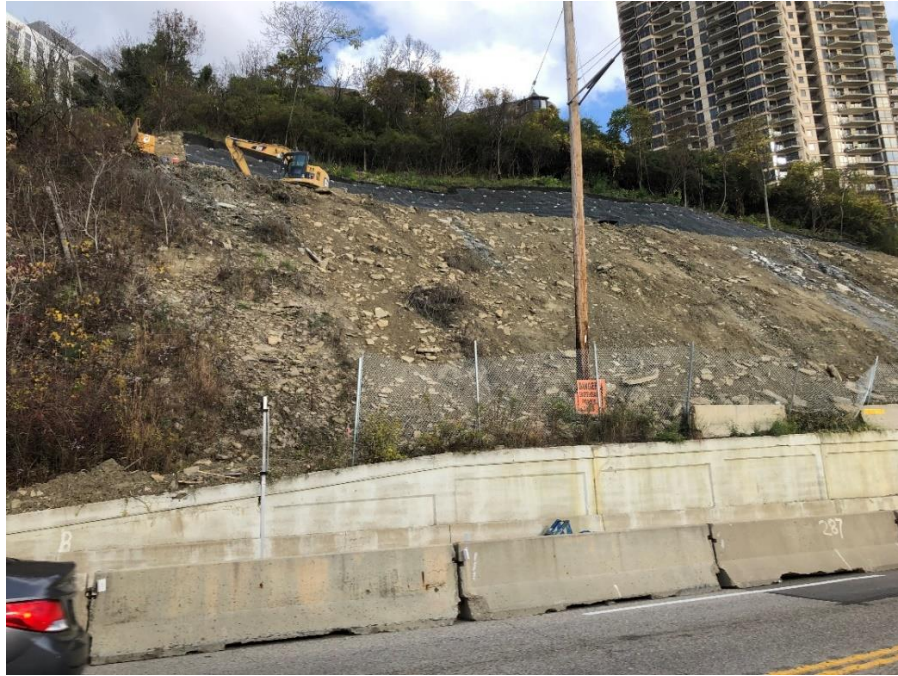
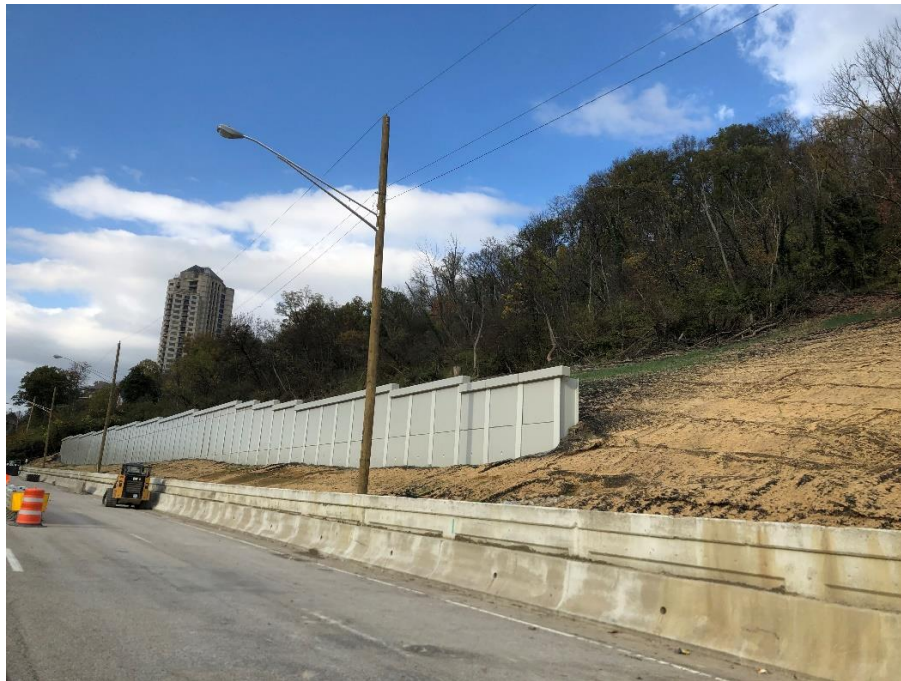
Figure 9: (a) Installation of metal mesh and soil nails and (b) section of a new soldier beam retaining wall (photos courtesy of Dr. John Rockaway).

251 The Columbia Parkway landslide is currently being stabilized at an estimated cost of \$17
252 million (City of Cincinnati – Transportation & Engineering, 2020). The stabilization project
253 extends from Bains Street (Mt. Adams area) on the west side to beyond Torrence Parkway (East
254 Walnut Hills area) on the east side, a nearly two-mile long stretch of the Parkway. Within this
255 stretch, 12 landslide locations have been chosen for stabilization with the stabilization method,
256 involving either metal mesh and soil nails or retaining walls (Figure 9), varying from location to
257 location (City of Cincinnati – Transportation & Engineering, 2020). The construction started
258 towards the end of 2019 and is expected to be completed by summer 2021 (City of Cincinnati –
259 Transportation & Engineering, 2020).

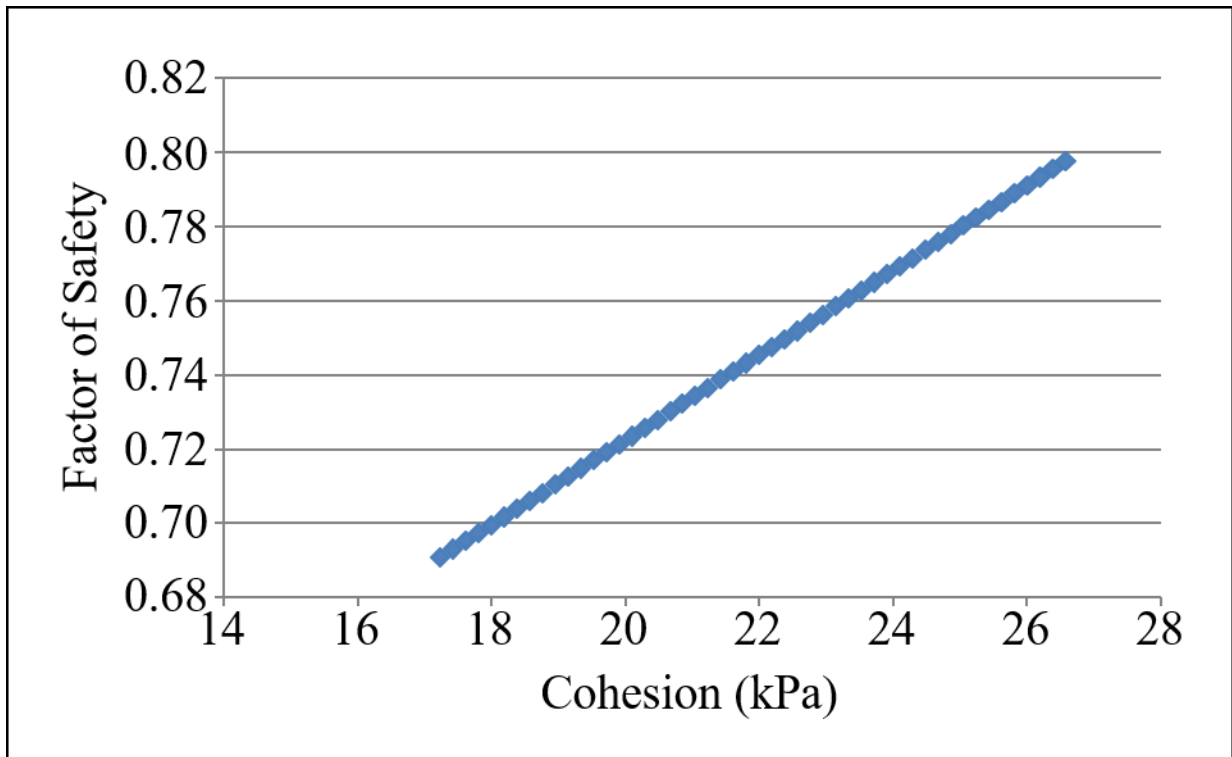
Figure 10: Relationship between strength parameters and factor of safety for the Ten Mile Road landslide: (a) cohesion vs FS and (b) friction angle vs FS.

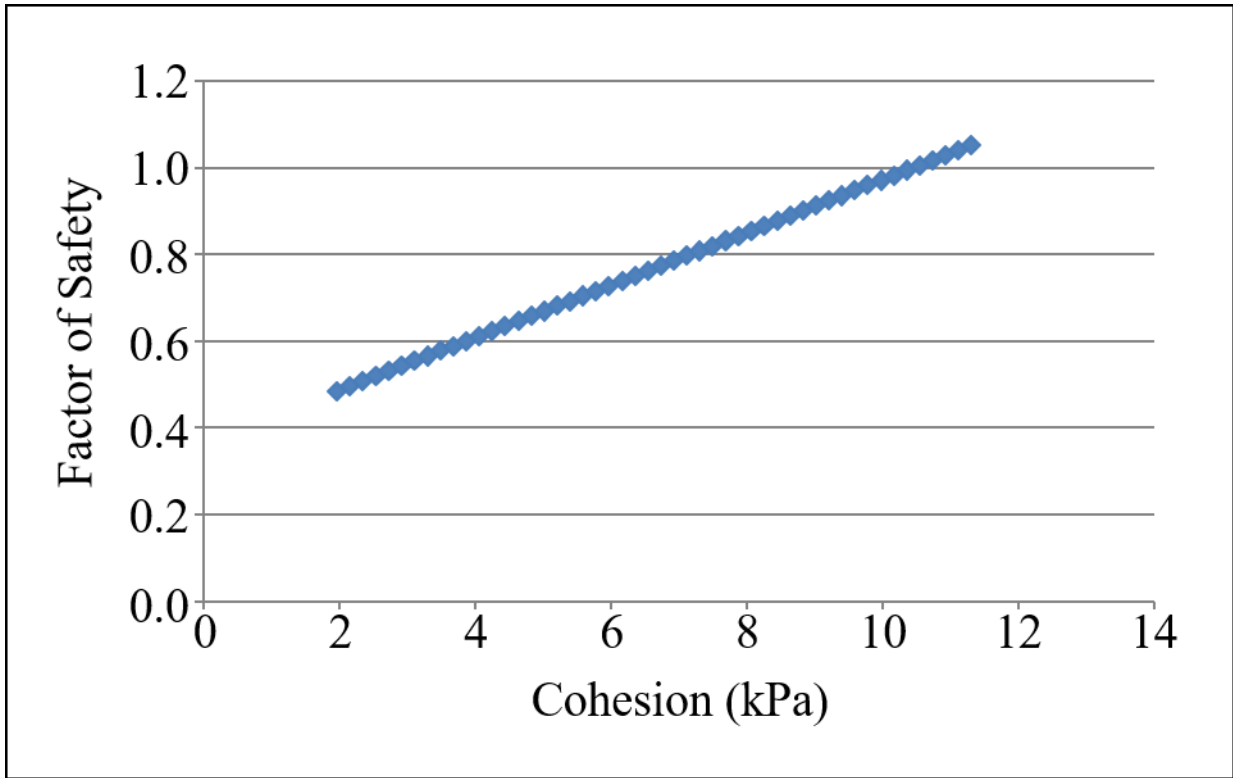
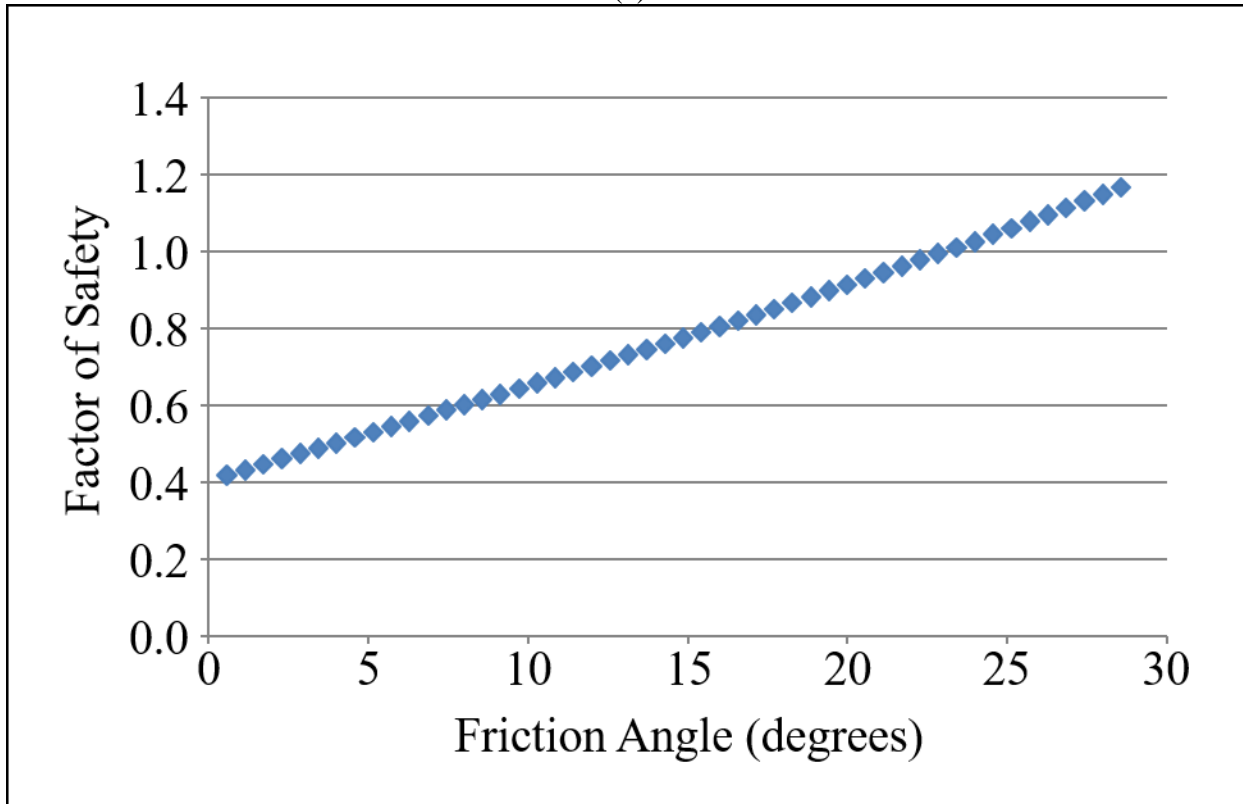
641 Figure 11: Relationship between shear strength parameters and factor of safety for the Columbia
642 Parkway landslide: (a) cohesion vs FS and (b) friction angle vs FS.
