Factors Contributing to Landslide Susceptibility of the Kope Formation, Cincinnati, Ohio

ABSTRACT

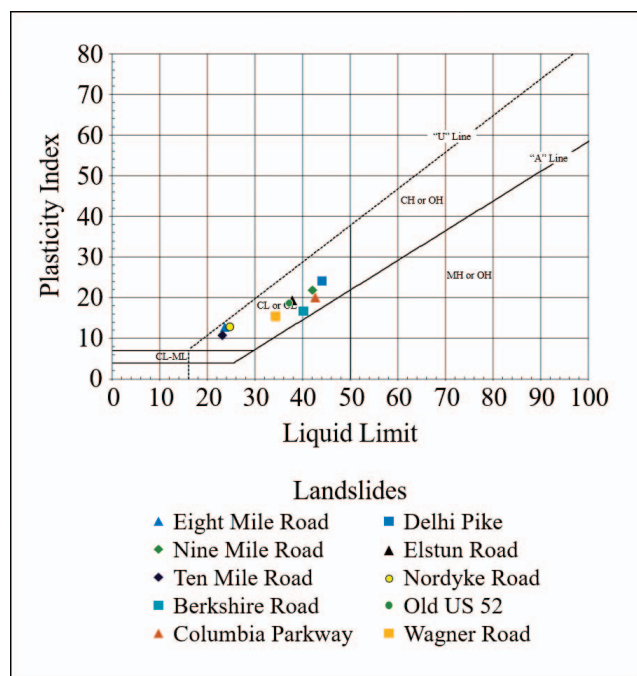
Figure 4. Plot of Atterberg limits of the fine-grained fraction of the colluvial soils from the landslide sites on the Casagrande plasticity chart.

Table 2 presents the Atterberg limits test results for the fine-grained fraction of the colluvium from the 10 sites. A plot of Atterberg limits on Casagrande plasticity chart is shown in Figure 4. The plot shows that the fine-grained fraction of the colluvial soil classifies as clay of low plasticity. Table 2 also lists the liquidity index (LI) values. The LI compares the natural water content with the Atterberg limits and indicates how a soil will behave when sheared. If LI is >1, the soil will behave as a viscous liquid when sheared, if it ranges from zero to one, the soil will behave as a plastic material on shearing, and if it is <0, the soil will behave as a brittle material. The LI values in Table 2 indicate a plastic behavior of colluvial soil during landsliding.

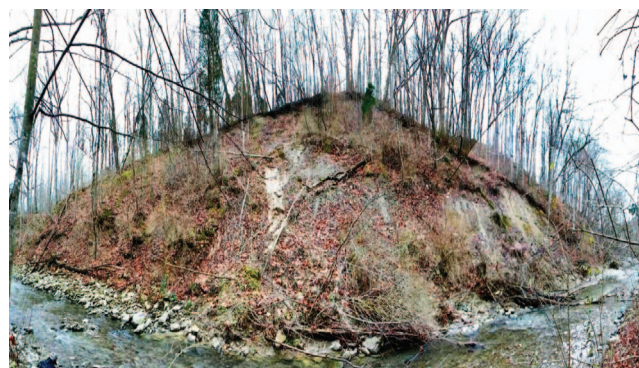
Figure 5. The Ten Mile Road landslide with well-developed head scarp. Notice the undercutting of the toe by a stream.

Ten Mile Road landslide (Figure 5), the critical surface with the lowest FS is shown in Figure 6, which matches the failure surface location observed in the field (Figure 5). The Slide program resulted in a FS of 0.83 for the dry condition and 0.79 for the saturated condition. The stability analysis indicated that for the FS to be >1, the cohesion of the soil should be >61.2 kPa (instead of 22.5 kPa) if the friction angle were to remain constant at 15.6°, or the friction angle needs to be >33.8° if the cohesion remains the same (22.5 kPa) (Table 3).

Many slopes in the Cincinnati area are subject to undercutting of the slope toe by stream erosion (Figure 5). This removes the lateral support, thereby reducing the resisting forces. Undercutting of the slope toe, facilitated by the low durability of the Kope Formation, is a very important factor contributing to high susceptibility of the Kope Formation to landsliding.

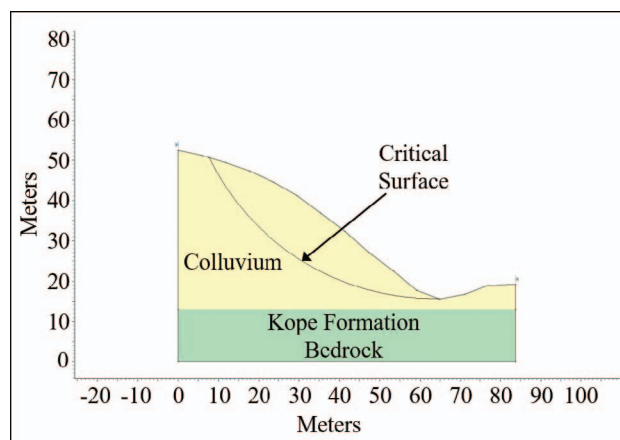
Figure 6. Critical surface for the minimum factor of safety for dry and saturated conditions for the Ten Mile Road landslide, as determined by the Slide program.

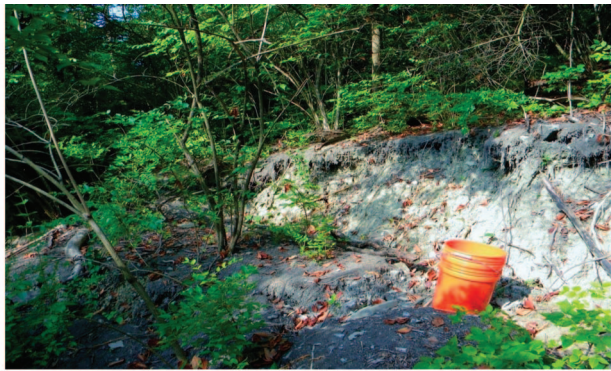
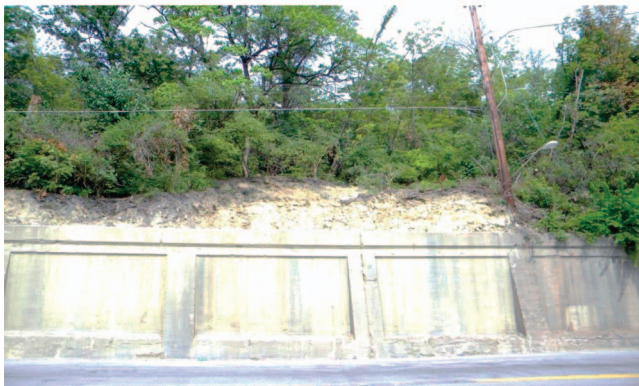
Figure 7. (a) Head scarp of the Columbia Parkway landslide and (b) toe of the Columbia Parkway landslide emerging on the top of the retaining wall.

For the Columbia Parkway landslide (Figure 7), the critical surface, as determined by the Slide program, is located along the contact between the colluvial soil and the underlying bedrock (Figure 8). It initiates at the top of the slope and emerges at the top of the retaining wall at the base of the slope (Figure 7). It should be noted that soil-bedrock contact may not be perfectly planar (Figure 8) but we assumed it to be planar for the purpose of stability

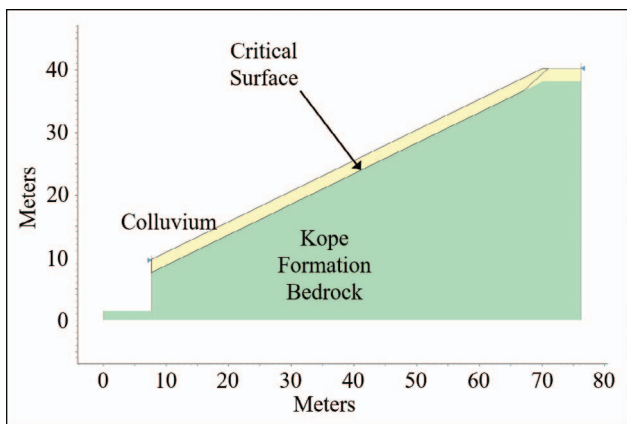
Figure 8. Critical Surface for the minimum factor of safety for the Columbia Parkway landslide, as determined by the slide program.

analysis. Also, we assumed a uniform, average colluvium thickness. Locally, the landslide may change into earthflow/mudflow. The minimum FS is 1.04 when the colluvium is dry and 0.68 when saturated. Stability analysis results show that the soil–rock friction angle needs to be $>18^\circ$ instead of 14.8° (Table 4) for the FS to be >1 , if the cohesion were to remain constant at

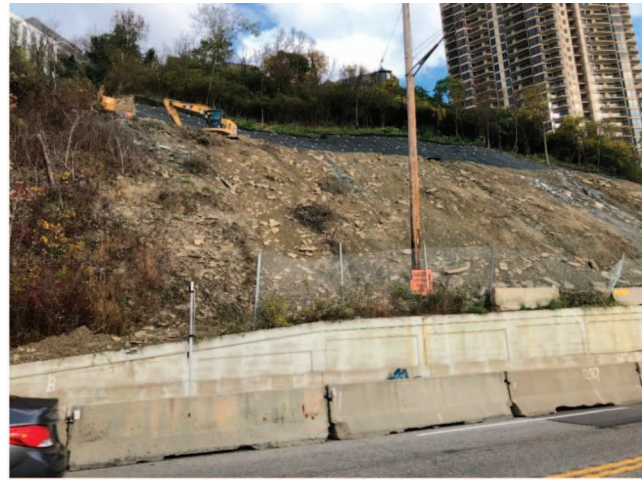
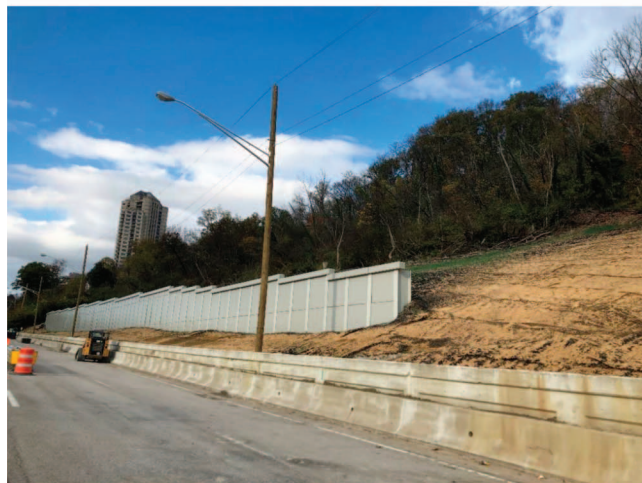
Figure 9. (a) Installation of metal mesh and soil nails and (b) section of a new soldier beam retaining wall (photos courtesy of Dr. John Rockaway).

The Columbia Parkway landslide is currently being stabilized at an estimated cost of \$17 million (City of Cincinnati—Transportation & Engineering, 2020). The stabilization project extends from Bains Street (Mt. Adams area) on the west side to beyond Torrence Parkway (East Walnut Hills area) on the east side, a nearly 3.2 km long stretch of the Parkway. Within this stretch, 12 landslide locations have been chosen for stabilization with the stabilization method, involving either metal mesh and soil nails or retaining walls (Figure 9), varying from location to location (City of Cincinnati—Transportation & Engineering, 2020).

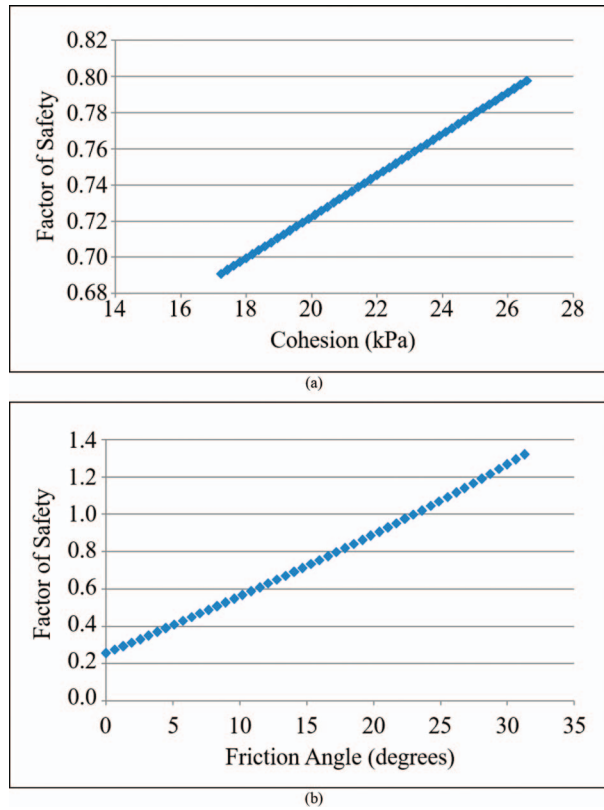
Figure 10. Relationship between strength parameters and factor of safety for the Ten Mile Road Landslide: (a) cohesion vs FS and (b) friction angle vs FS.

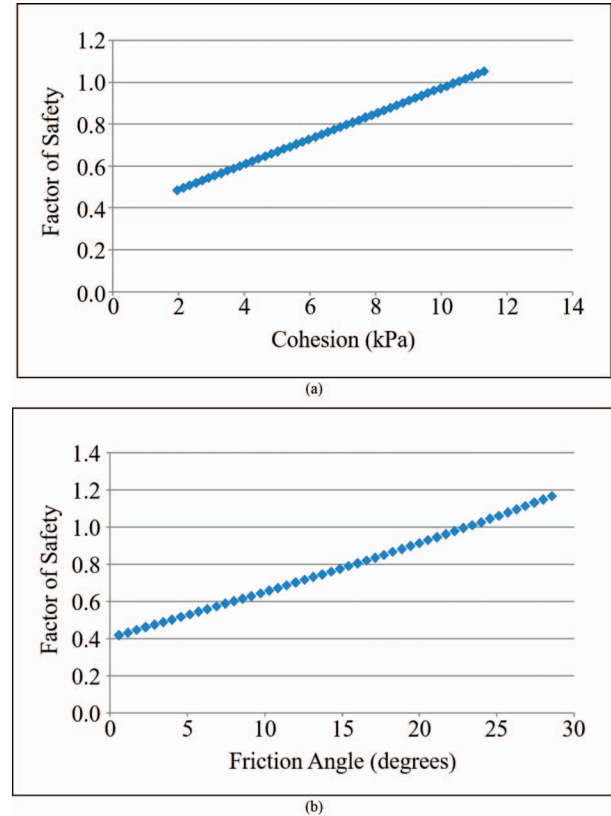
Figure 11. Relationship between shear strength parameters and factor of safety for the Columbia Parkway landslide: (a) cohesion vs FS and (b) friction angle vs FS.

6.8 kPa, or the cohesion should be > 8.9 kPa if the friction angle remains constant (14.8°) (Table 4). These results clearly suggest that strength parameters of the colluvial soil are lower than those required to maintain stability.

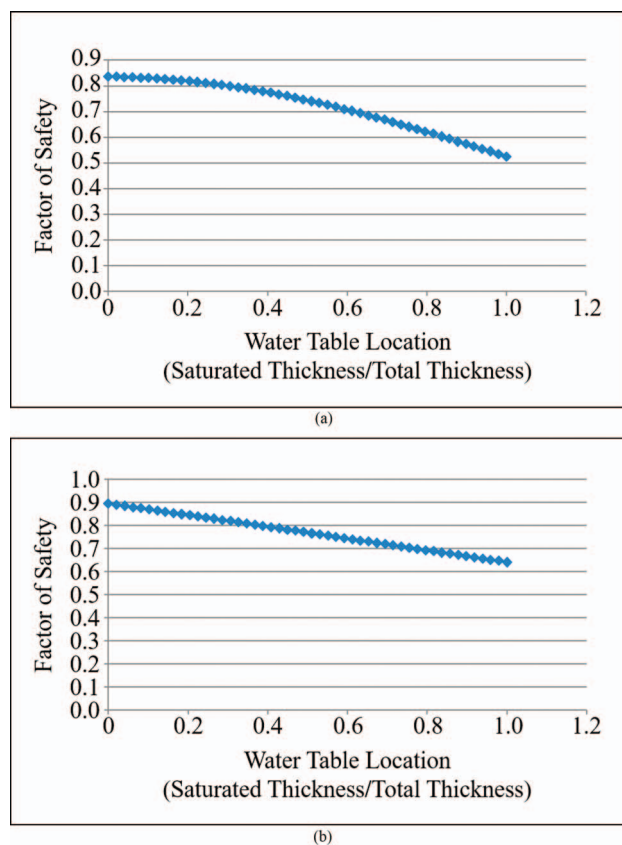
Figure 12. Relationship between water table location and factor of safety for the (a) Ten Mile Road landslide and (b) Columbia Parkway landslide.

plots in Figure 12 show that as the water table within the slope rises, the FS of the slope gradually decreases. The FS is at its lowest value when the water table is at the ground surface. i.e., the soil is completely saturated. Only partial saturation of the colluvial slopes is required to cause failure, as several other factors also contribute to instability. Many of the slopes in the study area show either continually flowing water or water seeps throughout the year. Thus, development of pore pressure is another important factor that explains the high susceptibility of the Kope Formation to landsliding.
