**SPECIALTY GEOTECHNICAL
WORKSHOP FOR DAM + LEVEE
INVESTIGATIONS + MODIFICATIONS**

Dam and Levee Safety Risk During Remedial Construction

**Jeff Schaefer PH.D., P.E., P.G.
Schaefer Geotechnical Consulting LLC**

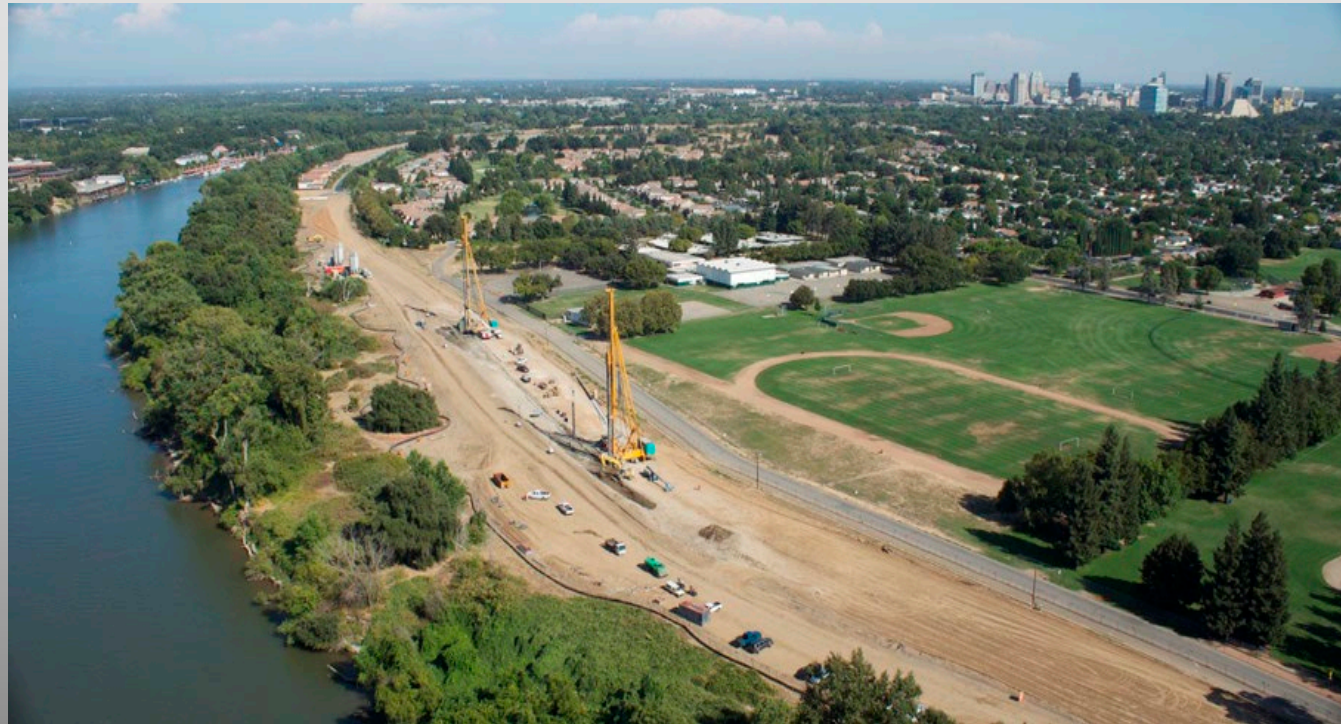
Excavations that lower the crest of the dam or levee can increase the risk of flood overtopping.

Degraded Levee for Cutoff Wall Construction

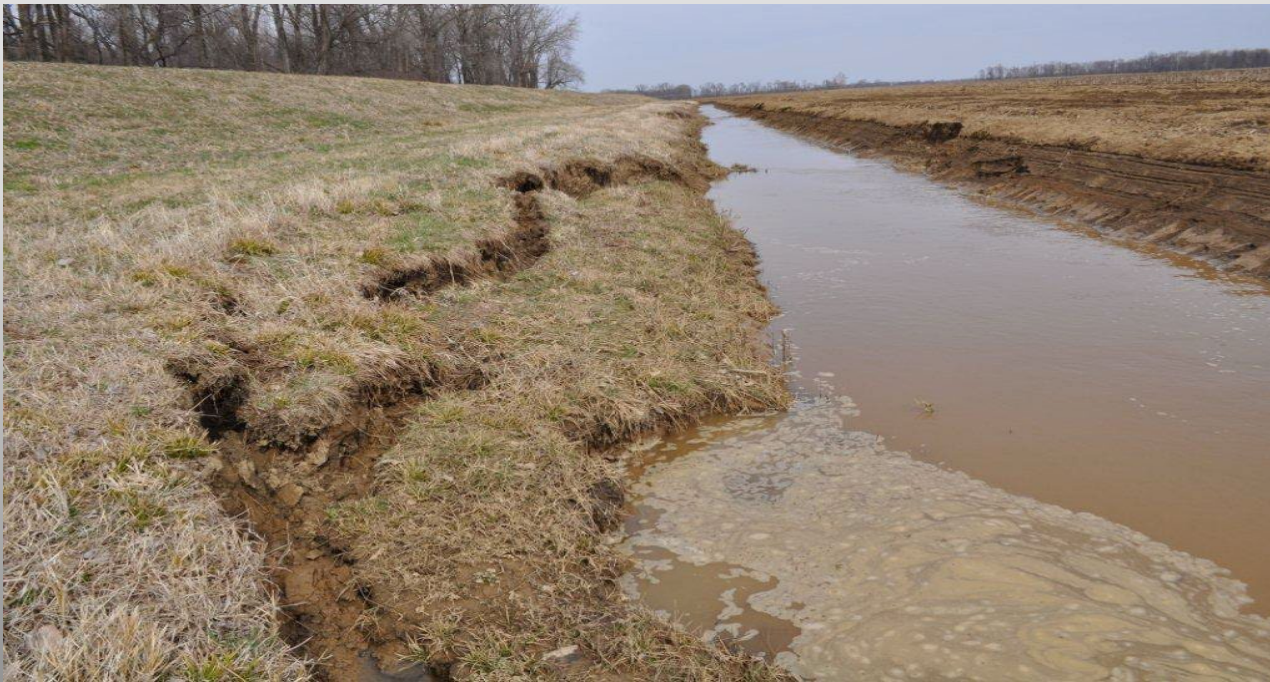
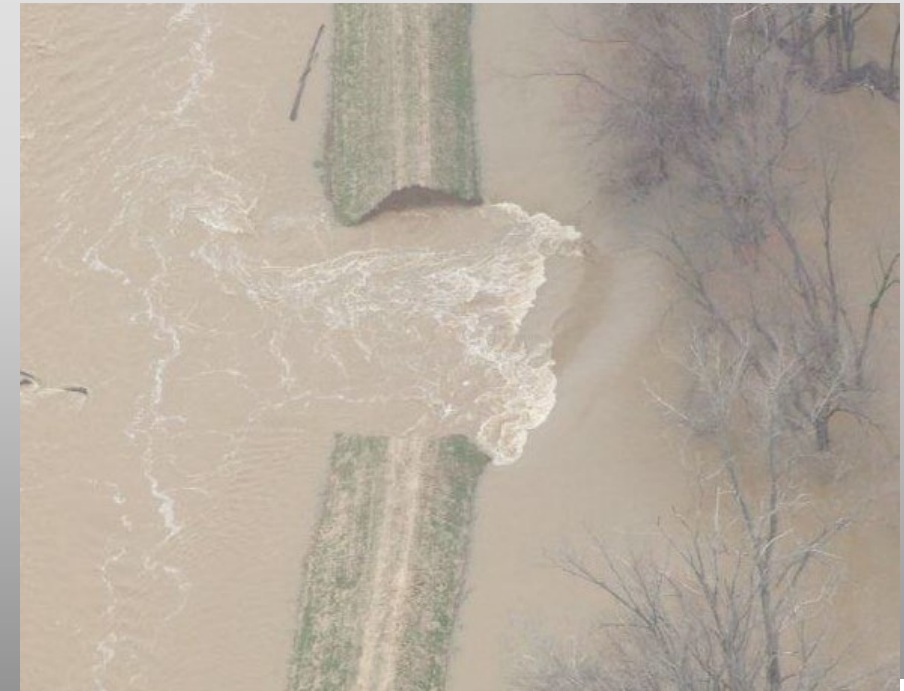
Excavations that remove a portion of the downstream slope or foundation can lead to increased susceptibility to internal erosion

Excavation of a Ditch at the Toe of a Levee that led to Breach

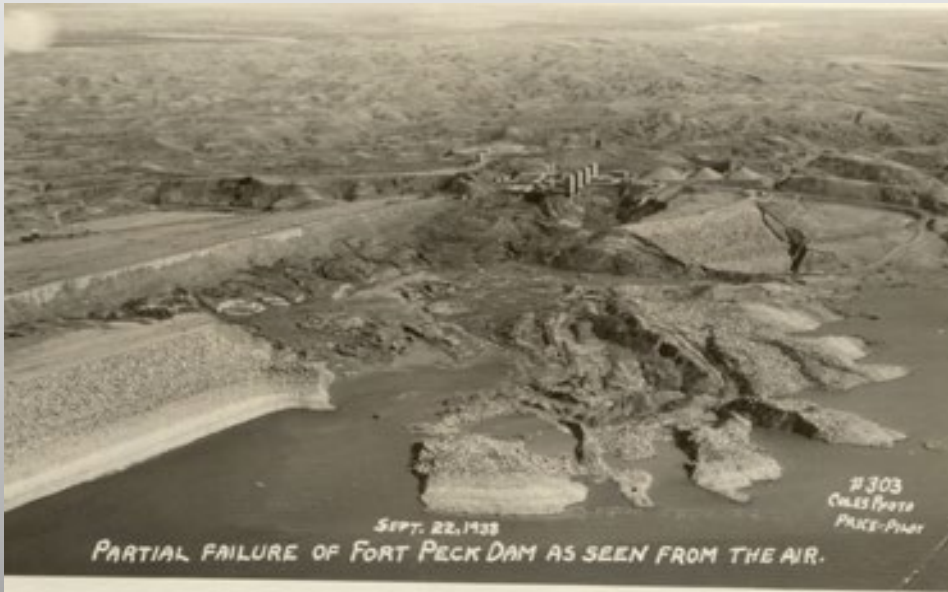
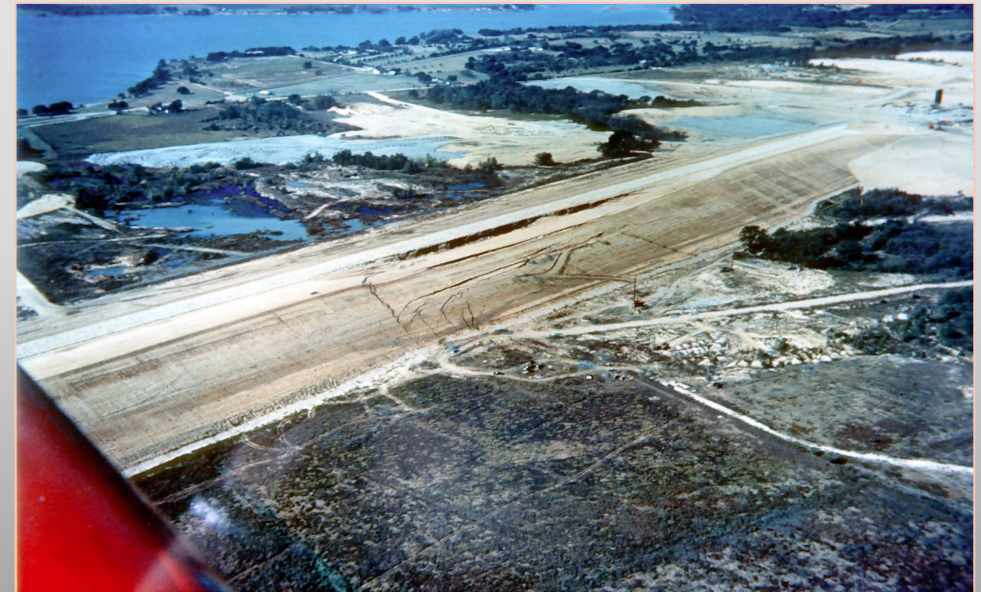
Rapid construction of embankments can increase likelihood of slope instability.

Fort Peck Dam (left) and Waco Dam (Right) Slides During Construction

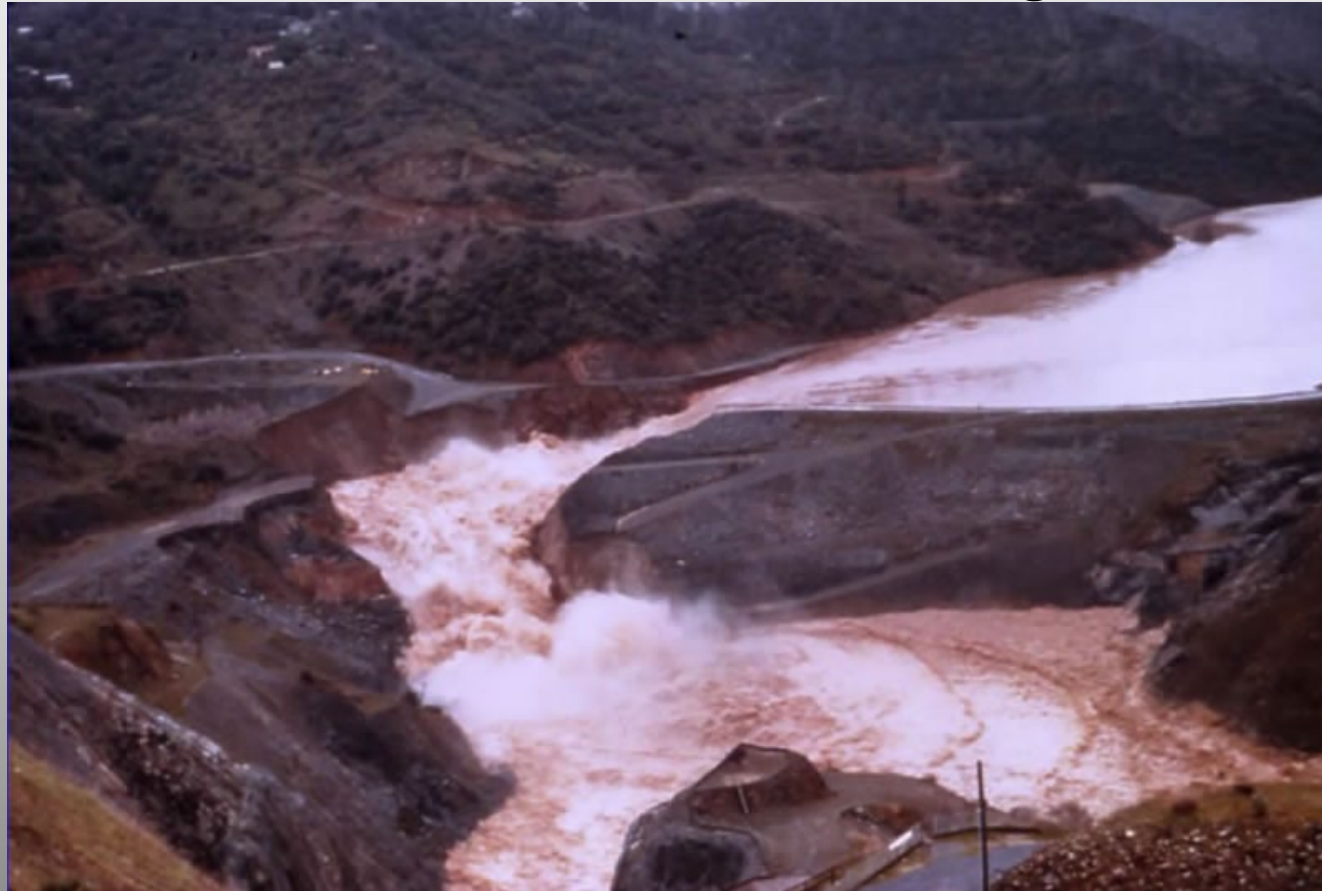
Inadequate cofferdams can lead to higher risk of flooding.

Auburn Dam Cofferdam Overtopping Failure

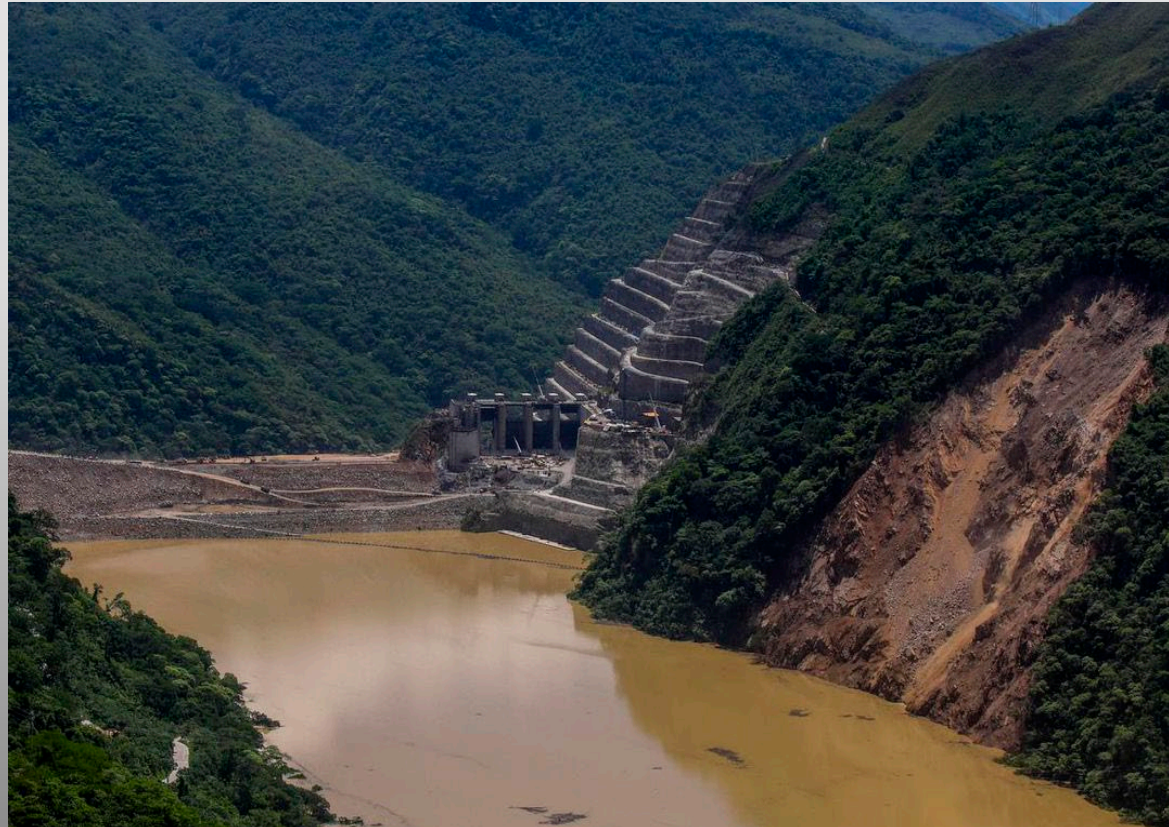
Clogged bypass tunnels can increase the risk of flooding.

Landslide Blocking Bypass Tunnels Ituango Dam

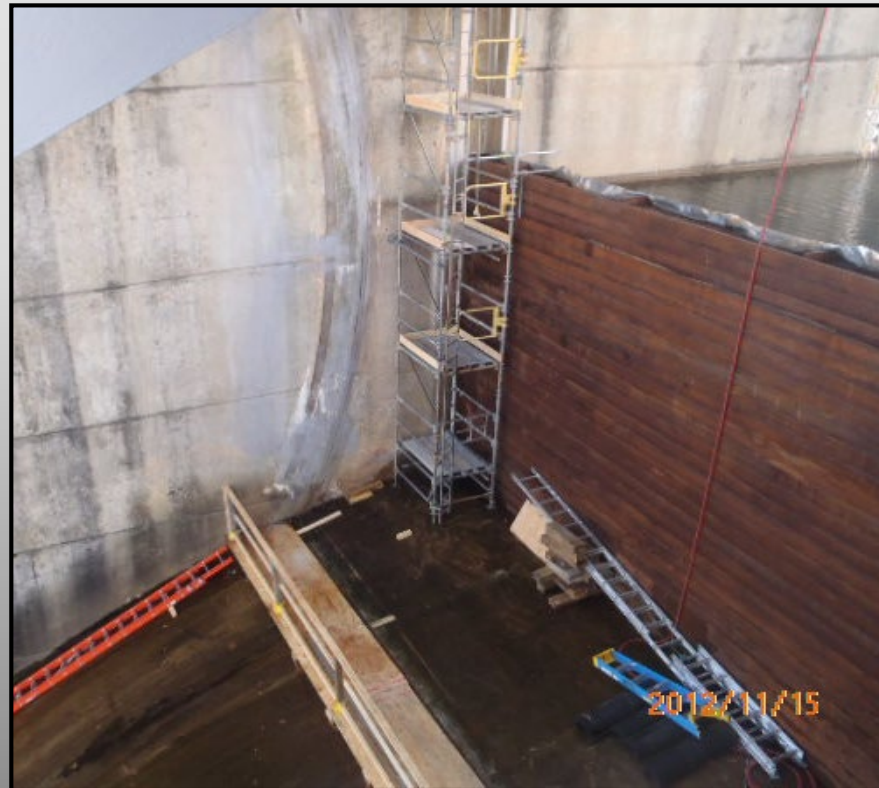
Spillway remediation can increase the chance for uncontrolled releases or overtopping.

Spillway Gate Repair Behind Temporary Bulkhead

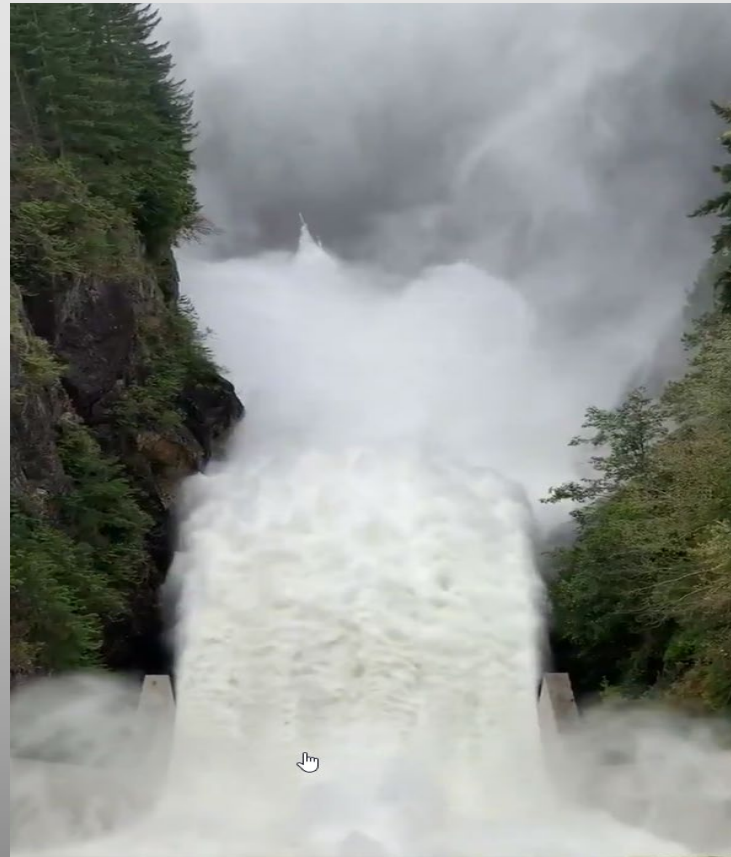
Gate repair can result in the inadvertent opening of gates.

Inadvertent Spillway Release During Repair Work

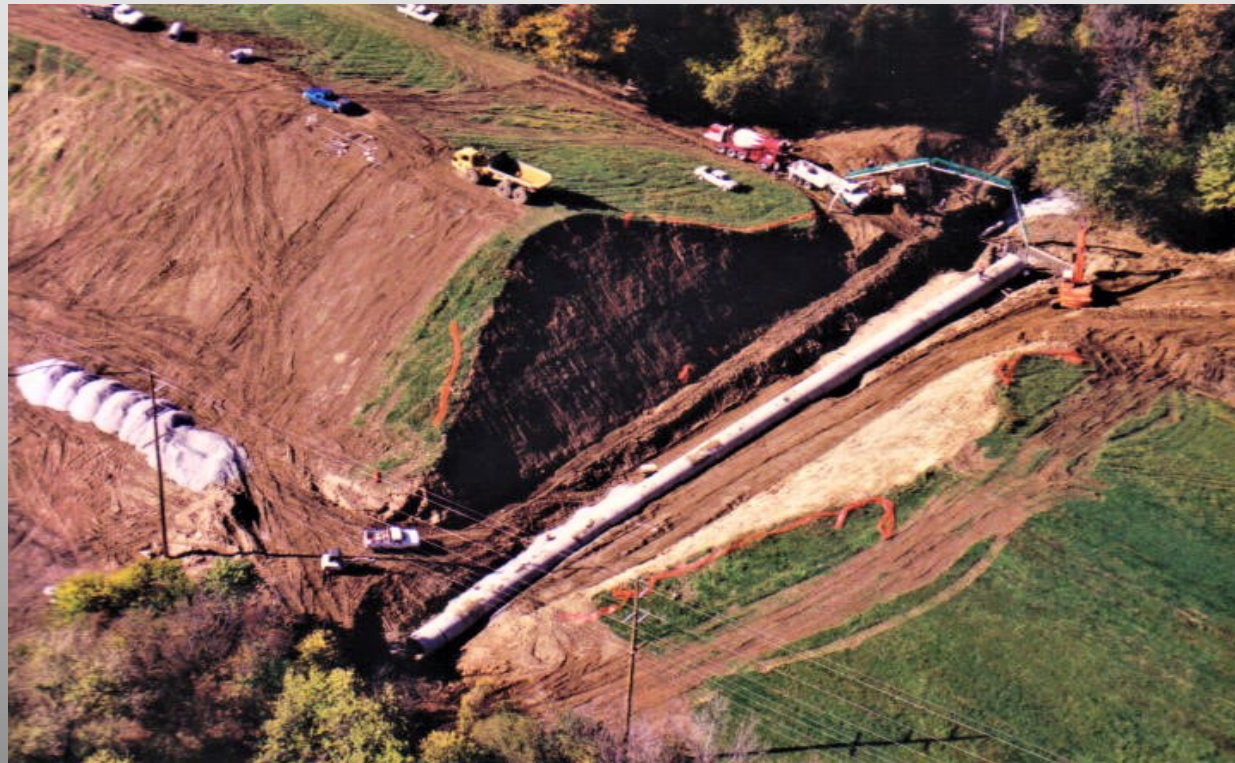
Temporary removal of flood protection (levee or floodwall) can expose the protected area to increased flood risk.

Levee Section Removed for Culvert Replacement

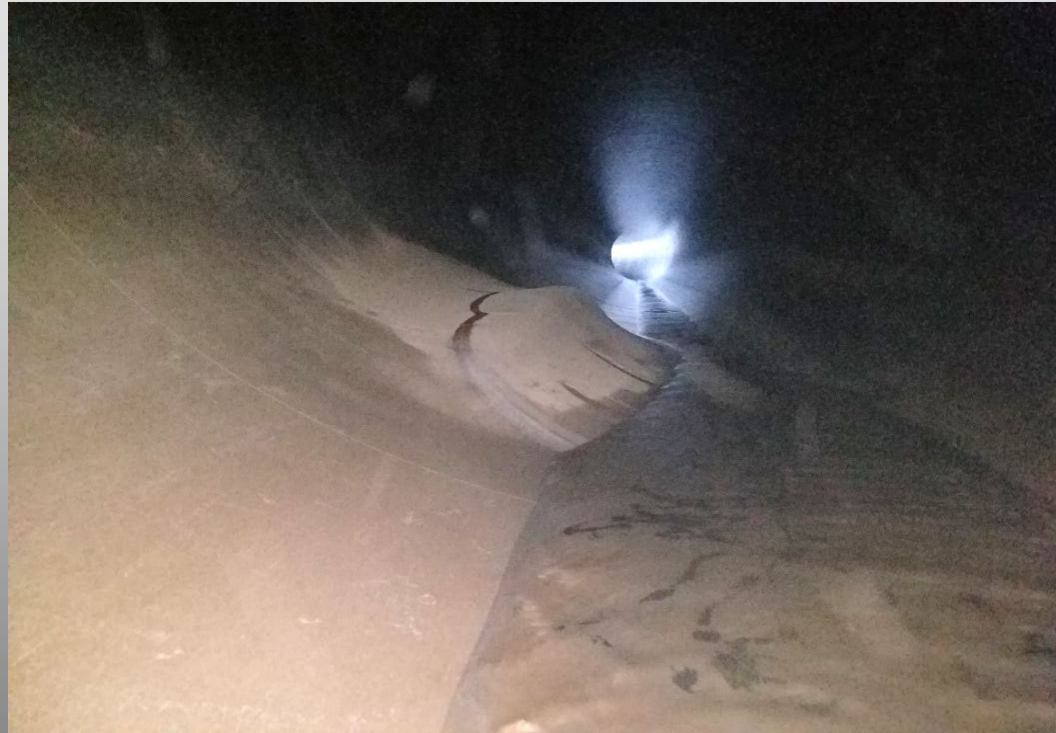
Constructing remedial elements like grout curtains and cutoff walls adjacent to existing structures can lead to damage and potential initiation of internal erosion.

Bottom Outlet Tunnel Damaged by Grout Curtain

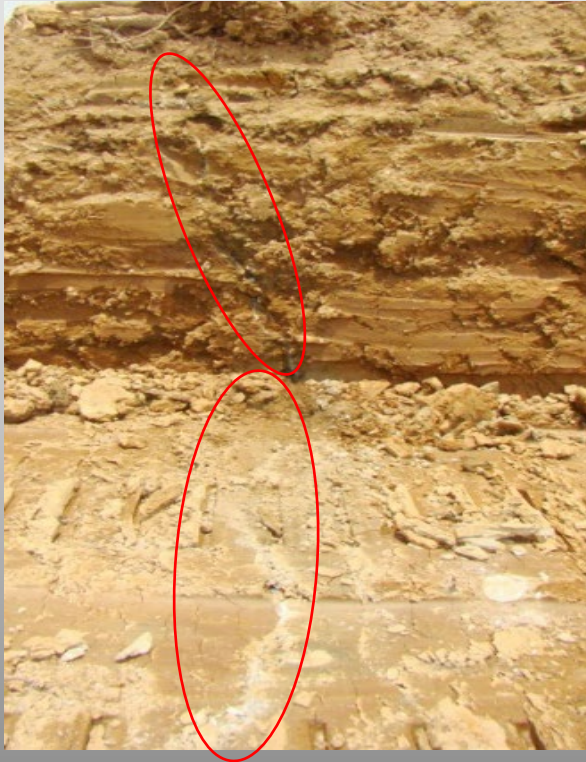
Drilling fluids and grouting pressures can cause hydraulic fracturing and ground displacement.

Grout Hydraulic Fracture

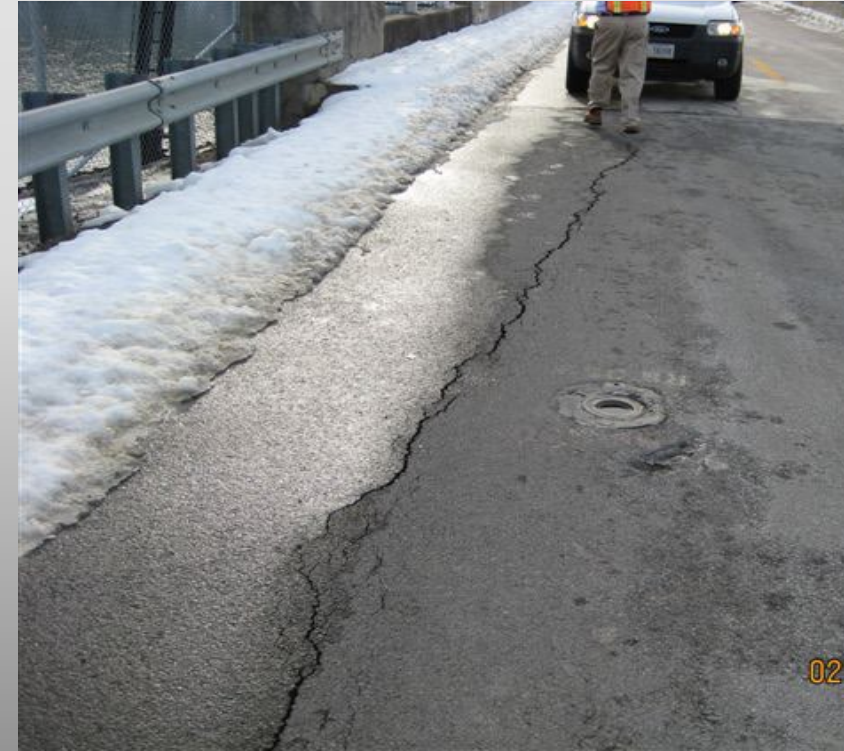
Crack in Dam Crest Related to Grouting

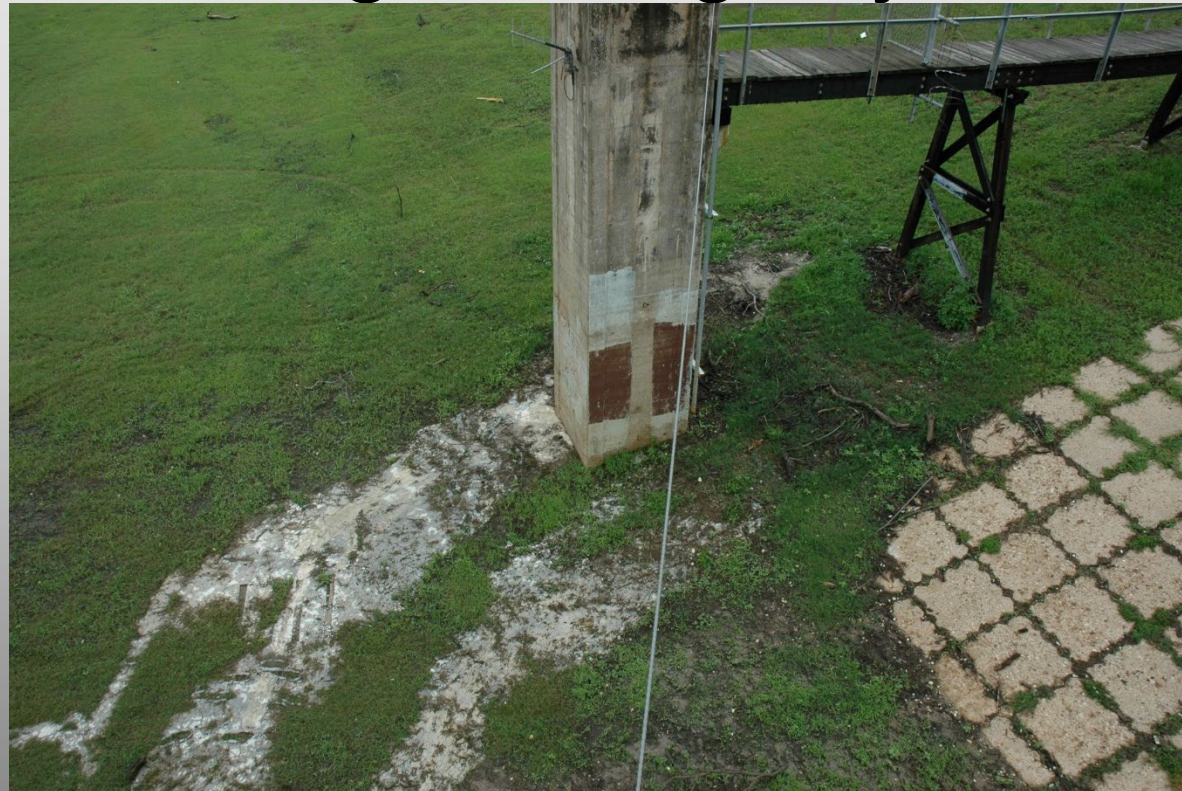
Uncontrolled drilling fluids or grouting activities have the potential to clog drainage systems.

Uncontrolled Grout Discharge

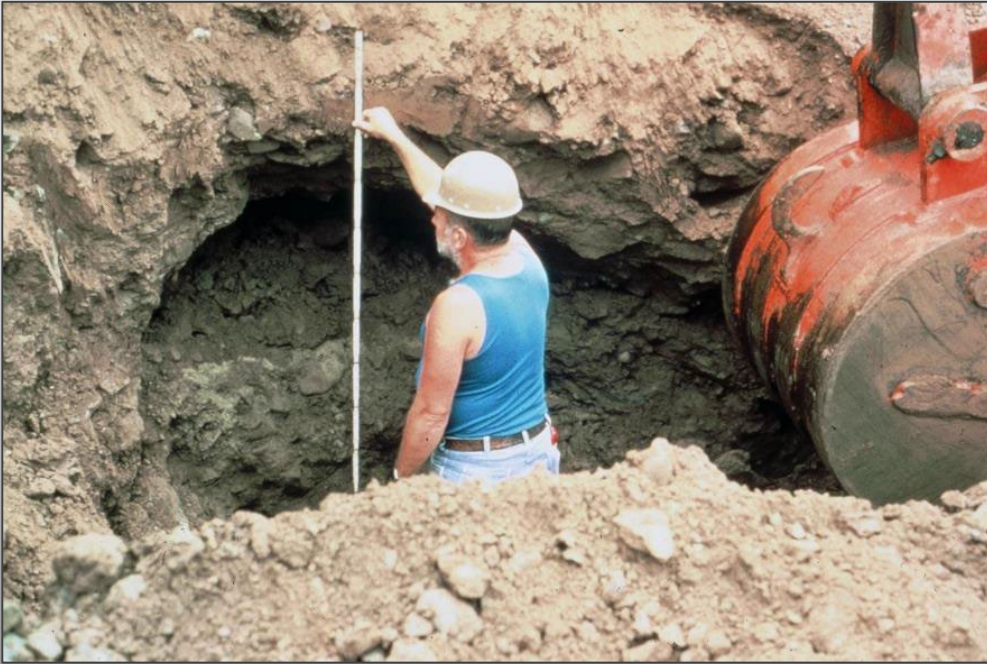
Improperly constructed filters or drains can potentially provide an unfiltered exit for seepage.

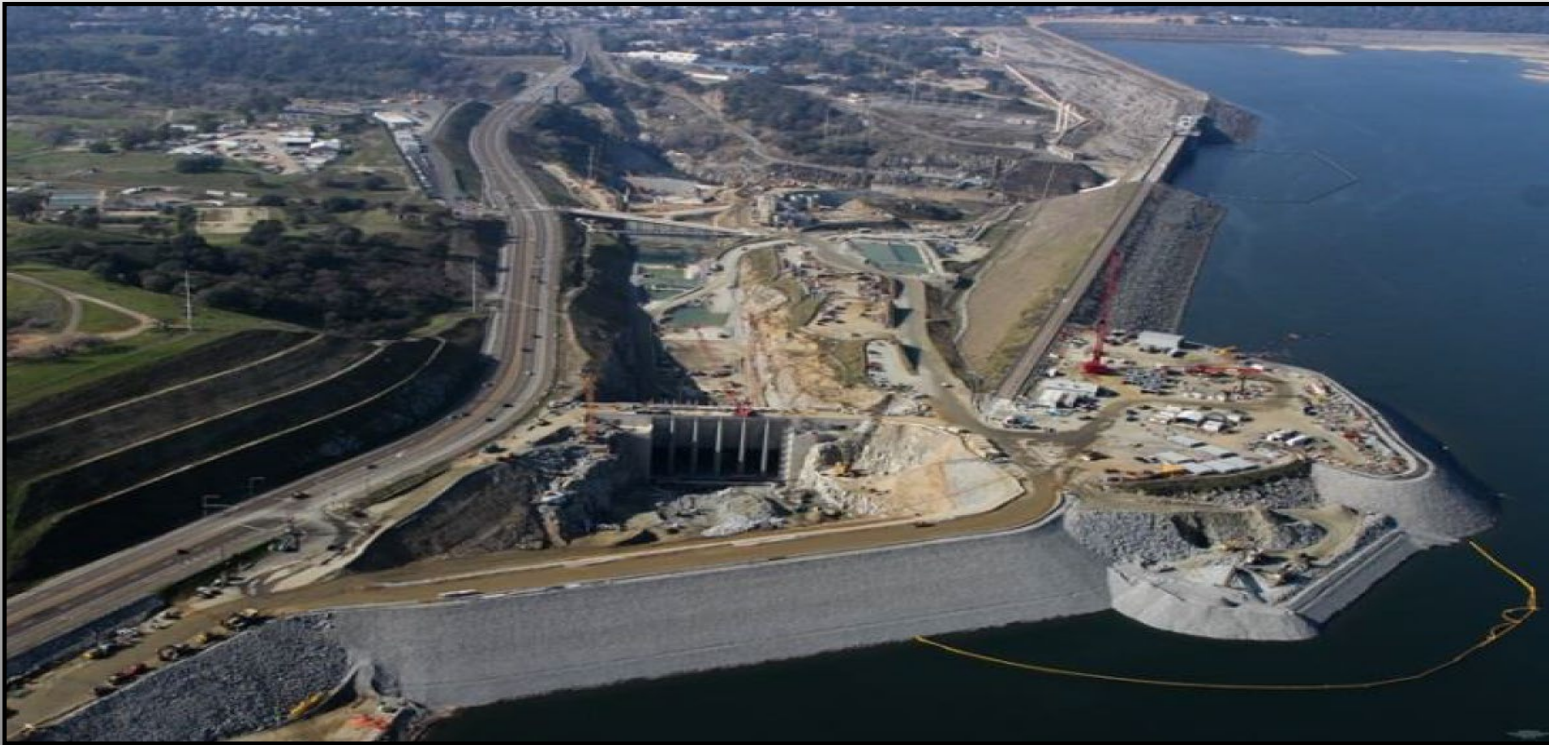
Robust cofferdams can reduce construction risk

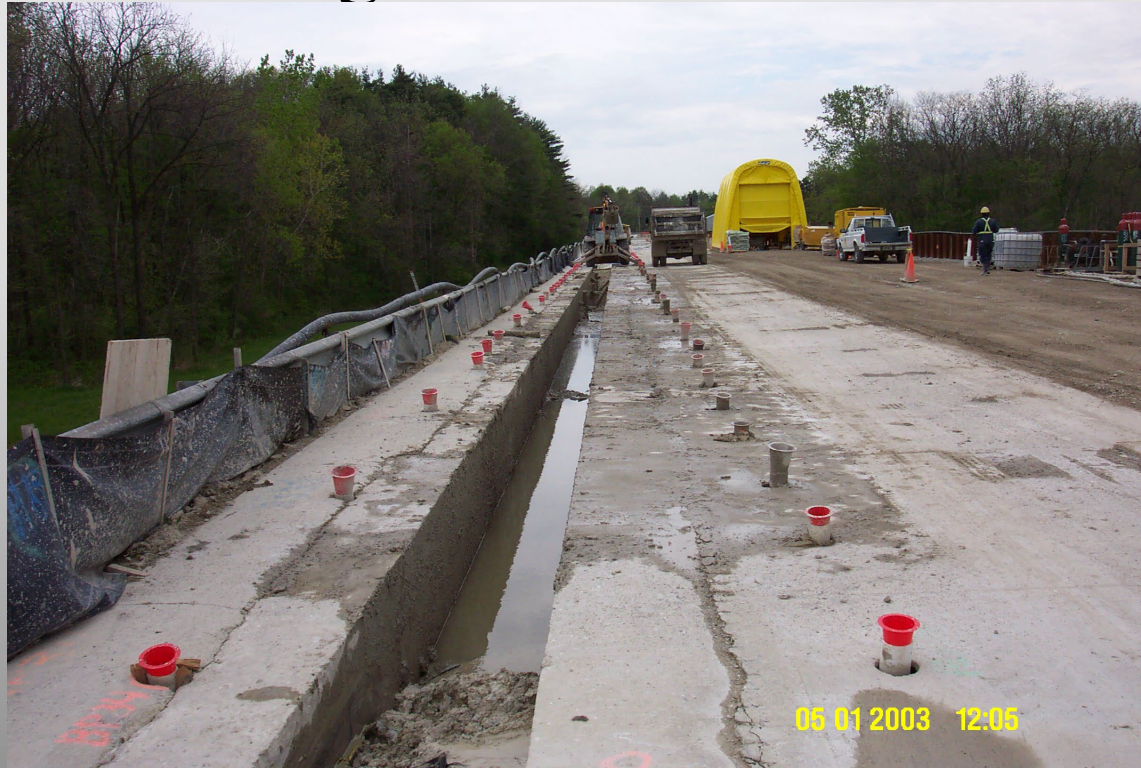
Special techniques can be required on portions of a project in order to mitigate risk.

Grouting Prior to Cutoff Wall Construction

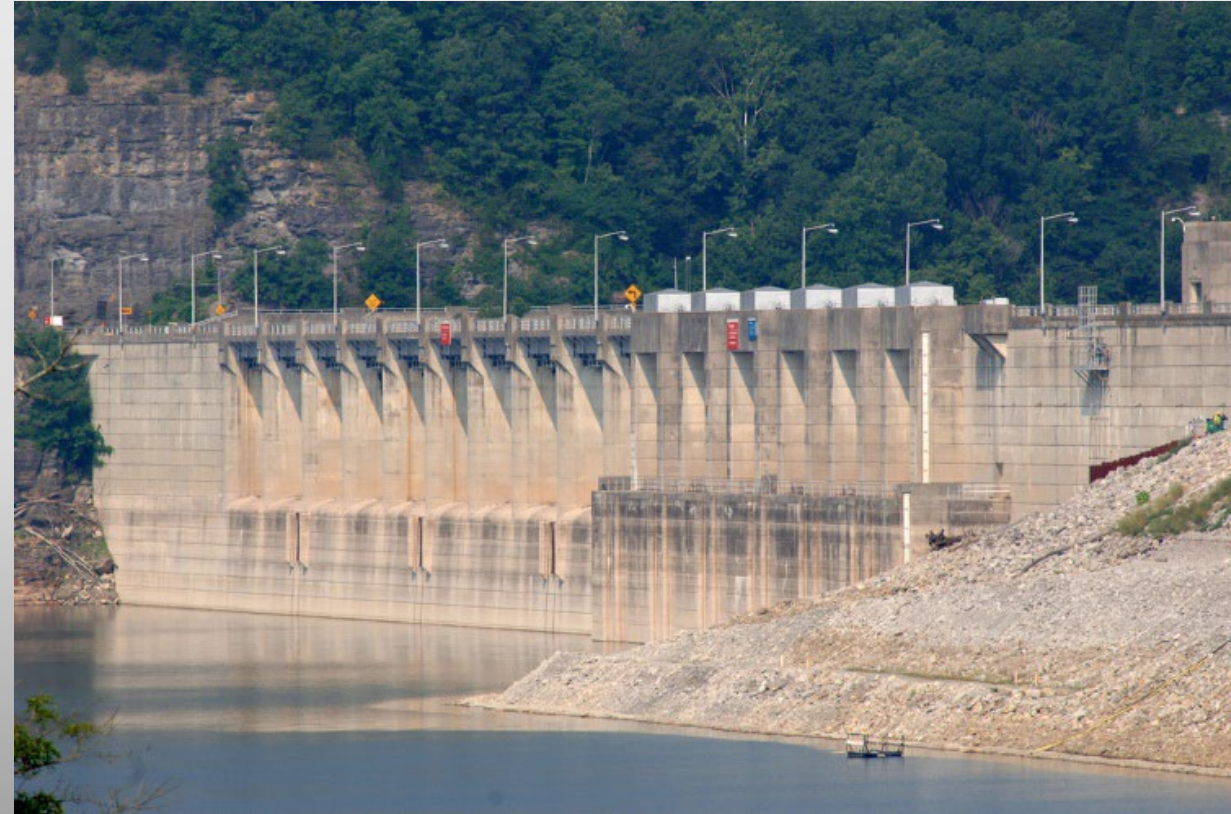
Mitigation of Risk

- Modify schedule to work during low water periods
- Restrict pool levels to reduce risk
- Increase shifts to shorten construction duration

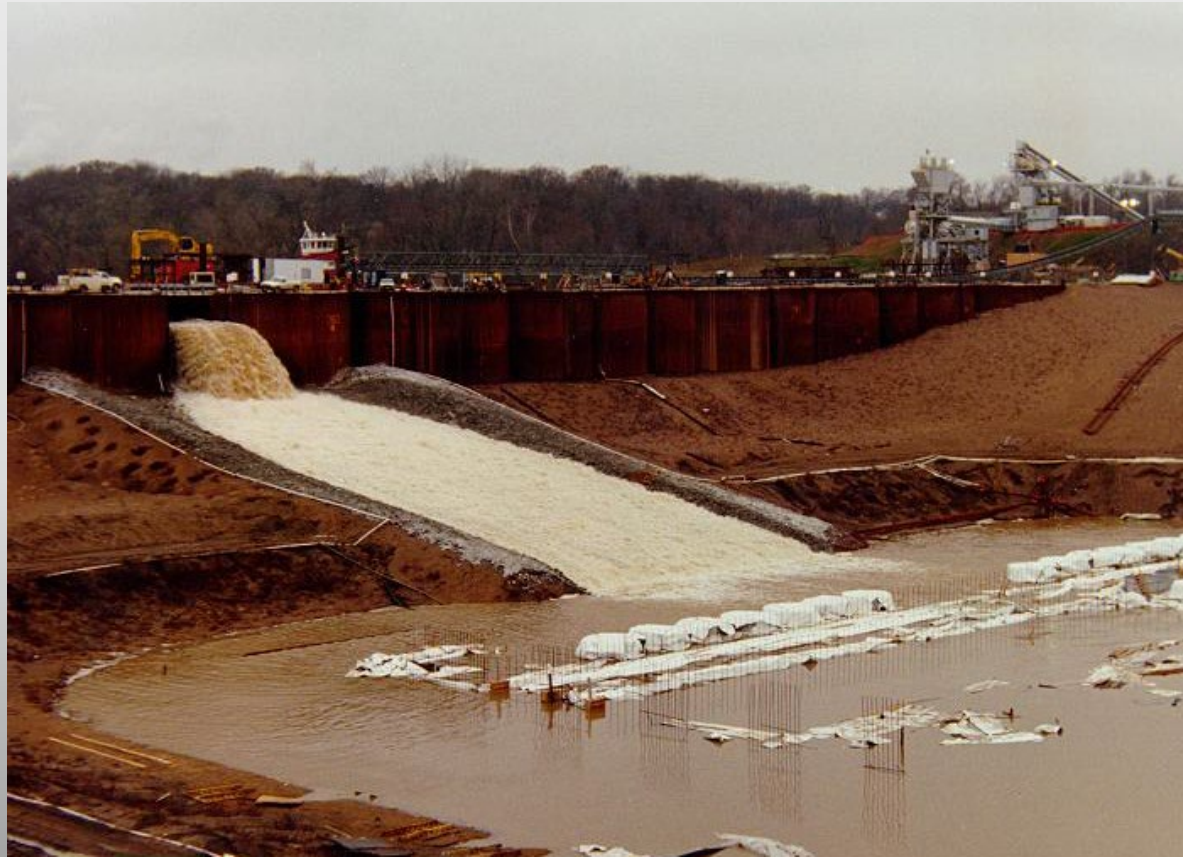
- Risk need to be determined for overtopping and other failure modes.
- Cofferdams have also failed due to sliding instability and internal erosion.
- For enclosed cofferdams, the risk of breaching due to overtopping, can be mitigated with components to allow controlled flooding of the excavation area.

Controlled Flooding of Cofferdam

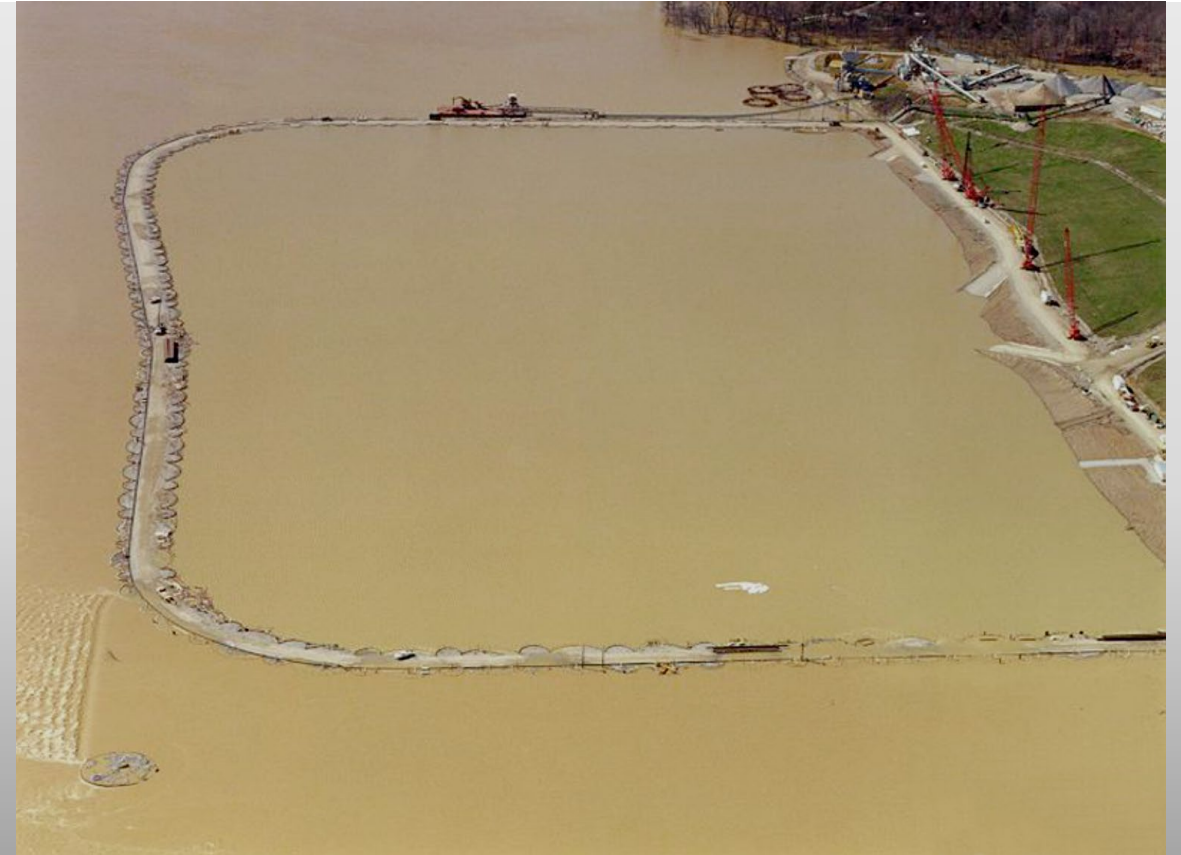
Cofferdam Overtopping

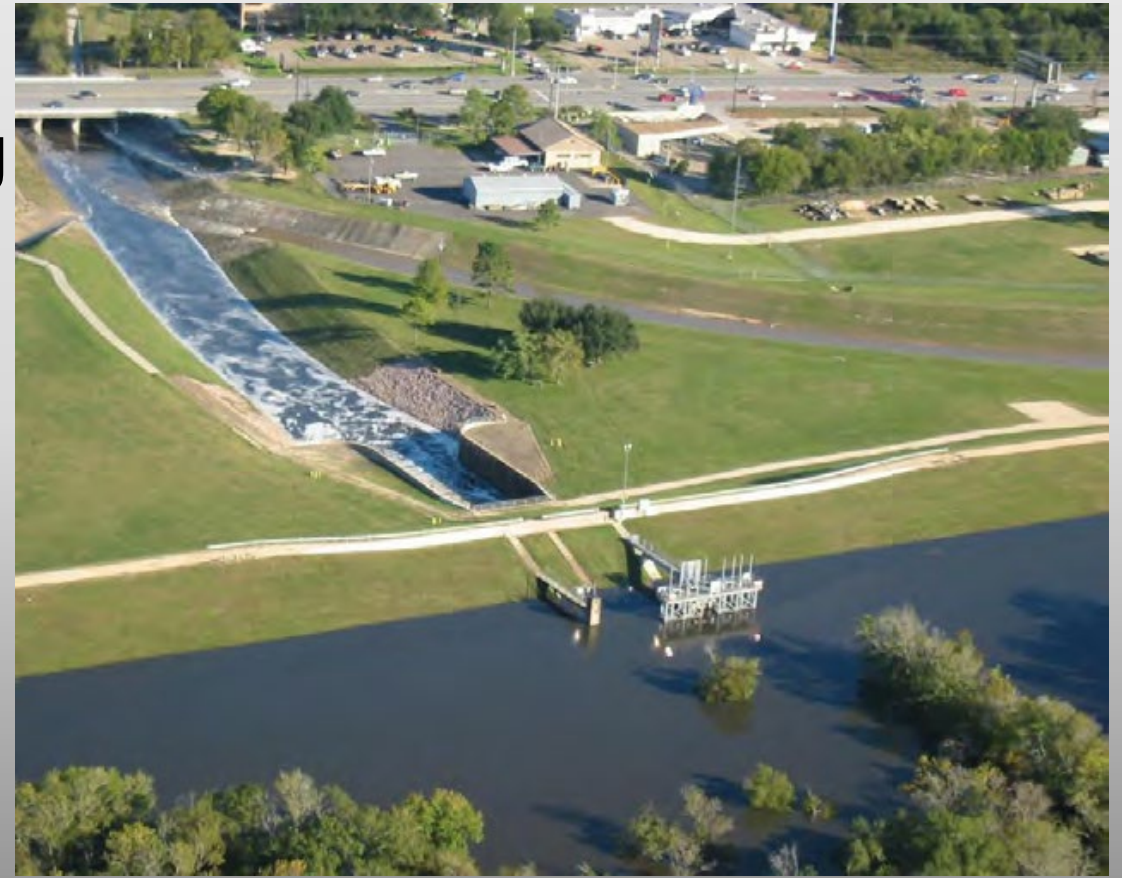
Cofferdam required to replace outlet works due to Internal Erosion along and into the conduit.

Outlet Works Prior to Replacement

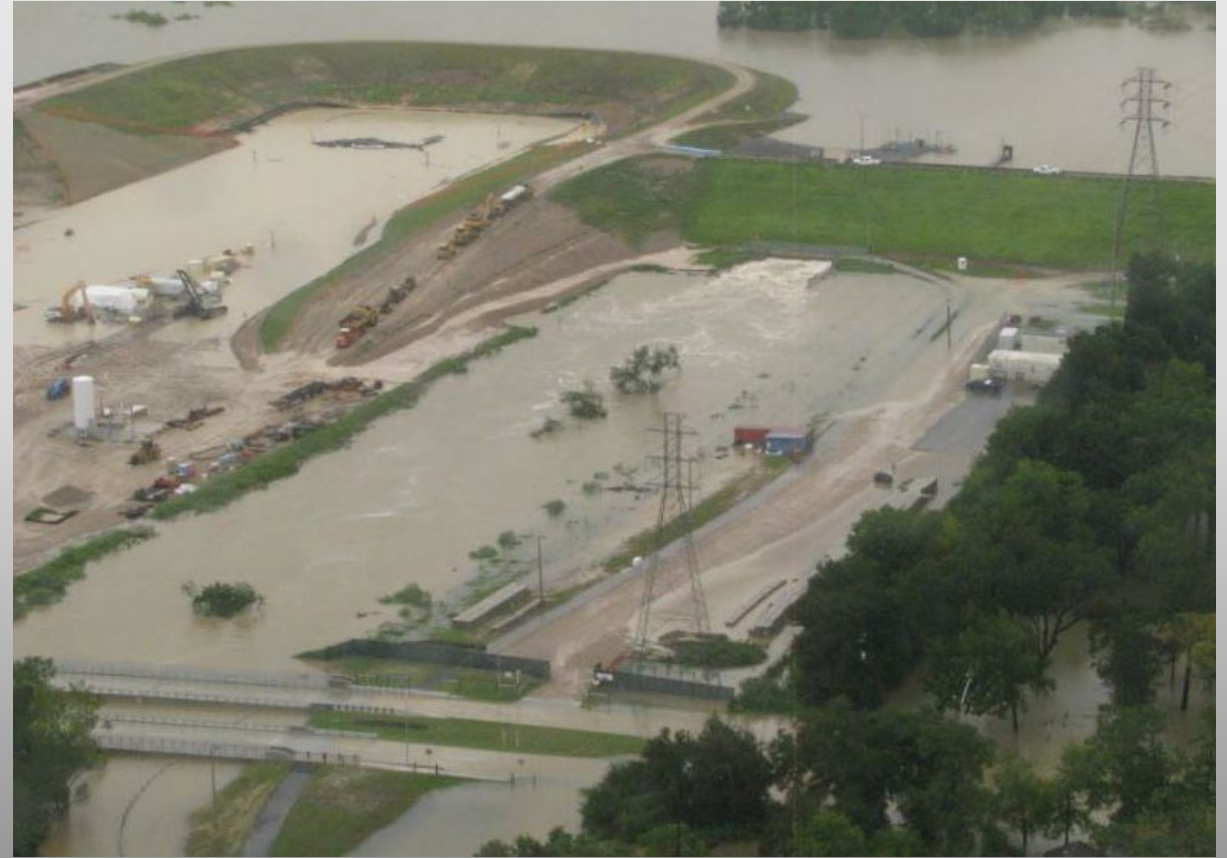
- Hurricane Harvey resulted in record pool just 10 ft below crest.
- The recommended height from the VE Study would have overtopped.
- Significant damages would have occurred if the construction risk was on properly considered by the decision makers.

Cofferdam During Record Pool

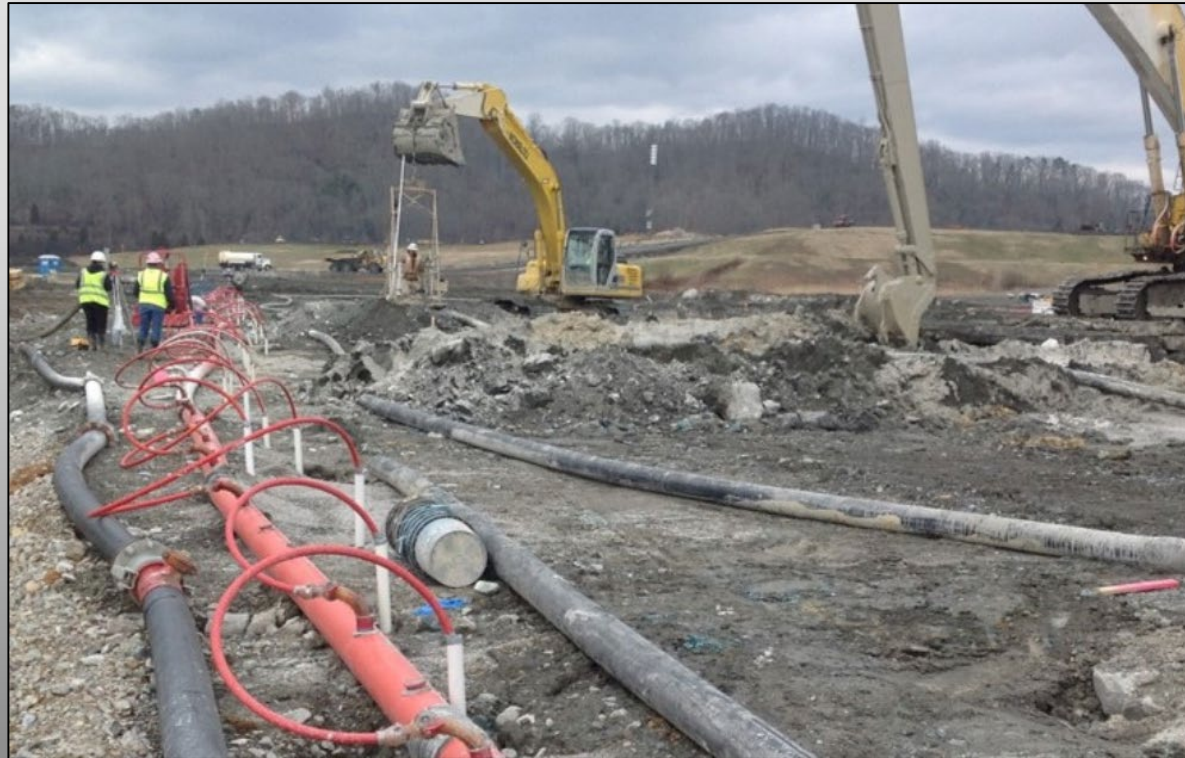
- It was estimated that the dewatering system had a 10 percent chance of failing.

Dewatering System

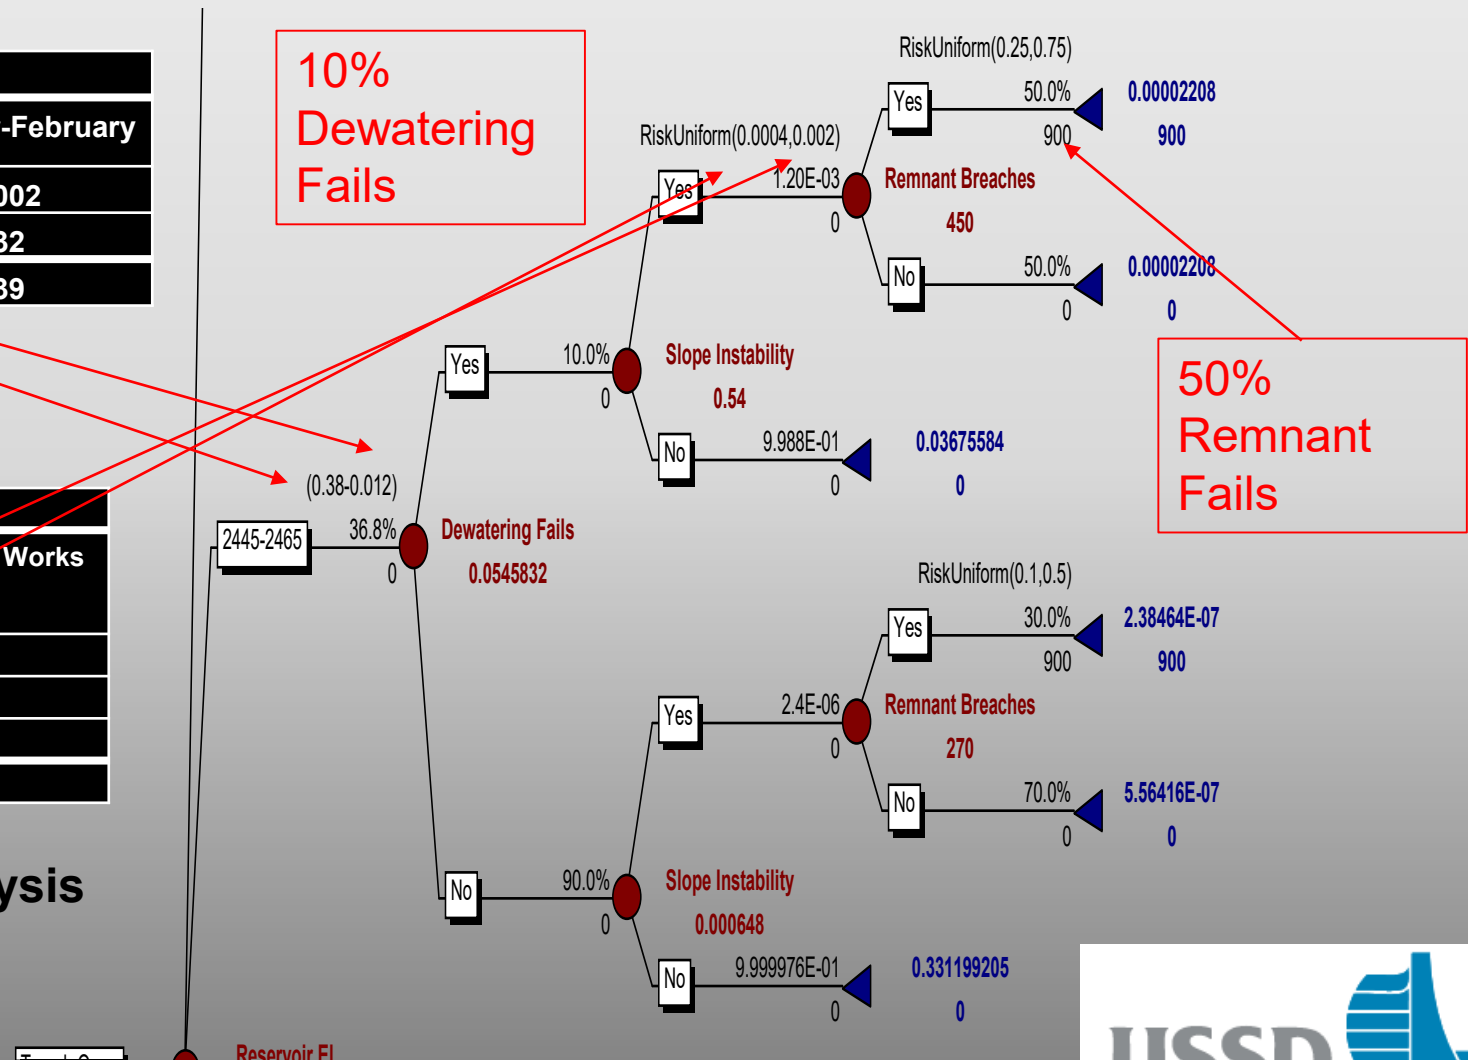
Season	Failure Probability	Loss of Life
March-June	4.66×10^{-5}	4.20×10^{-2}
July-October	2.02×10^{-5}	1.82×10^{-2}
November-February	1.99×10^{-5}	1.79×10^{-2}

Results for Each Period
