# Presentation of September 4, 2010 Canterbury Earthquake

William Godwin, PG, CEG  
AEG Vice President, 2019-20  
Webinar – May 6, 2020

# Preliminary Observations

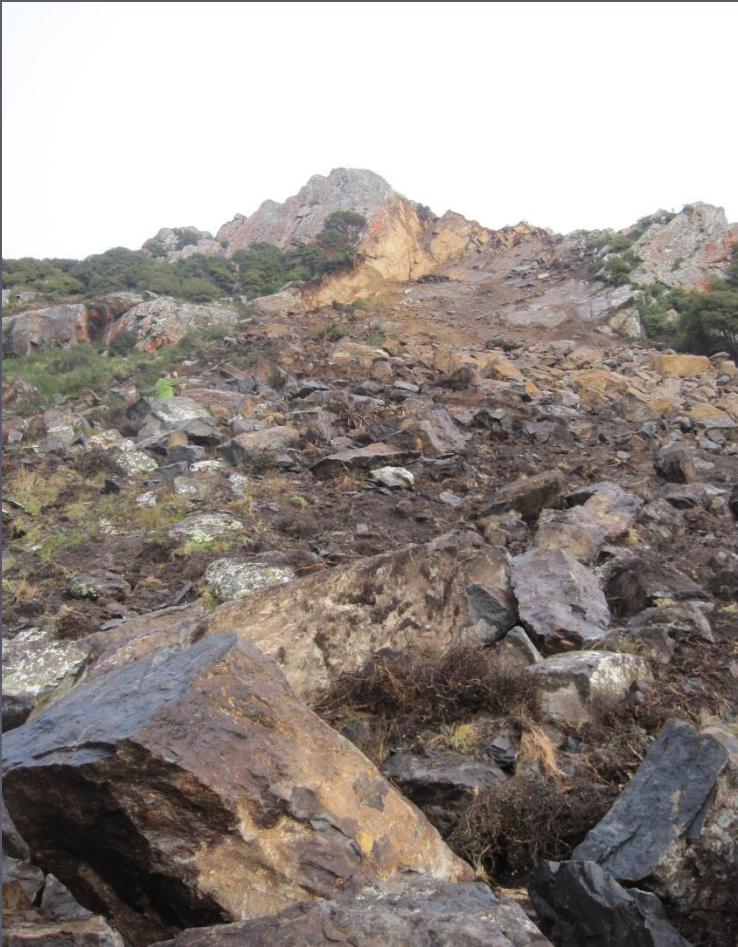
# Rock Avalanche

View upslope towards source

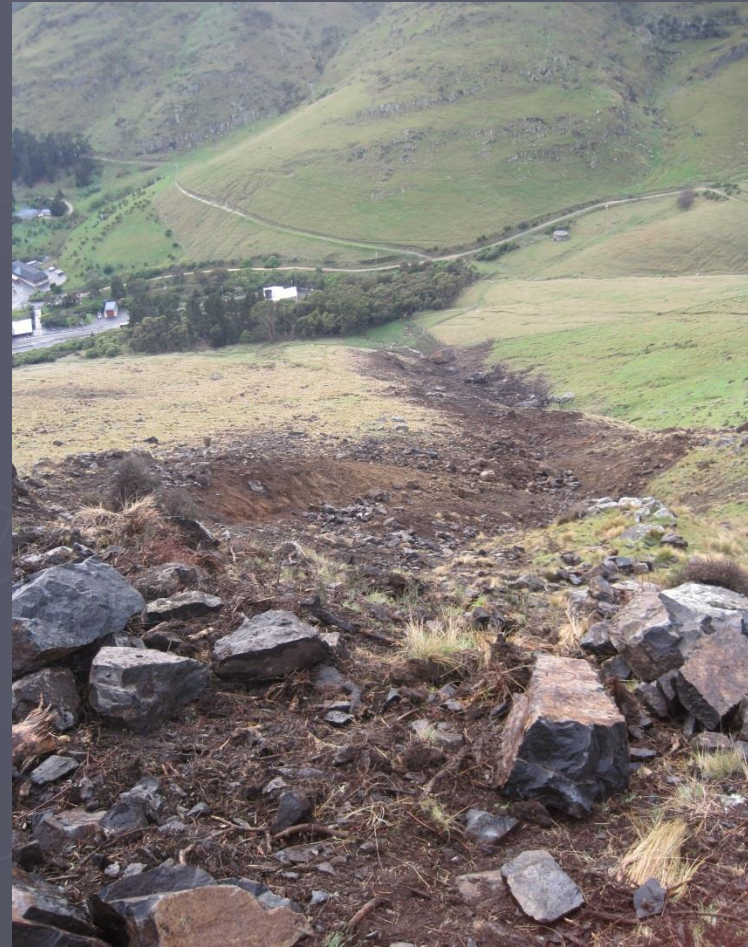
View down the chute towards tunnel portal

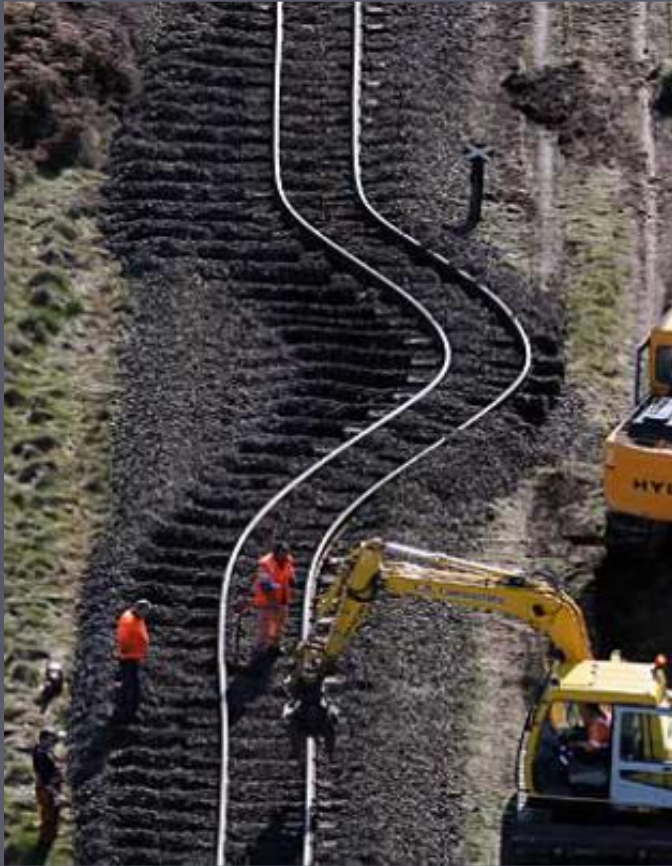
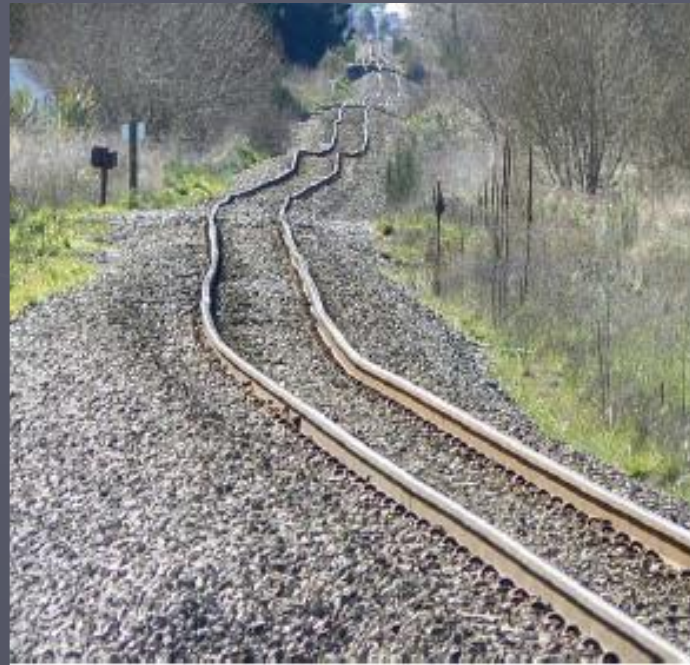
# Railroad embankments

Rolleston (at left). Woodford Glen  
(top)

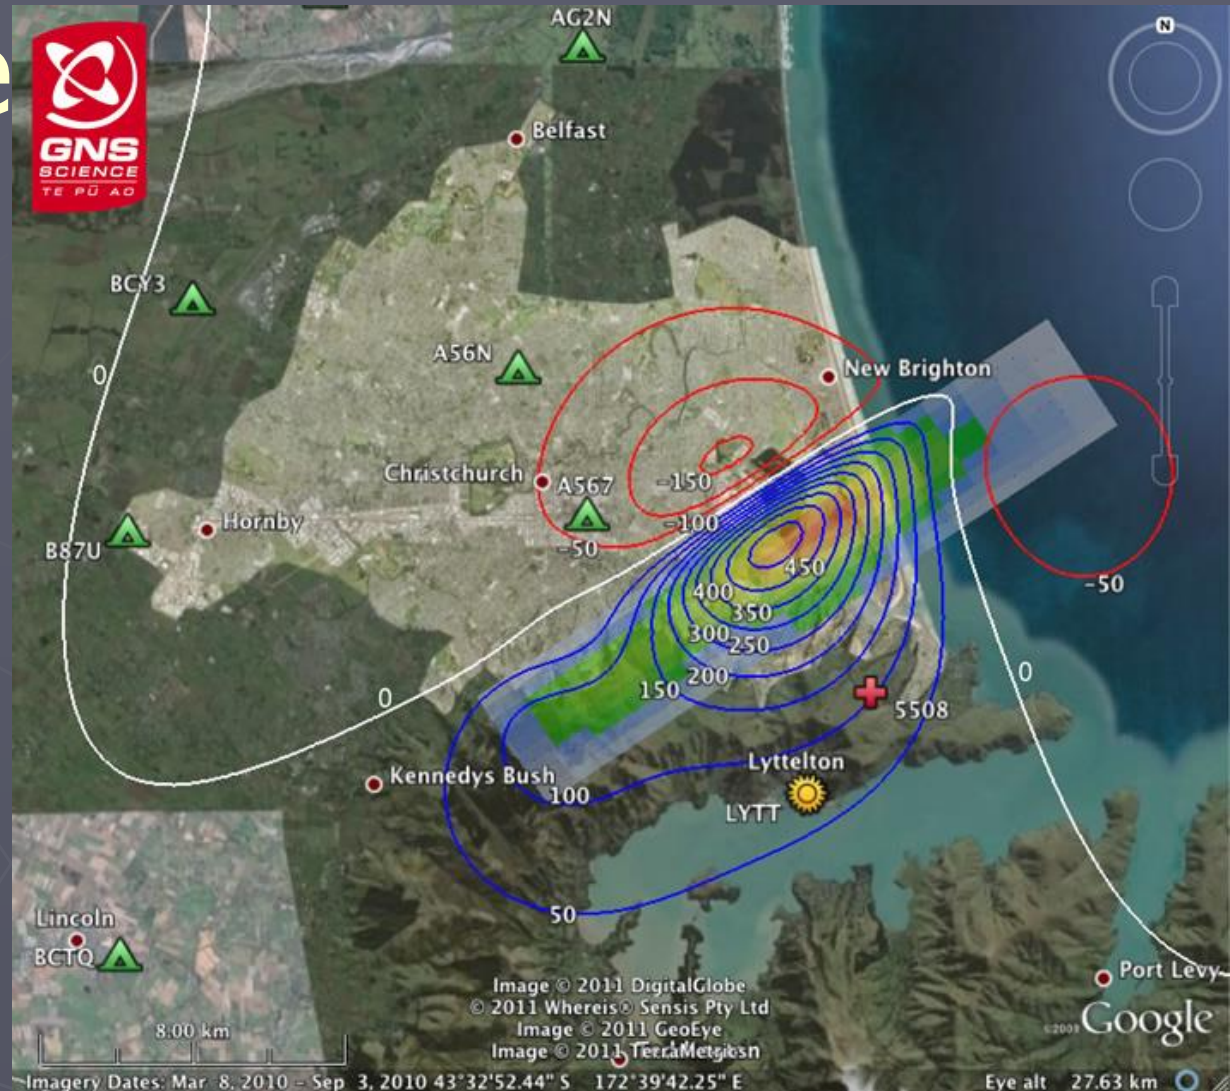
# 2011 $M_w$ 6.3 Christchurch Earthquake

- On Tuesday 22 February 2011 at 12.51 p.m. Christchurch was badly damaged by a magnitude 6.3 earthquake, which killed 185 people and injured several thousand.
- The earthquake epicentre was near Lyttelton, just 10 kilometres south-east of Christchurch's central business district.
- 15-kilometre-long fault did not express surface rupture
- Predominantly reverse movement
- Peak ground accelerations of more than 2g

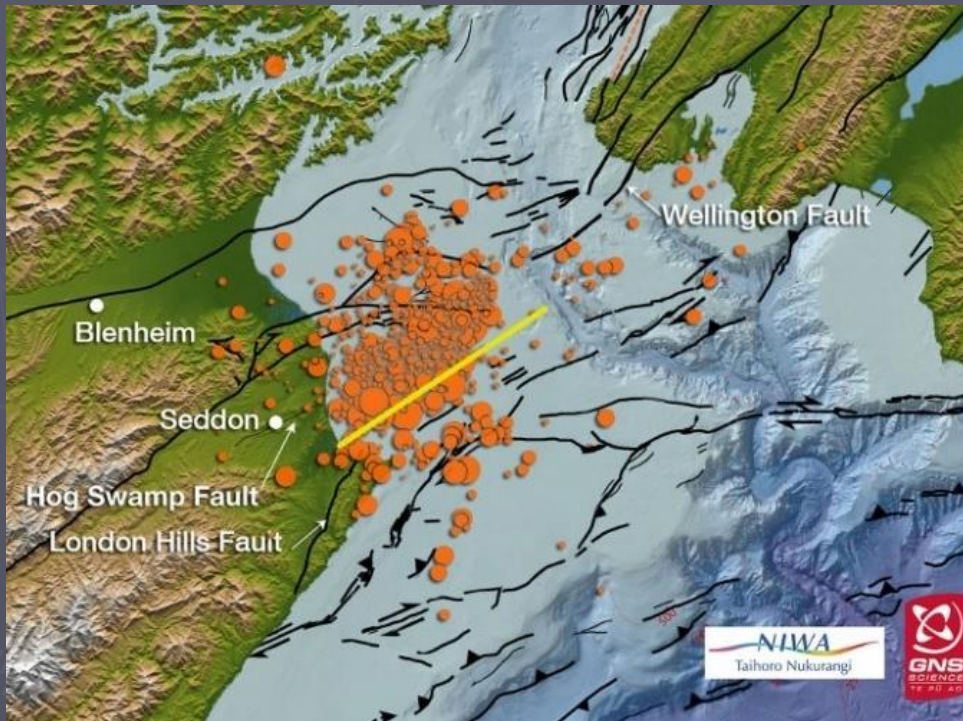
2013 Cook Strait earthquake  
 $M_w$  6.5. Unknown offshore fault  
Ground accelerations 1/10<sup>th</sup> that of similar magnitude Christchurch earthquake

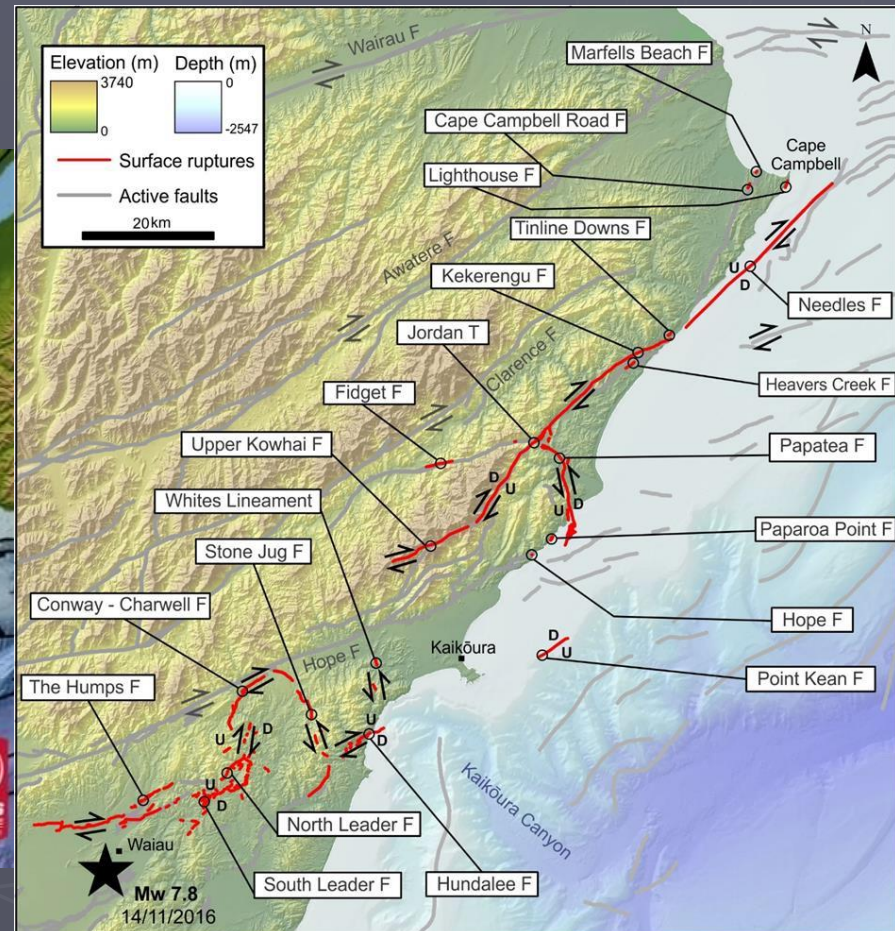
2016 Kaikōura earthquake  
 $M_w$  7.8. The rupture lasted nearly 2 minutes  
ground was displaced, horizontally and vertically by up to 12 metres. 20 separate fault ruptured (world record)
