# **The Residential Geotechnical Evaluation for Ownership Transfer: A Risk Assessment Guideline**

**Harry S. Audell**

**Special Publication No. 25**

**The Association of Environmental &  
Engineering Geologists**

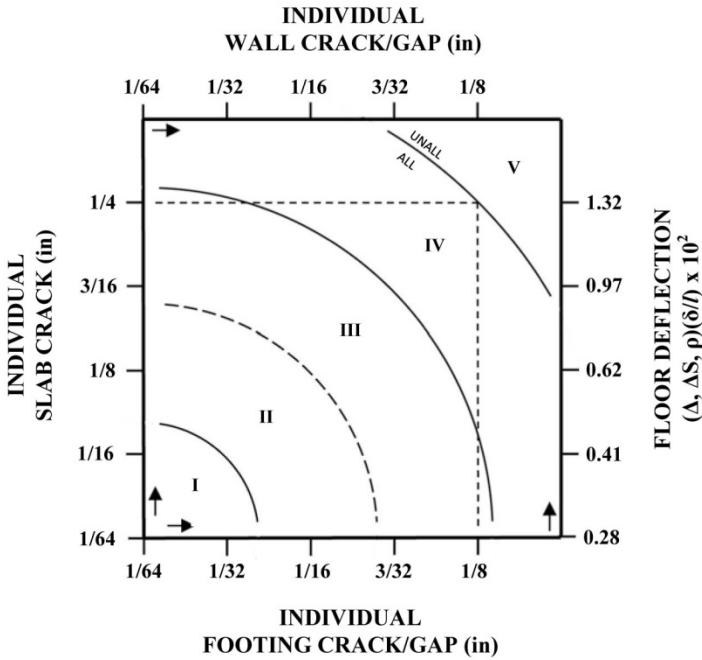
Figure 9. Quadruple curve matrix-area nomogram to determine geologic impact based upon primary indicators. For abbreviations refer to text. Modified from Audell (1999a).

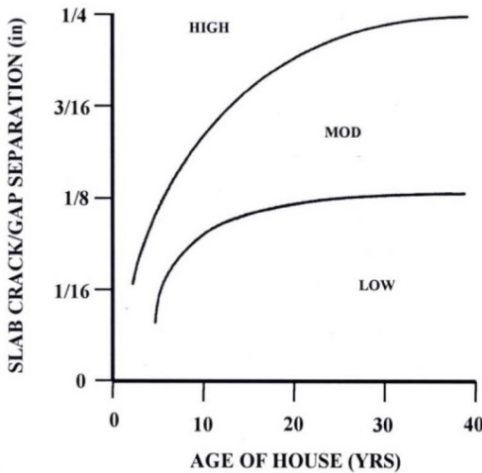
Figure 12. Double curve-area graph to determine historic ground activity based upon dimension of slab cracks/gaps versus the age of the house. Modified from Audell (1999b).

Two double-curve area-graphs determine HGA and one triple-curve area-graph determine CGA. The HGA graph based upon wall crack dimension is shown in Figure 11 and the HGA graph based upon slab crack dimension is shown in Figure 12. The graph for CGA is shown in Figure 13. Examples for determining the rate of historic and current ground activity is shown in Figures 19, 20 and 21, respectively,

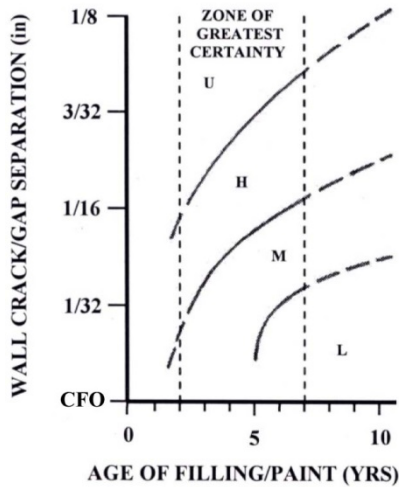
Figure 13. Triple curve-area graph to determine current ground activity based upon dimension of wall cracks/gaps versus the age of patch or paint. Modified from Audell (2006).

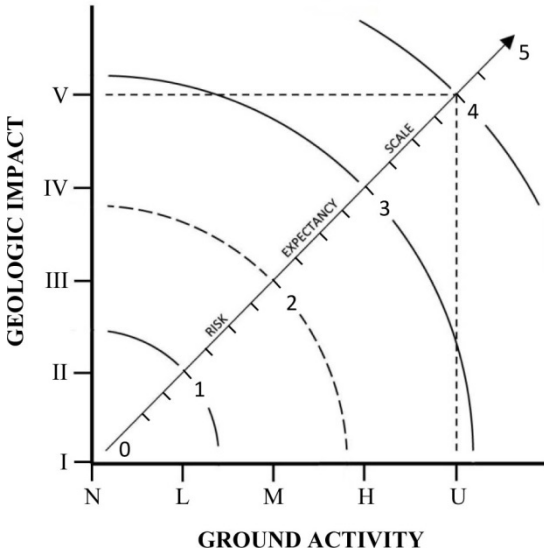
Figure 14. Quadruple curve-area graph to determine the Risk Expectancy Score (RES) based upon geologic impact versus ground activity. Modified from Audell (1999c).

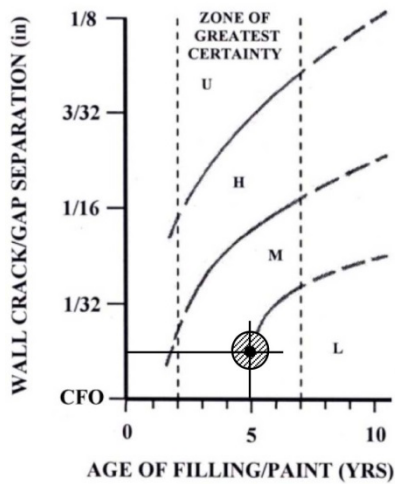
Figure 21. Determination of current ground activity based upon dimension of wall cracks versus the age of patch or paint for Example RGE. The level of current ground activity is moderate.

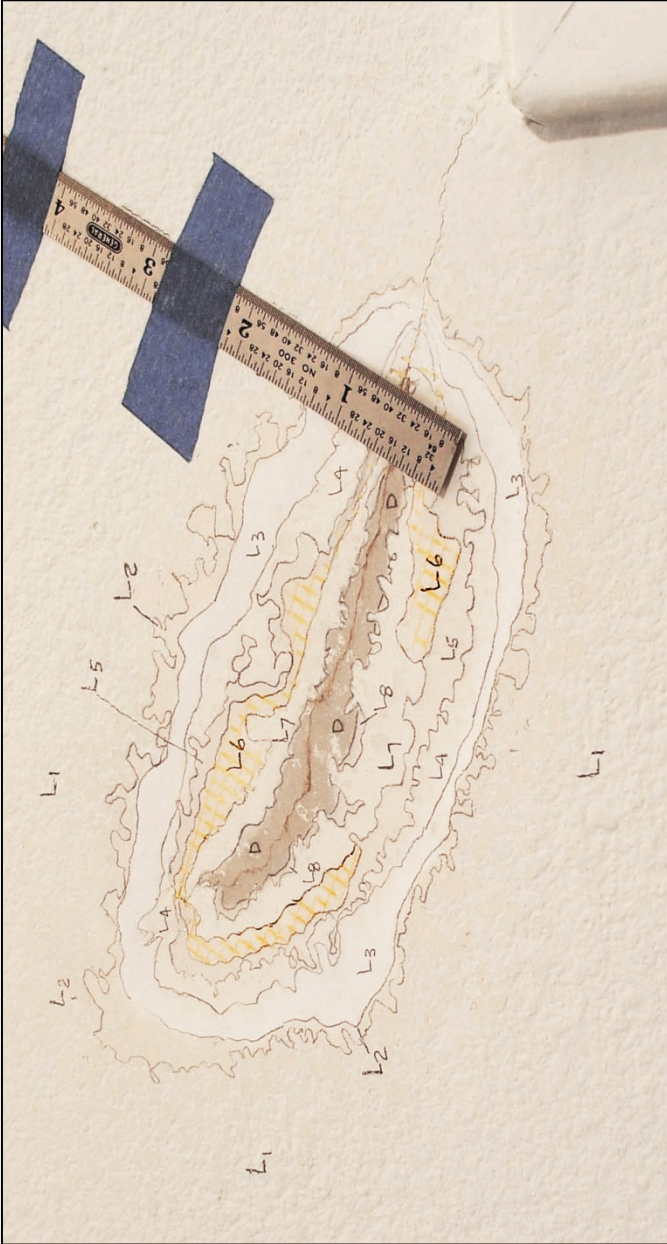
Figure 23. Exhumed drywall crack (NDTC) shows numerous paint layers and drywall backing. Exposed crack in drywall is roughly twice the separation as crack on surface. (Abbreviations: L-layer and D-drywall).

Distinguishing crack recurrence in an exterior plaster wall requires close examination of the patch or filler material used for the repair. Frequently, paint alone is used to fill a crack. Drying paint will often shrink into the crack leaving the separation open, but along some lengths bridges are formed where the paint has filled the separation. Paint bridges (Figure 24) are diagnostic and may indicate the recency of ground movement and subsequent building distortion. The presence of uncracked paint bridges usually indicates no distortion after painting, and a cracked paint bridge indicates either continuous or renewed distortion after painting. Knowing the age of the paint provides a time constraint for the determination of the latest episode of building distortion in general terms.

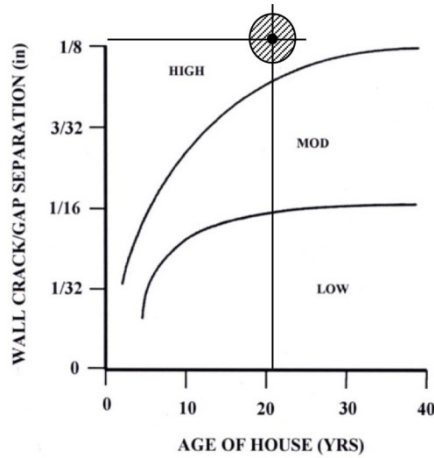
Figure 30. Determination of historic ground activity based upon dimension of wall cracks versus the age of the house for Case History. The level of historic ground activity is high.

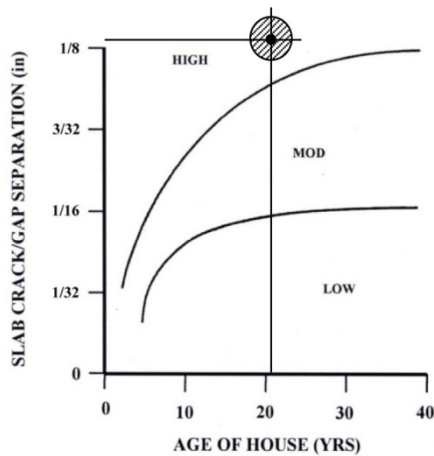
Figure 31. Determination of historic ground activity based upon dimension of slab cracks versus the age of the house for Case History. The level of historic ground activity is high.
