AEG/USSD Workshop  
December 6-8, 2021  
Ft. Lauderdale, Florida

# Emergency Repairs to Mosul Dam

## A High Risk Dam on a Karst Foundation

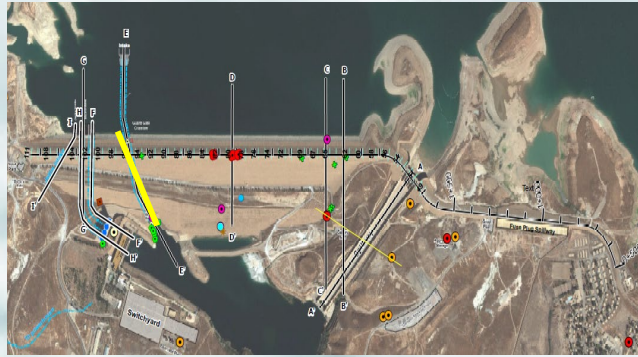
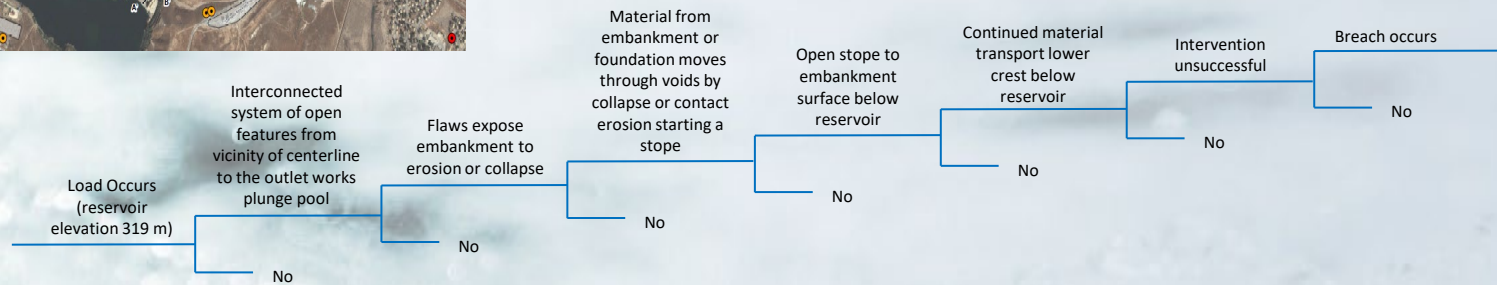
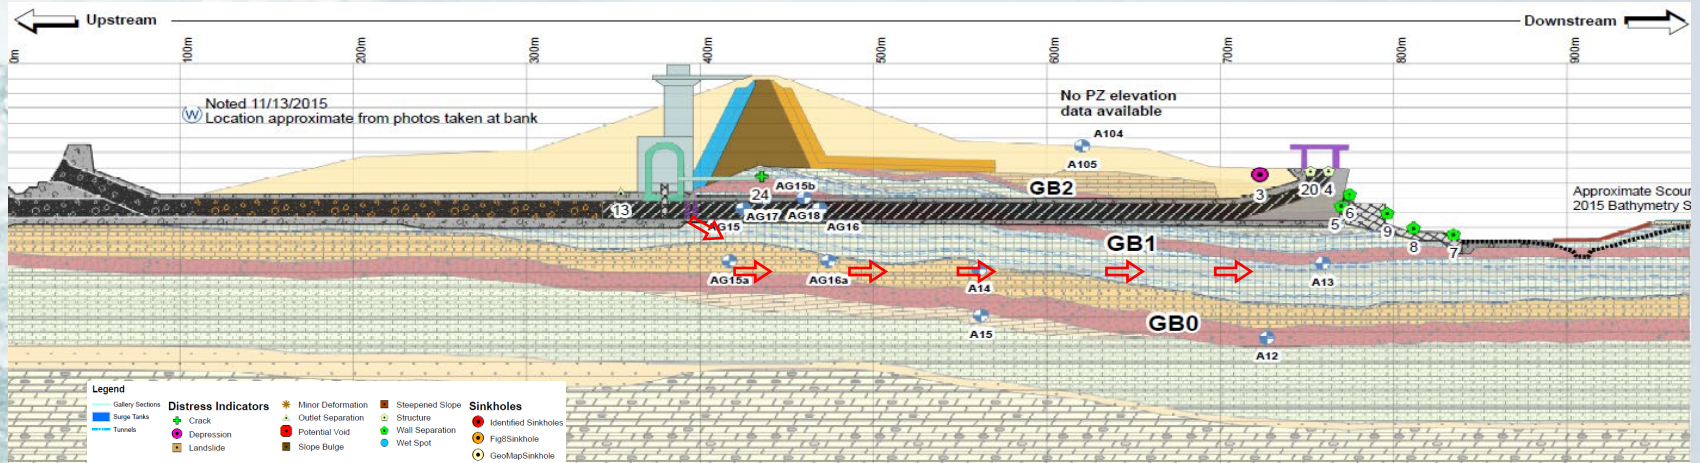
- PFM N1 – Internal Erosion through the Shallow Main Valley Rock Foundation
- PFM N2/3 – Internal Erosion through a Deep Flaw in the Main Valley Foundation
- PFM N4 – Internal Erosion through the Right Abutment Rock Foundation
- **PFM N5A – Internal Erosion (Stopping) through the Left Abutment Rock Foundation**
- PFM N5B – Internal Erosion (Scour) through the Left Abutment Rock Foundation F-Bed
- **PFM N10 – Internal Erosion through Rock Defects in the Vicinity of the Bottom Outlet Conduit**

# Internal Erosion along the Bottom Outlet Conduits

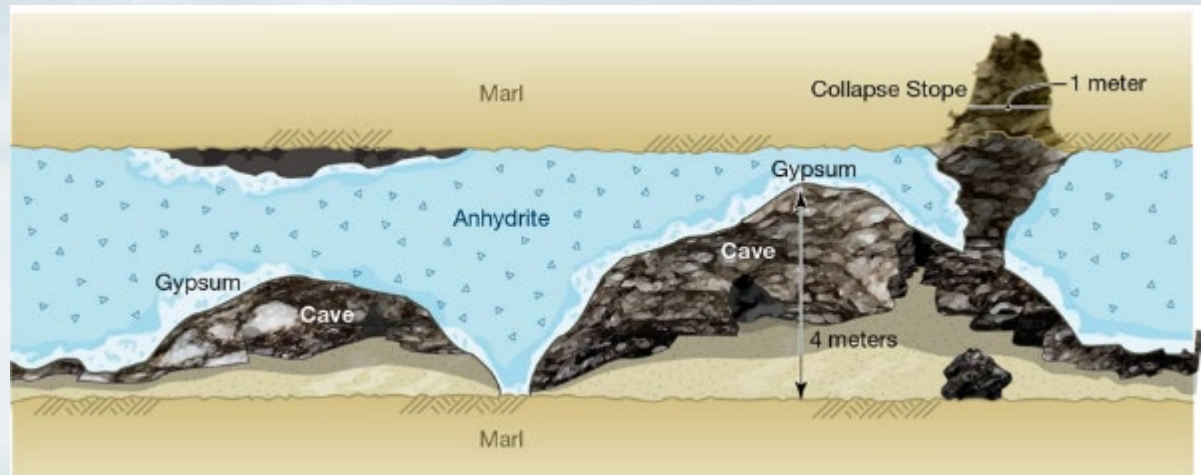
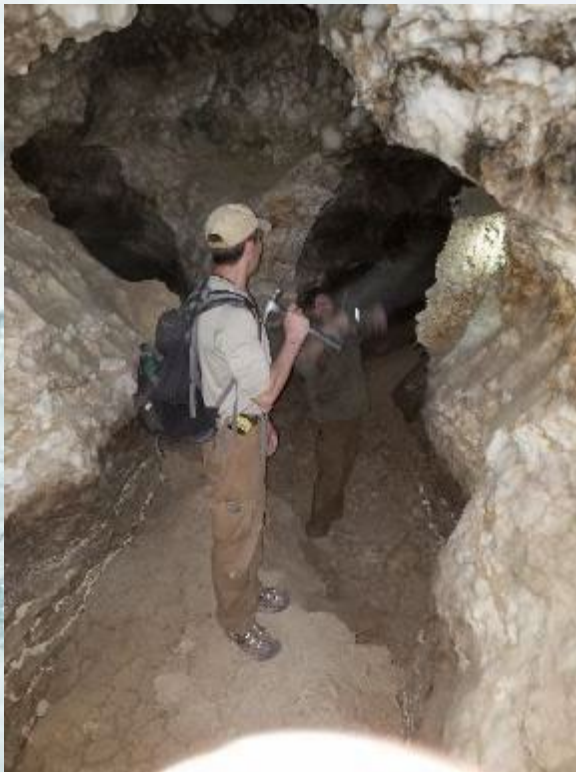
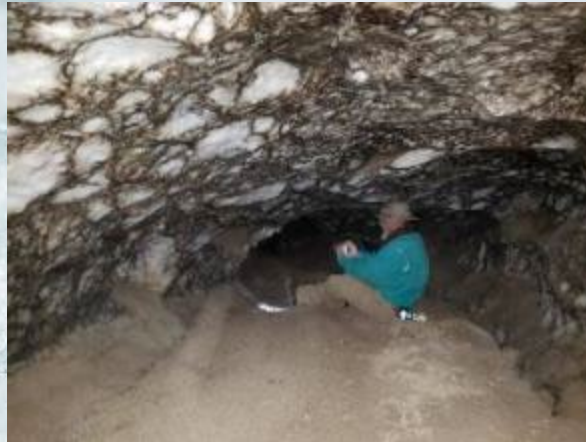
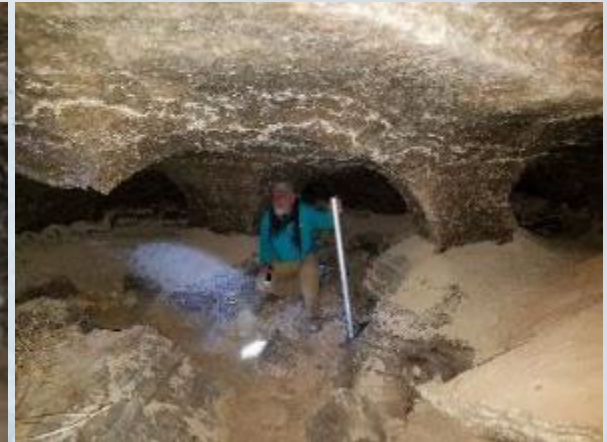
# GYPSUM DISSOLUTION FRONT

As anhydrite is exposed to water it turns to gypsum and dissolves, leaving voids, cavities and beds of collapse breccia

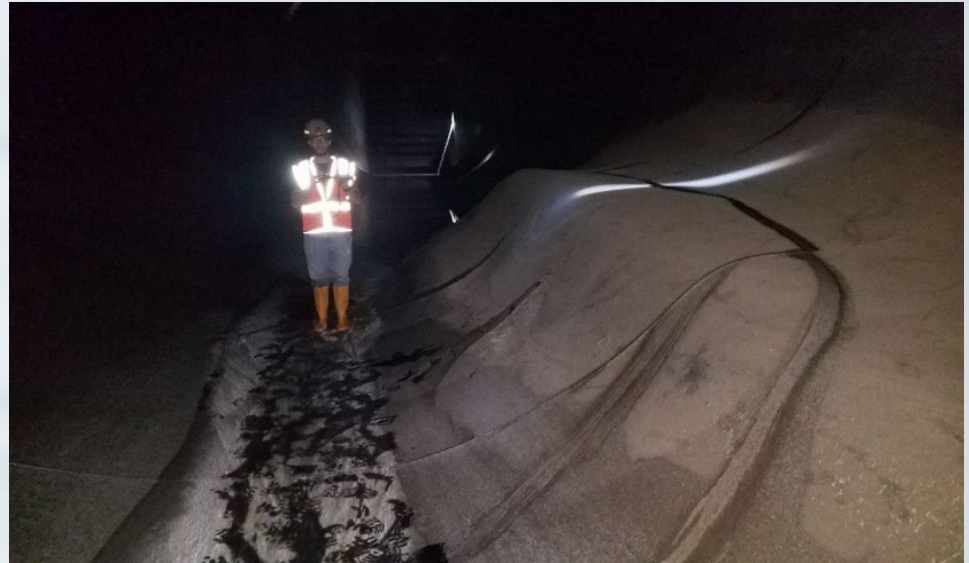
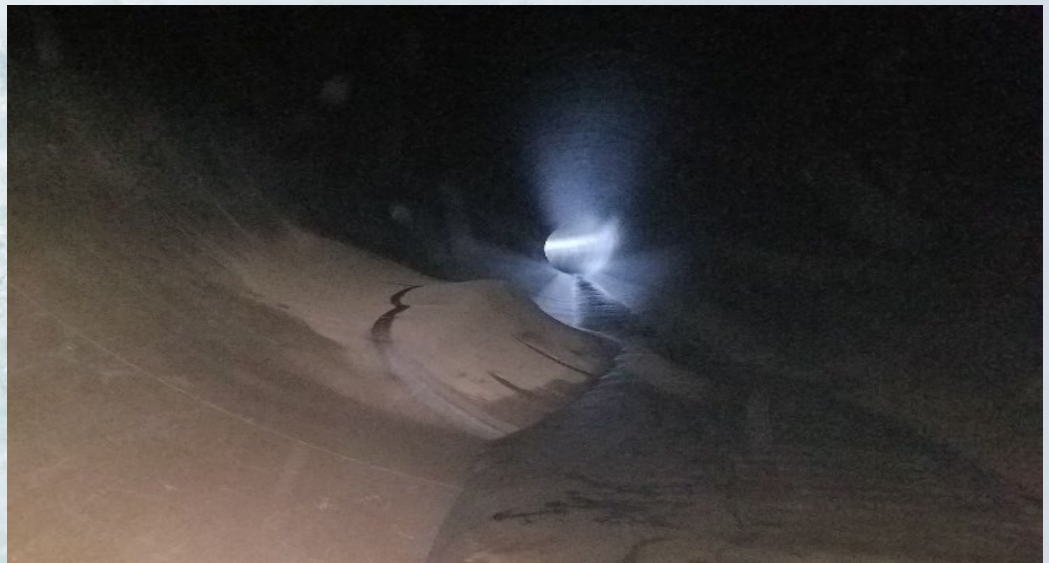
# Discovery – West B.O. Tunnel

- Last Inspected:  
March 31 2017
- 15 Nov 2017:  
Dewater West  
Bottom Outlet
- 17 Nov 2017:  
Discover  
Deformation in Steel  
Liner on East Side of  
Tunnel
- 28m downstream of  
Guard gate
  - Length=13m
  - Width= 3.9m
  - Height=1.1m

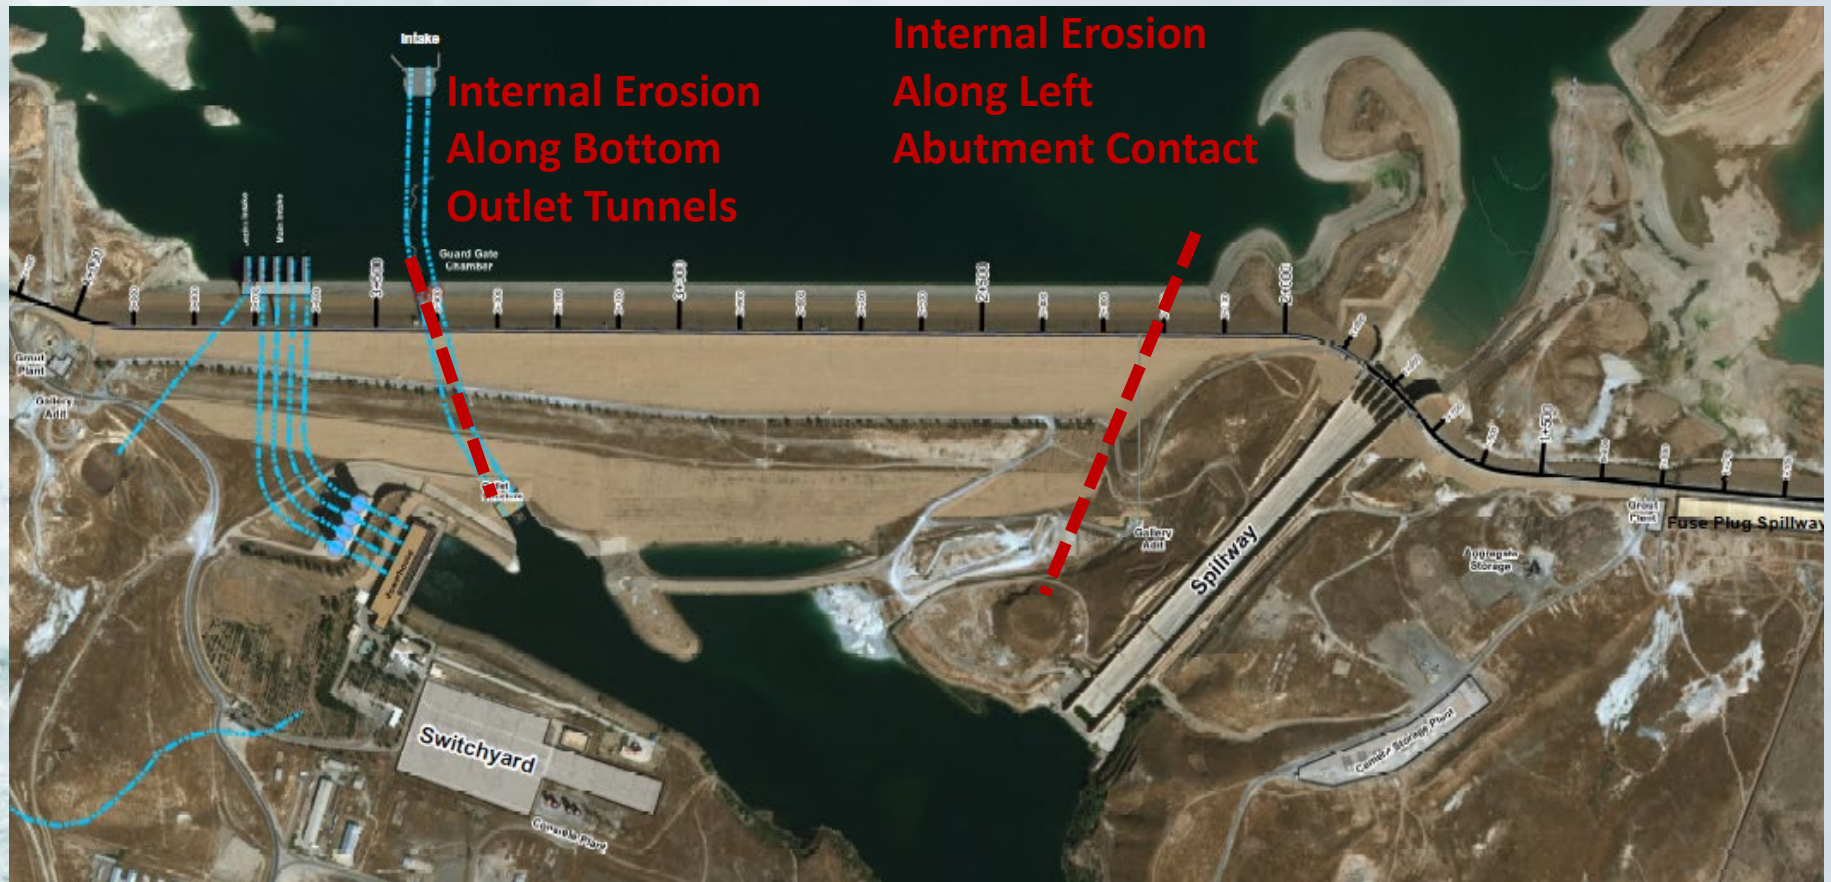
Multiple 4 to 6 meter voids

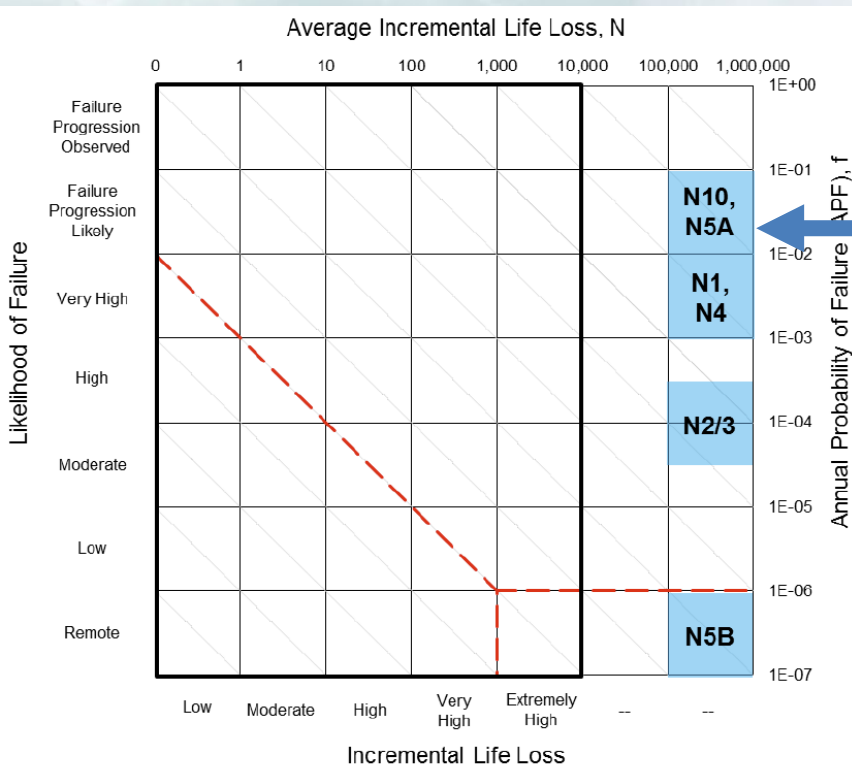
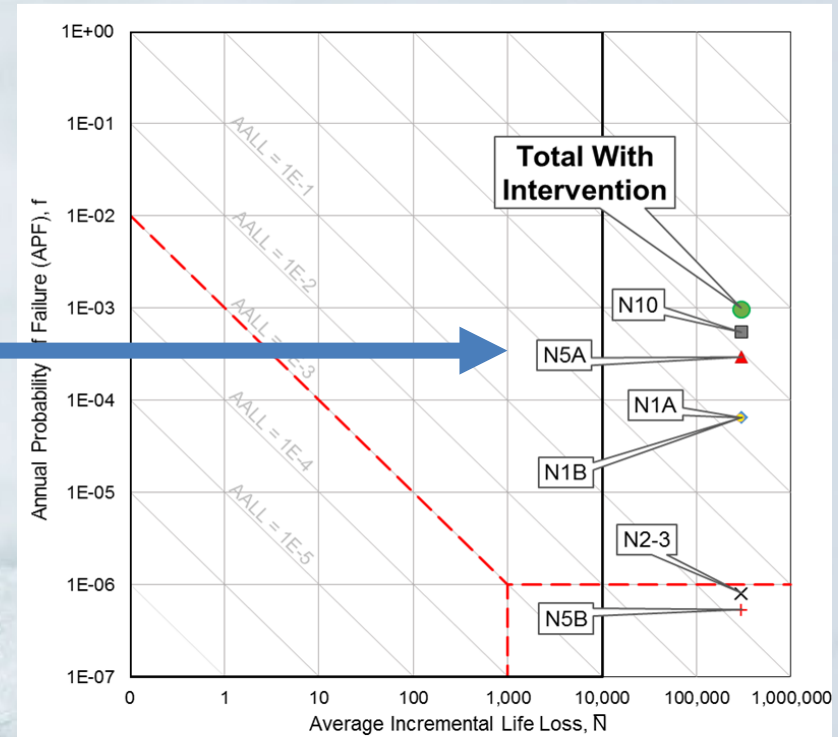
In general, risks fell 2 orders of magnitude.  
Still very high risk due to downstream population
