A Post-Earthquake Investigation in the Eastern United States

AEG Webinar
May 21, 2020

Dave Fenster, AEG Past President

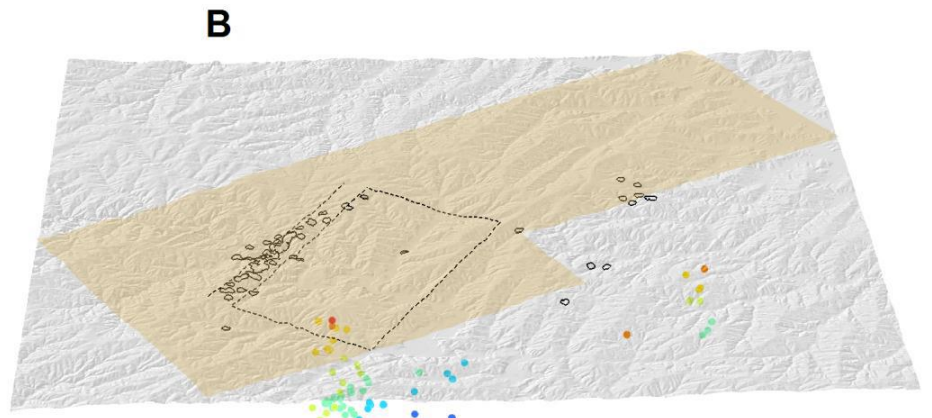
- Surface projection of aftershocks after M. Chapman (2012)
- Approximate updip surface projection of rupture plane
- Approximate vertical surface projection of rupture plane

Approximate updip surface projection of rupture plane

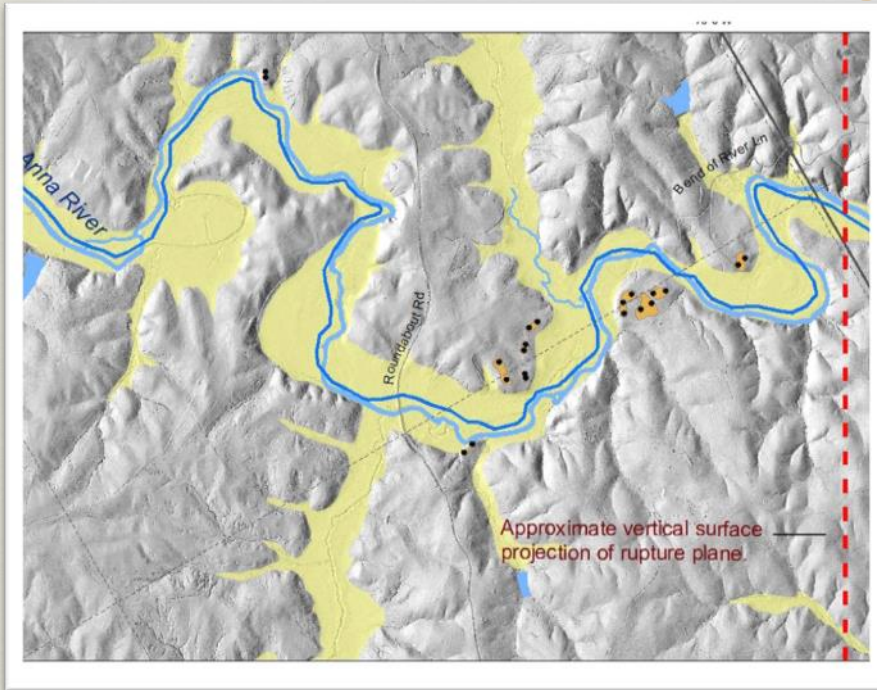
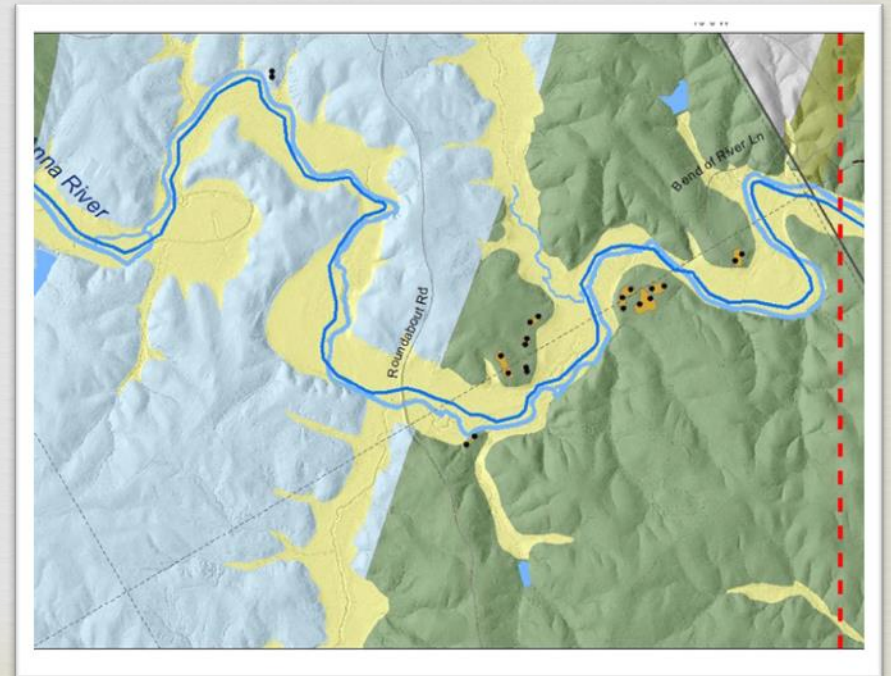
GEOMORPHIC STUDY

- ❧ Absence of Surface Faulting
- ❧ Absence of Geomorphic Indicators of deformation
- ❧ No Data on M_{max}
- ❧ No Data on Slip Rate or Recurrence
- ❧ Not a New Seismic Source
