Turning Geologic Data into Knowledge; A summary of dam failure case histories

Pete Shaffner P.G.

Senior Engineering Geologist Risk Management Center US Army Corps of Engineers Denver, Colorado

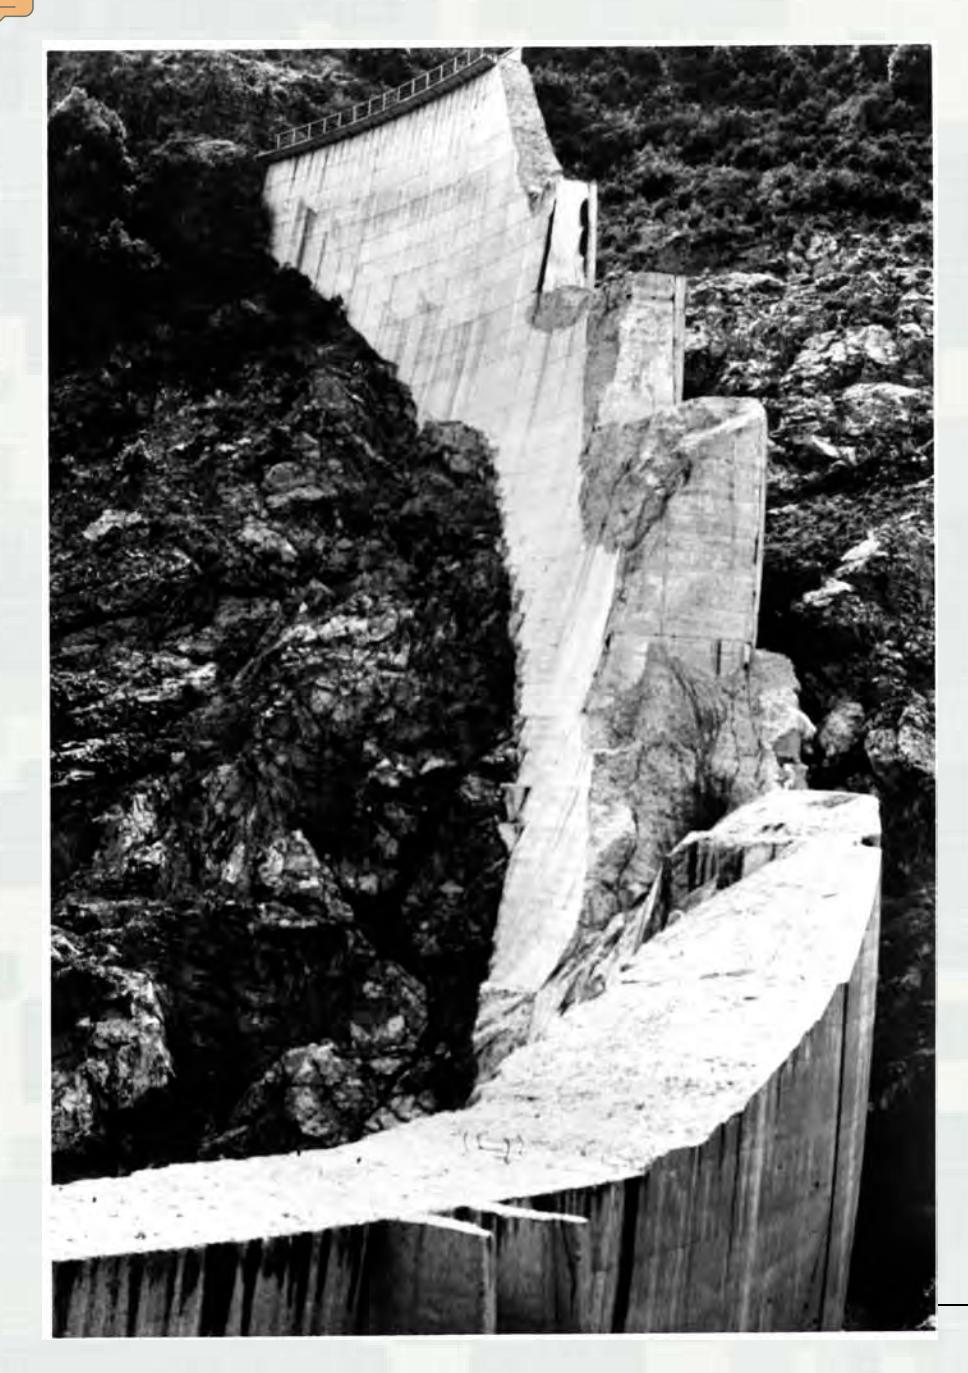
Malpasset Dam 1959

- Designed by Dr. Andre Coyne, the world's foremost expert in arch dam engineering
 Geologists mapped the local area when a gravity dam was considered
- The design was switched to an arch dam
 A large rock wedge slid along a shear zone in the left abutment upon first filling in 1959
- 421 people were killed
- Pierre Londe spent 8 years studying the failure

421 deaths

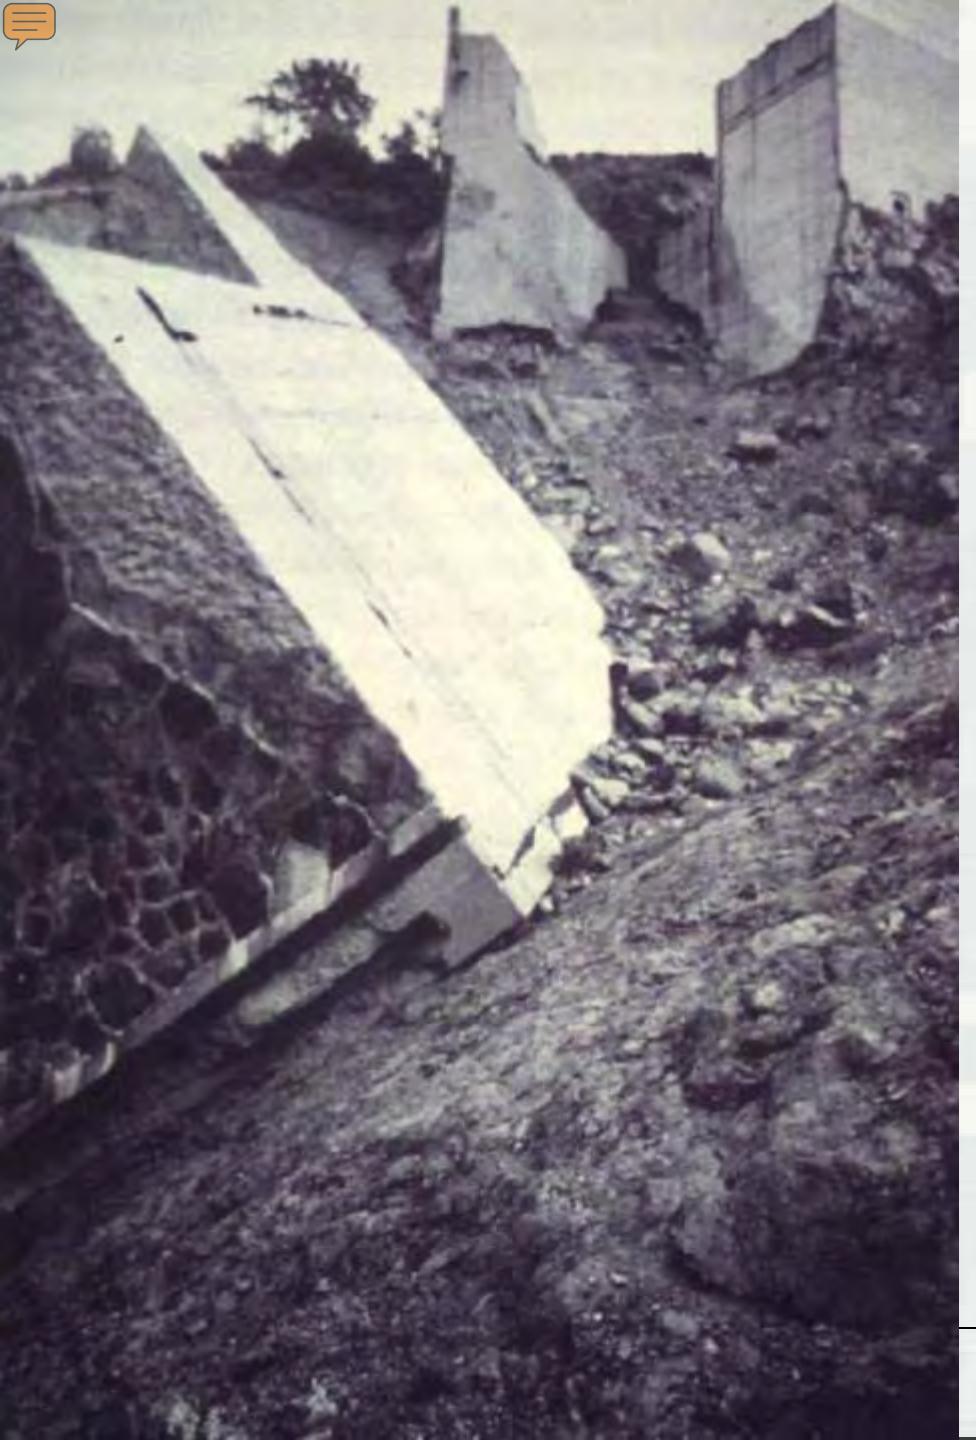
Malpasset Dam

• Failure was caused by hydraulic uplift of a large rock wedge lying beneath the dam's left abutment

- Uplift forces acting on the foundation block were not understood or accounted for ("new" vulnerability?).
- The geometry of the "system" was not understood or analyzed
- Today we would incorporate grouting upstream and drainage downstream
- Geologic mapping of the foundation <u>and downstream</u> <u>abutments</u> to define the geologic discontinuities and potential sliding blocks is essential
- Some of these lessons were not incorporated into the investigations, design and construction of concrete dams for over a decade
- Some of these lessons are still being ignored today

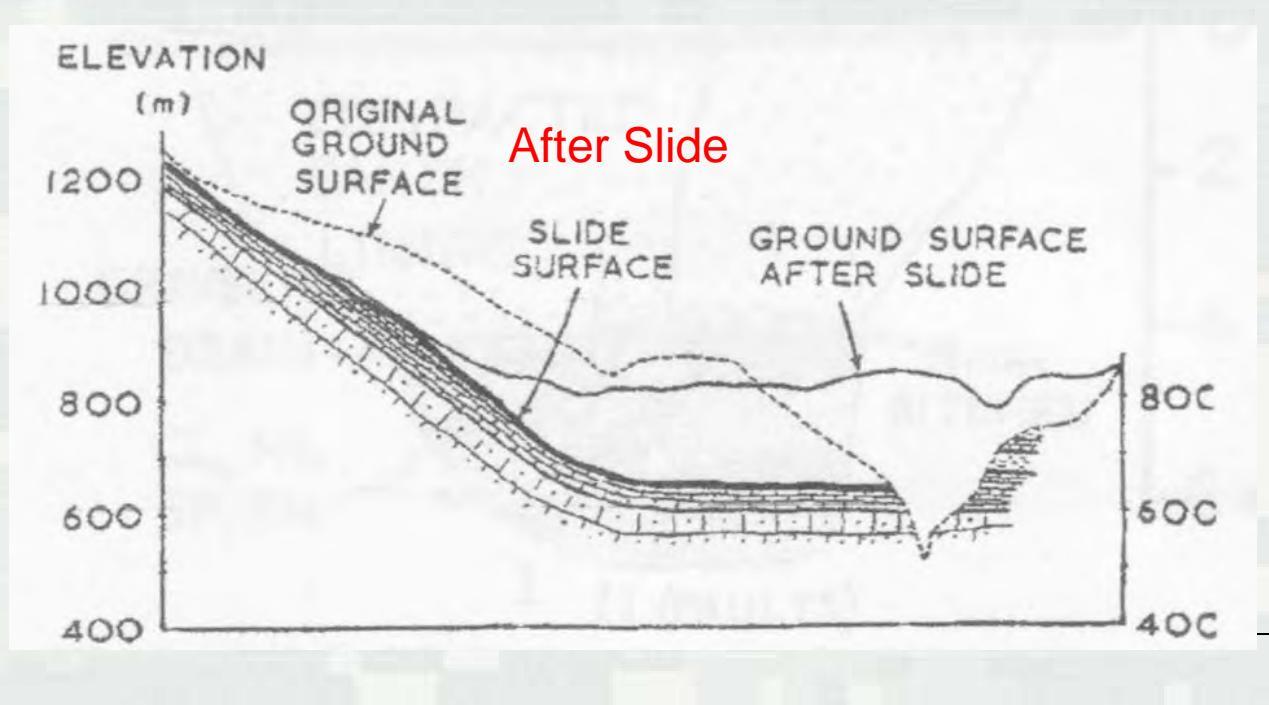
Vaoint Landslide

View of left bank, looking downstream

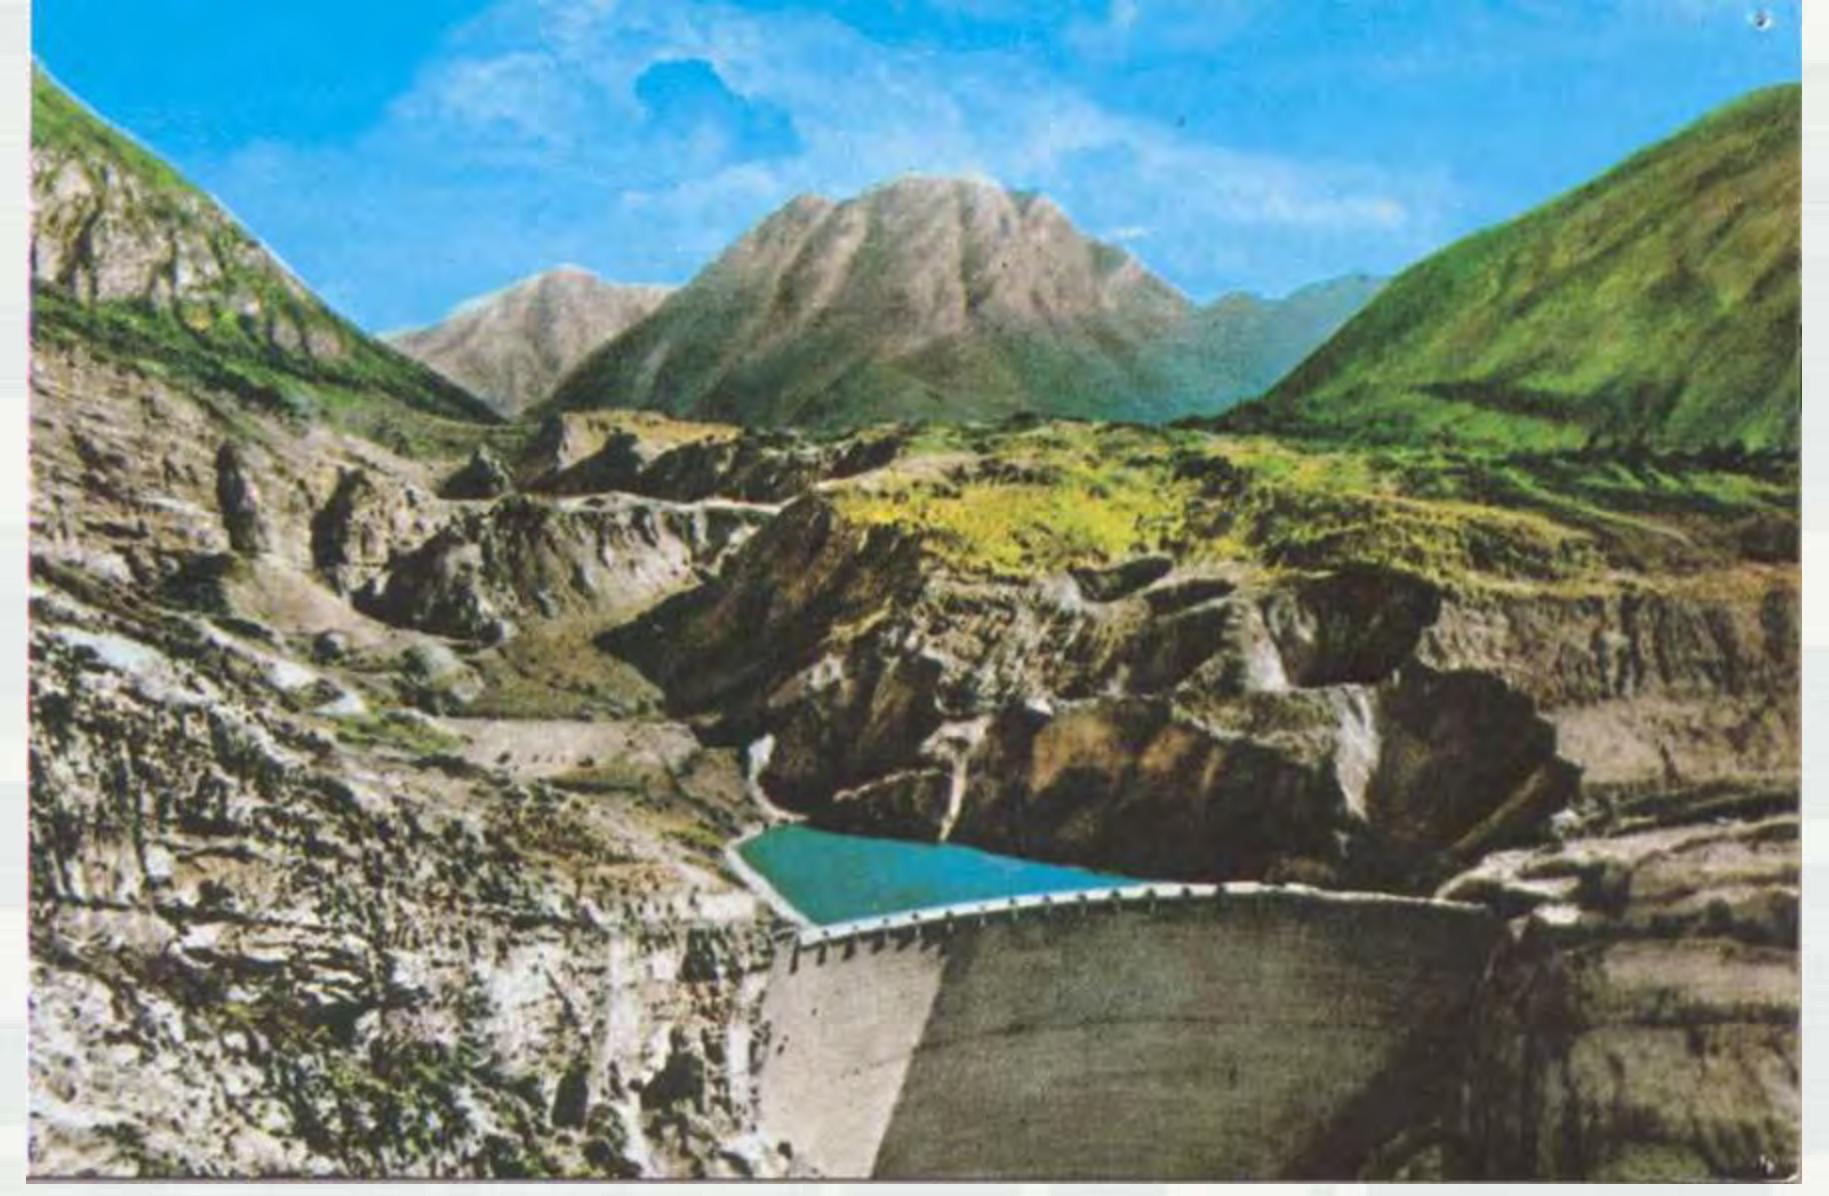
300 million C.Y slide moved at 70 mph: Oct 9, 1963

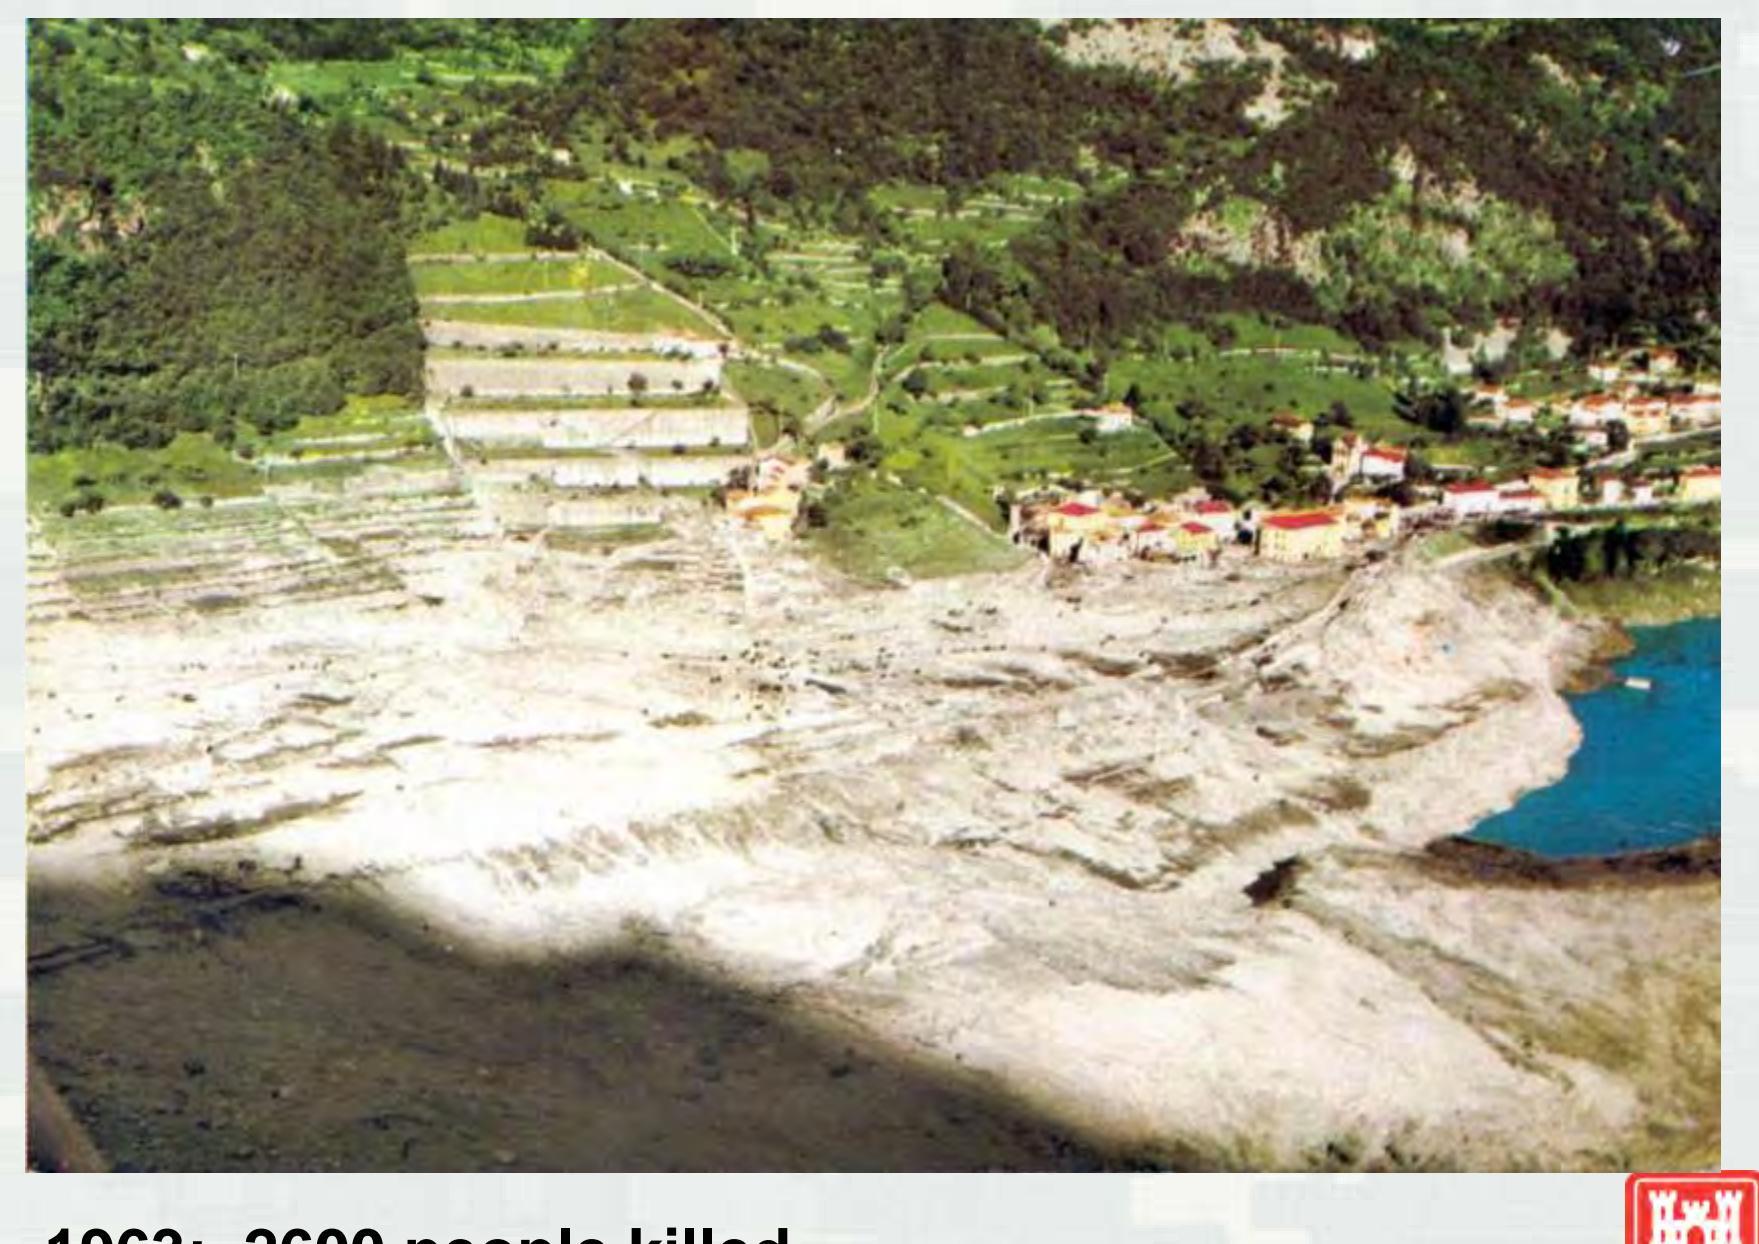
1963; 2600 people killed

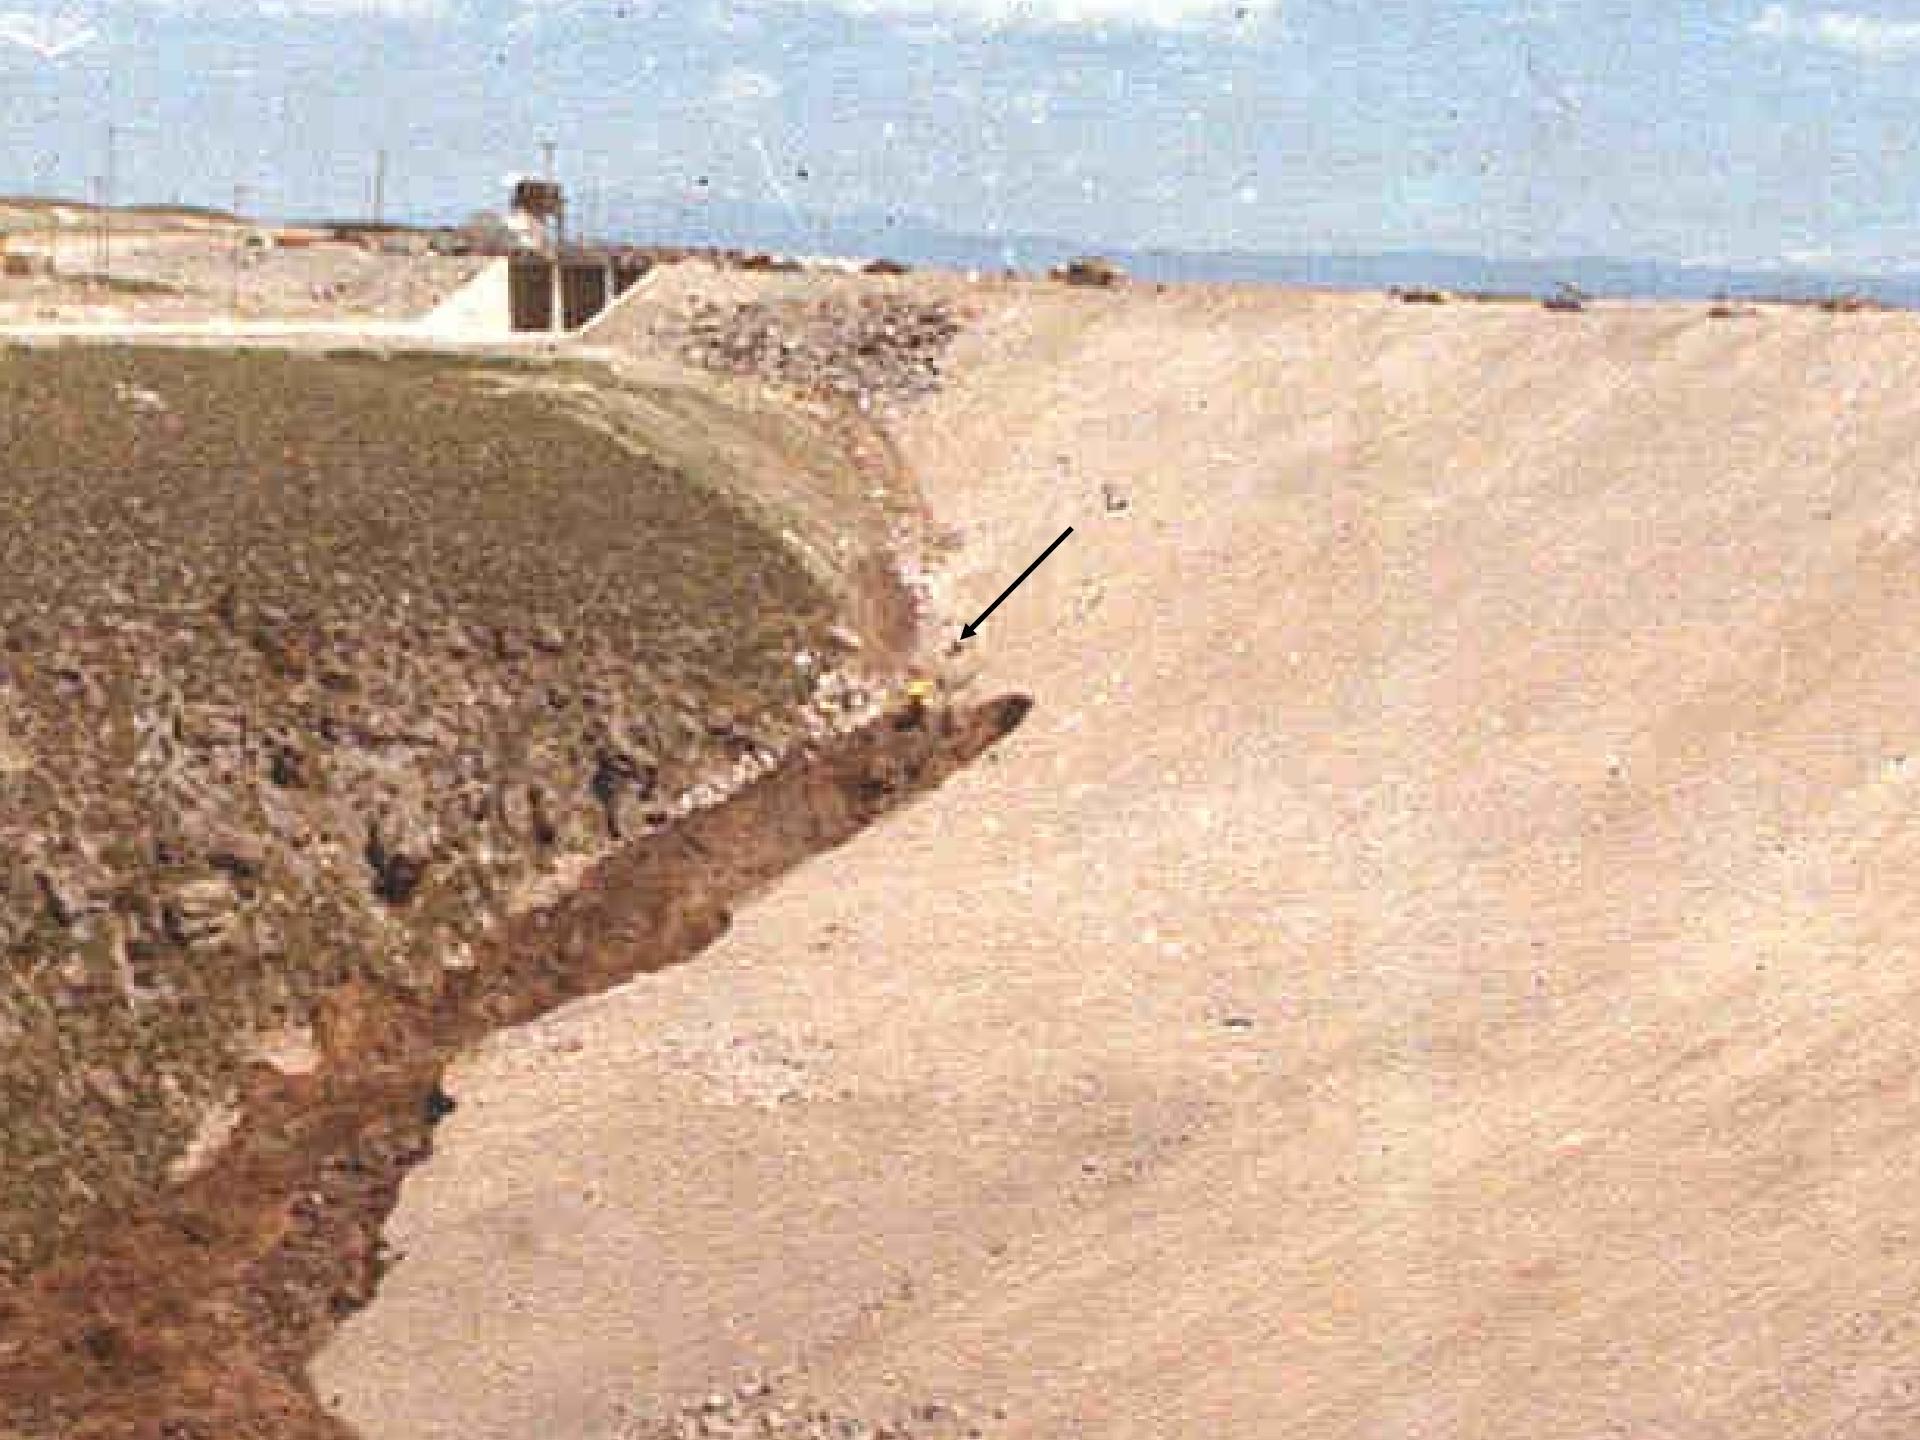
Dozers Lost In Hole About 11:20 am

AFTER VAINLY TRYING TO FILL BRE IN EMBANKMENT OF TETON DAM. "CAT" OPERATORS BACK TOWARD

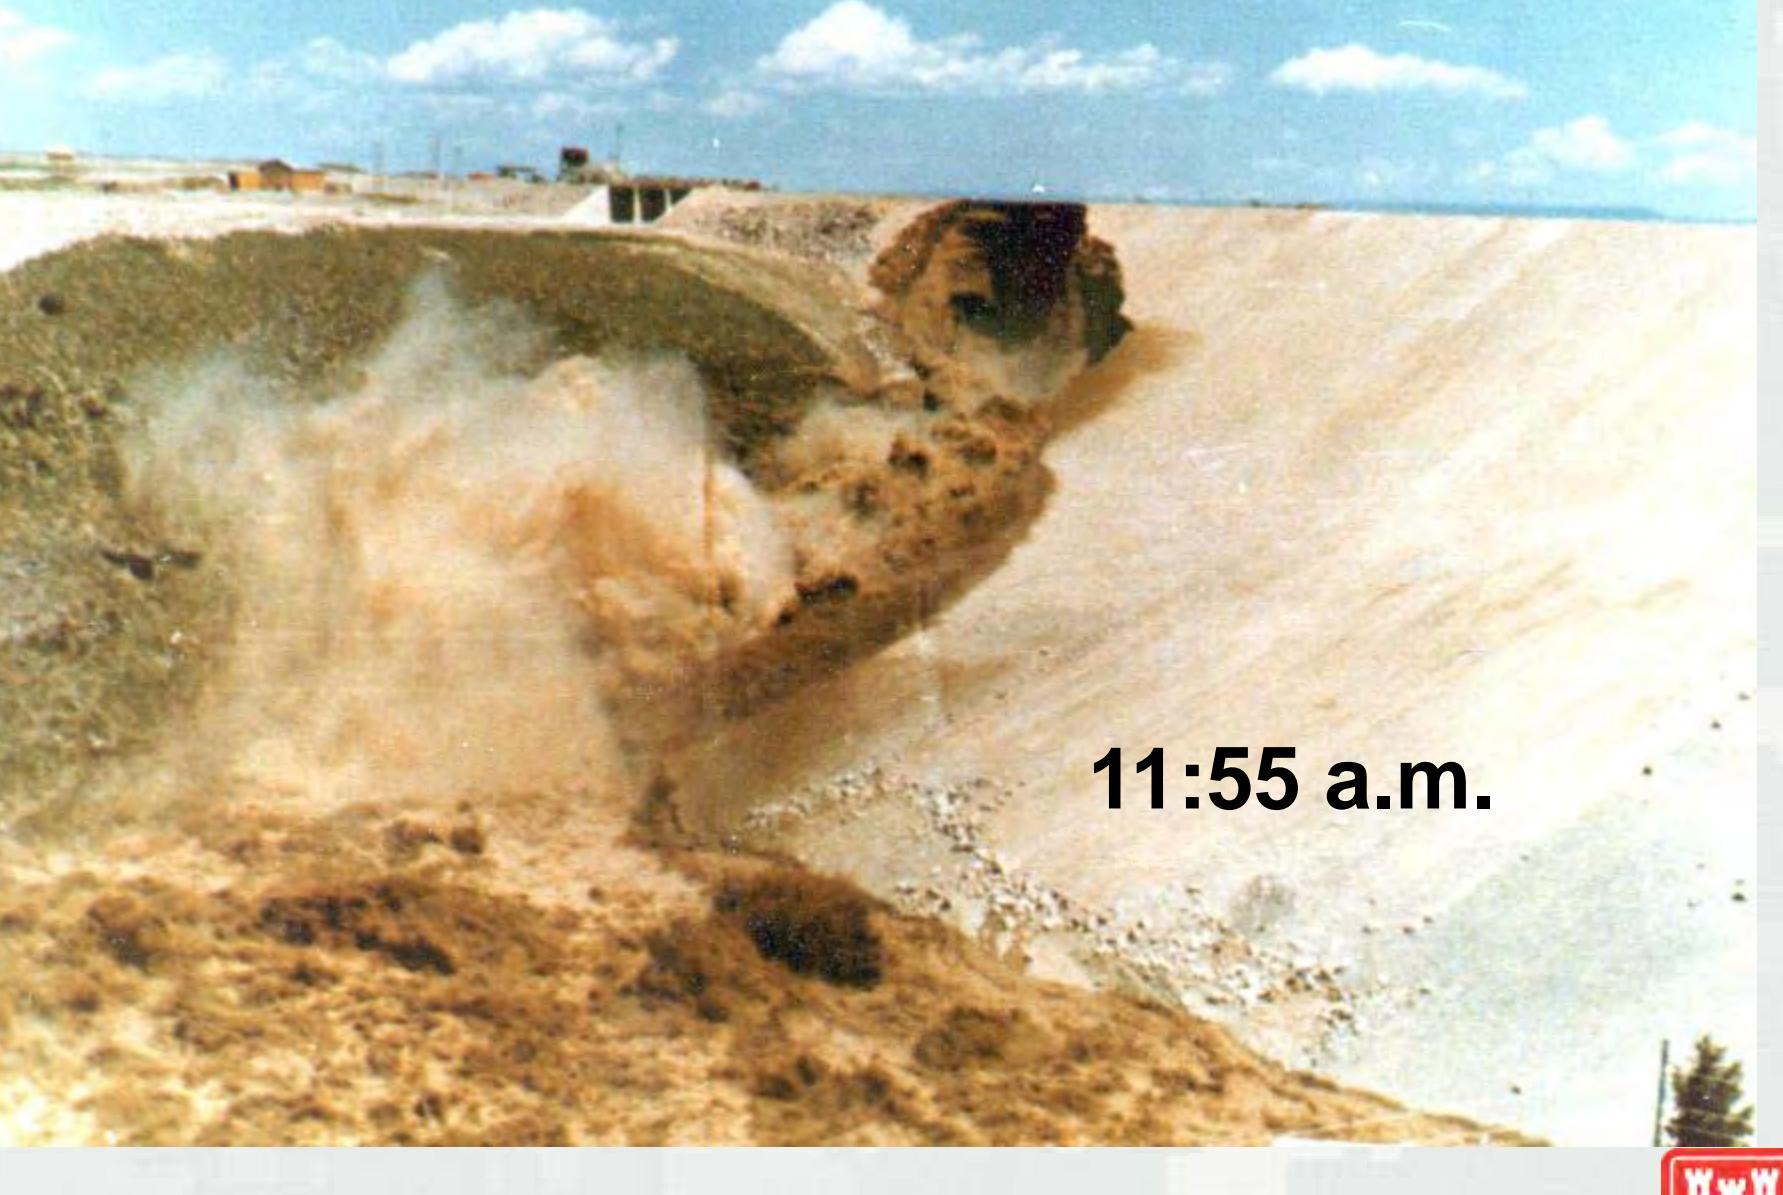
Less than 4 hours from 20 gpm detected seepage to total breach

Only FOUR hours to get from 20 gpm to breach

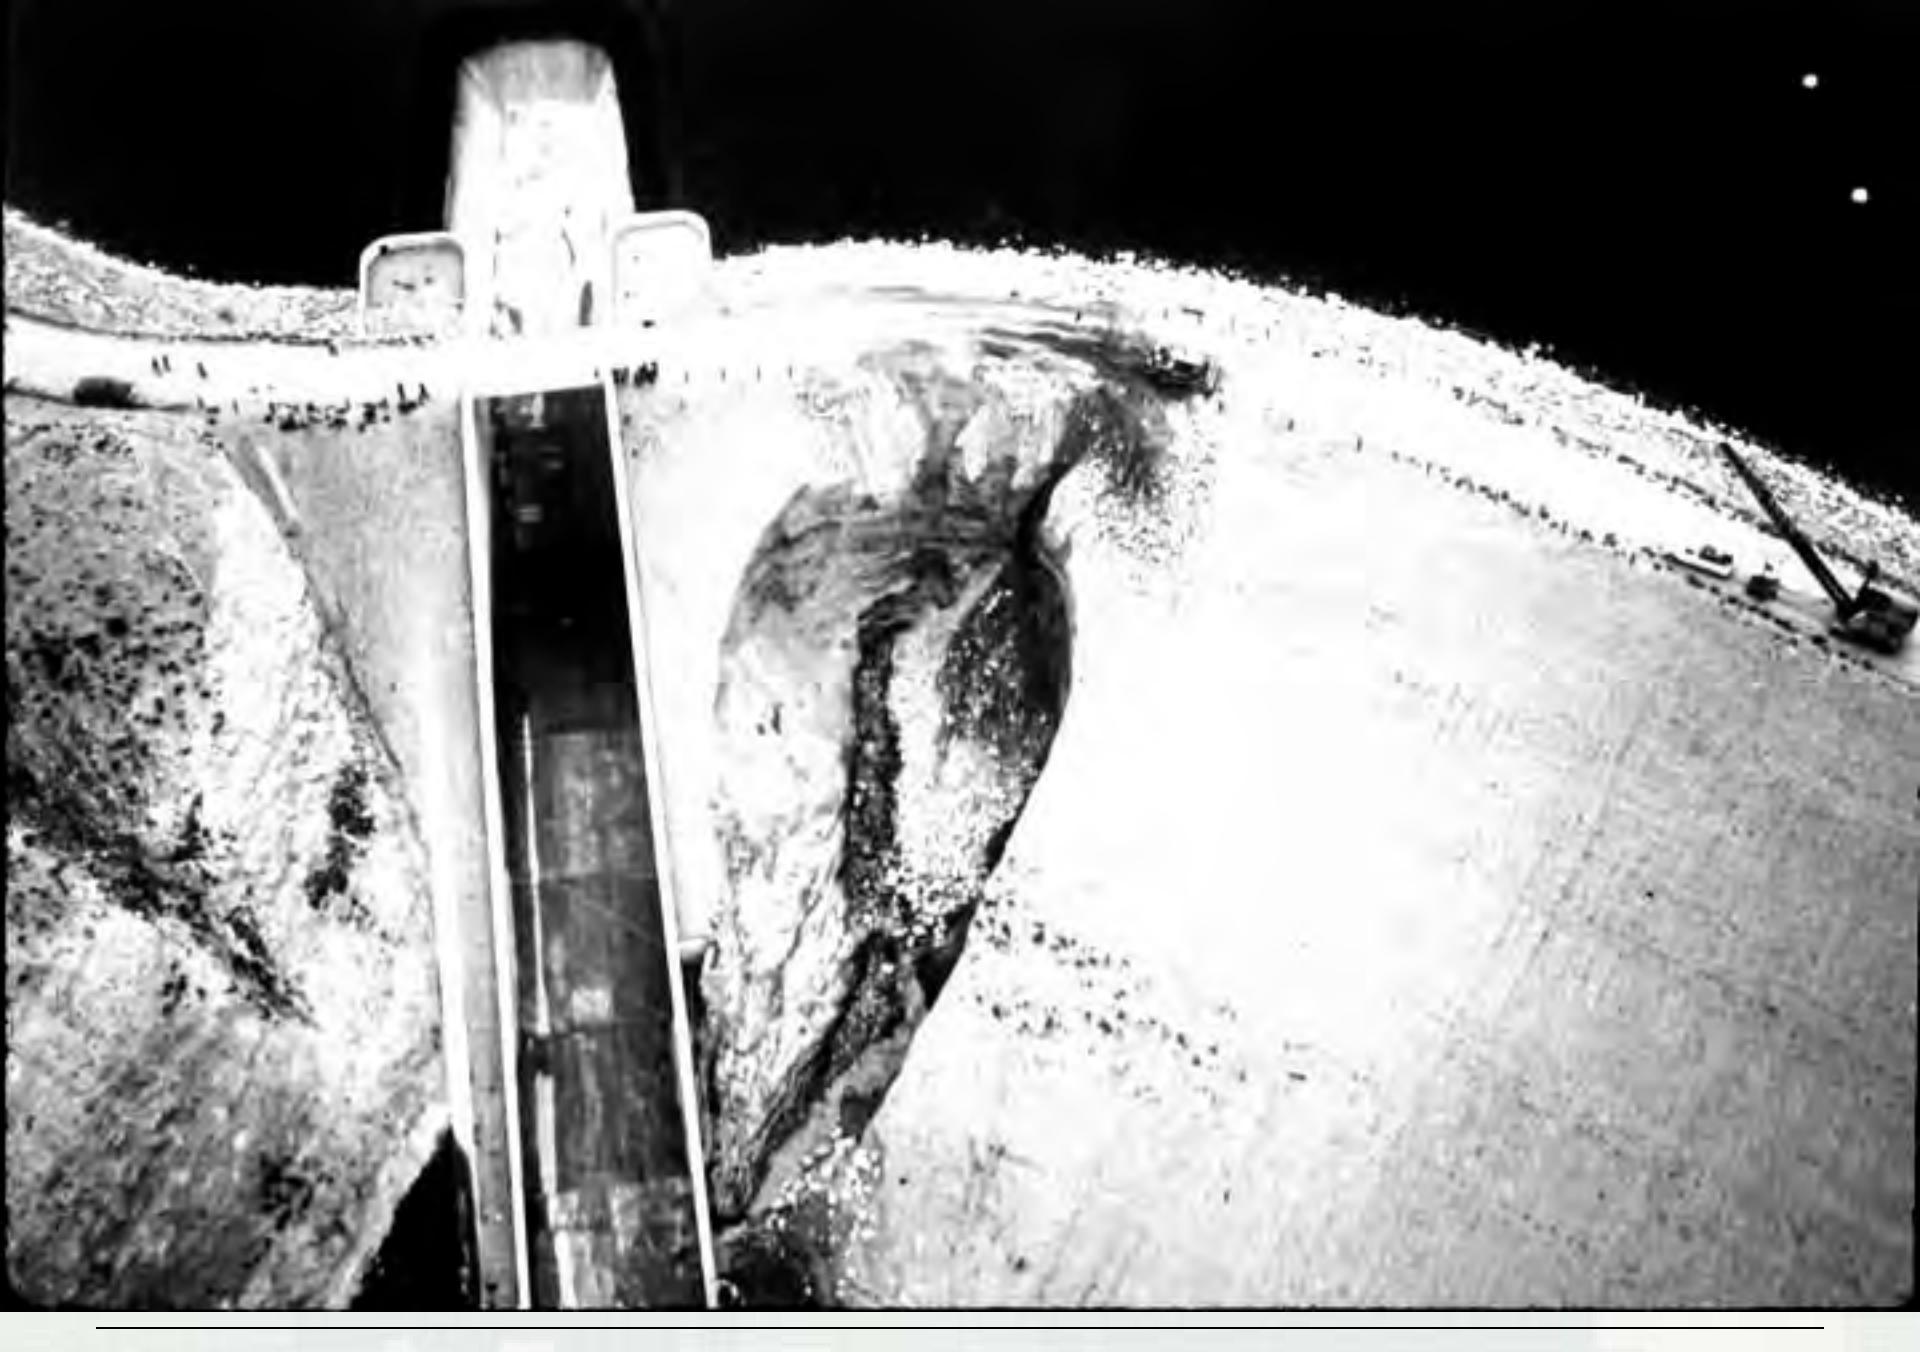
This erosion incident several months earlier was labeled as a "slope stability failure" and backfilled with more permeable material.

There were two of these "incidents" prior to the main problem, but engineers failed to comprehend the seriousness of the problem

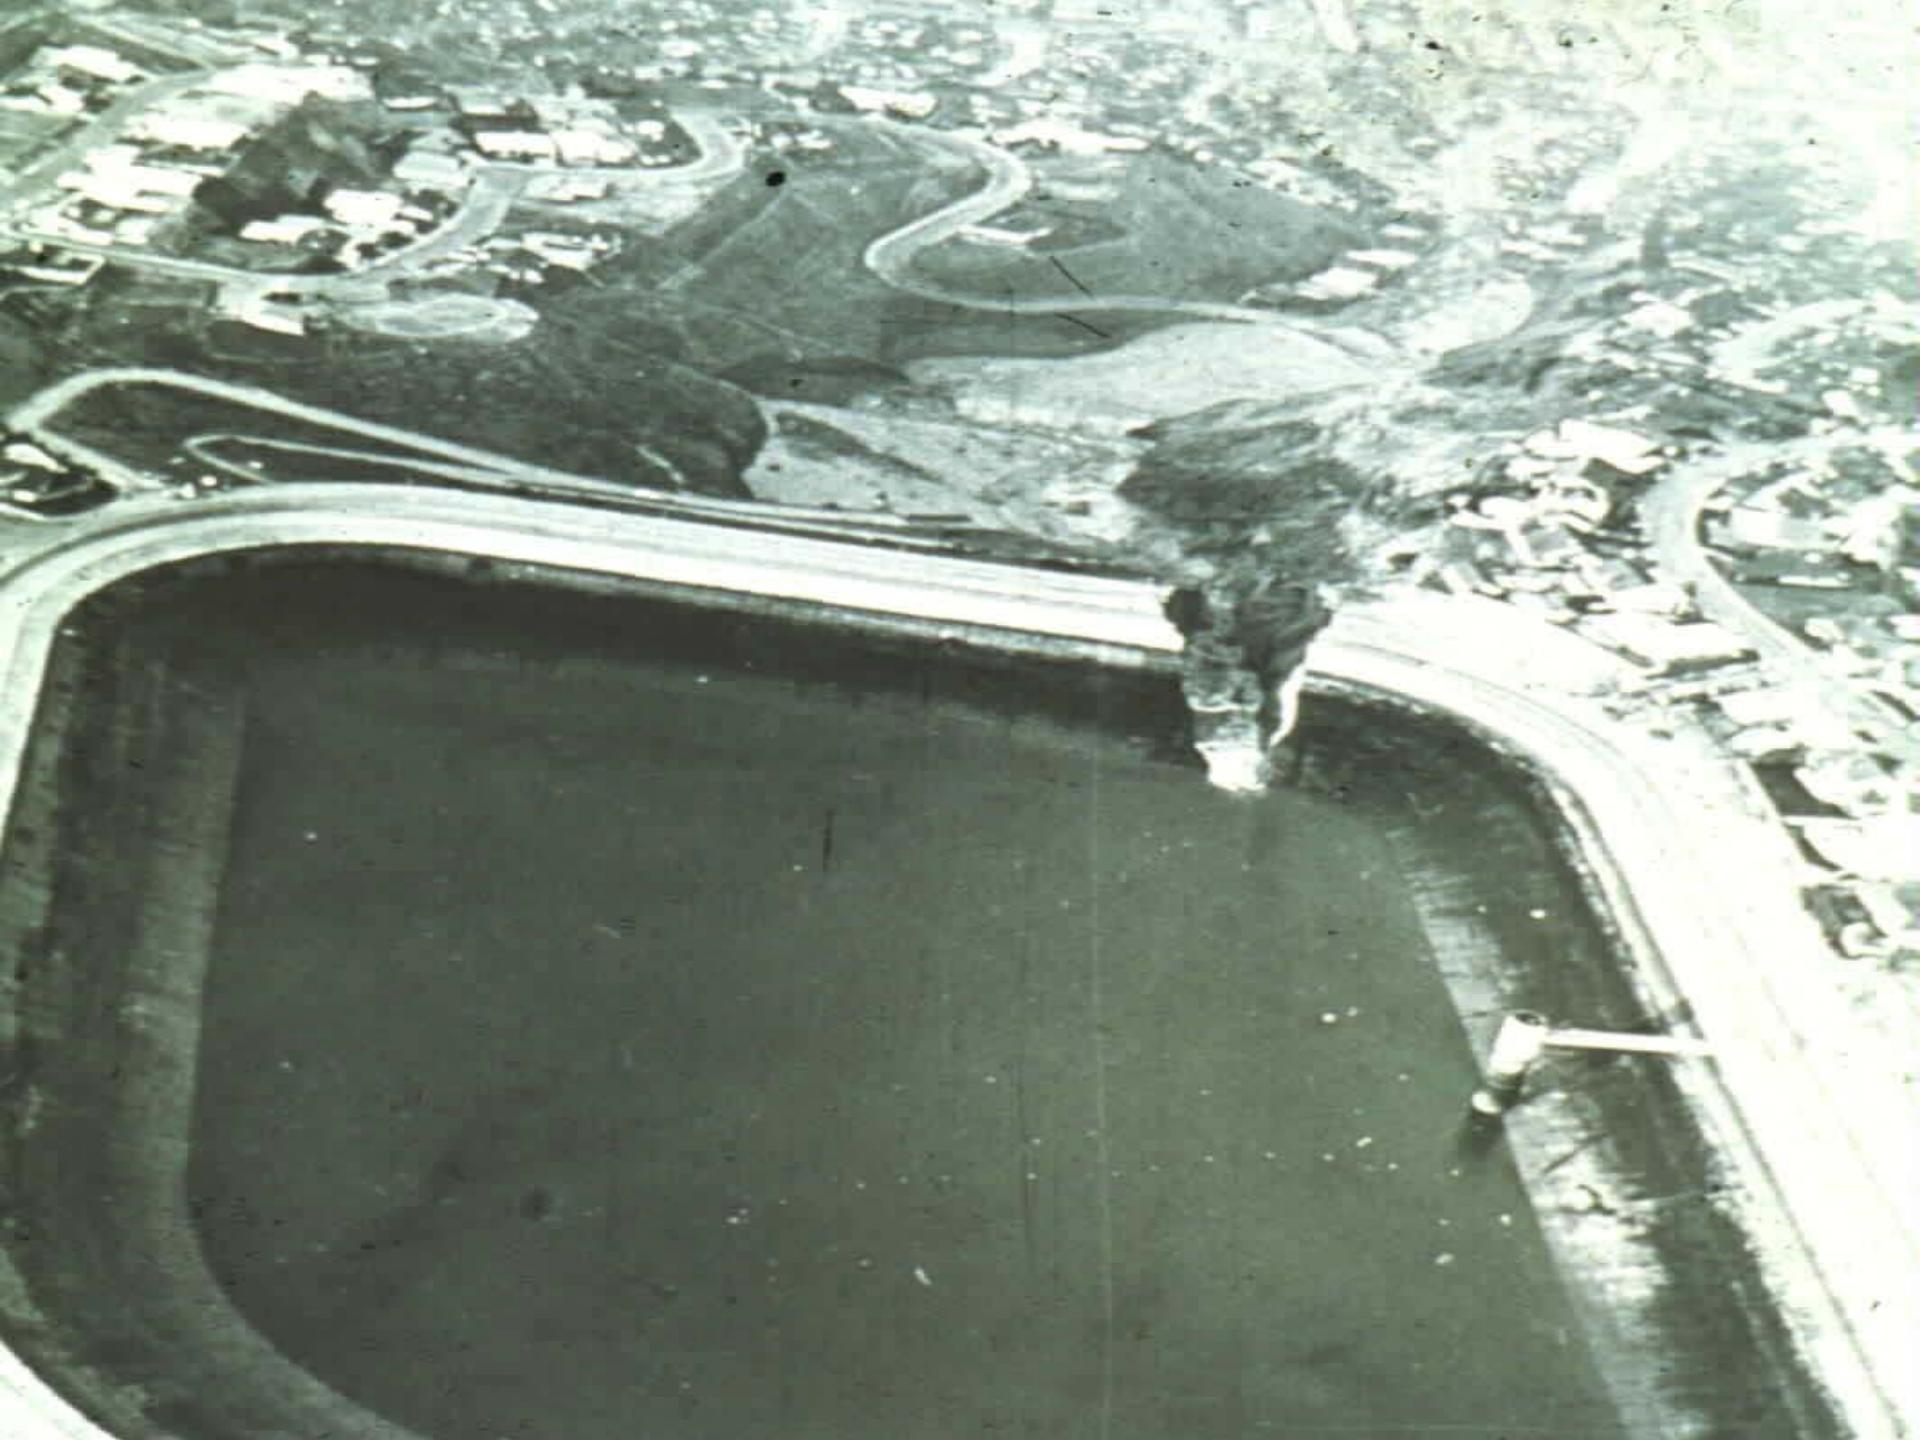
Baldwin Hills Dam California

- Completed in 1951, Failed in 1963
- 5 fatalities, 1000 homes damaged
- Over 11 million in property damage
- Reservoir had earth lining sandwiched between asphaltic membranes and poor monitoring of drain
- Several minor, steeply dipping faults were mapped as passing through the reservoir
- Differential settlement likely from oil wells or fault consolidation
- Failed to account for geologic conditions

Aseismic Movement of Fault

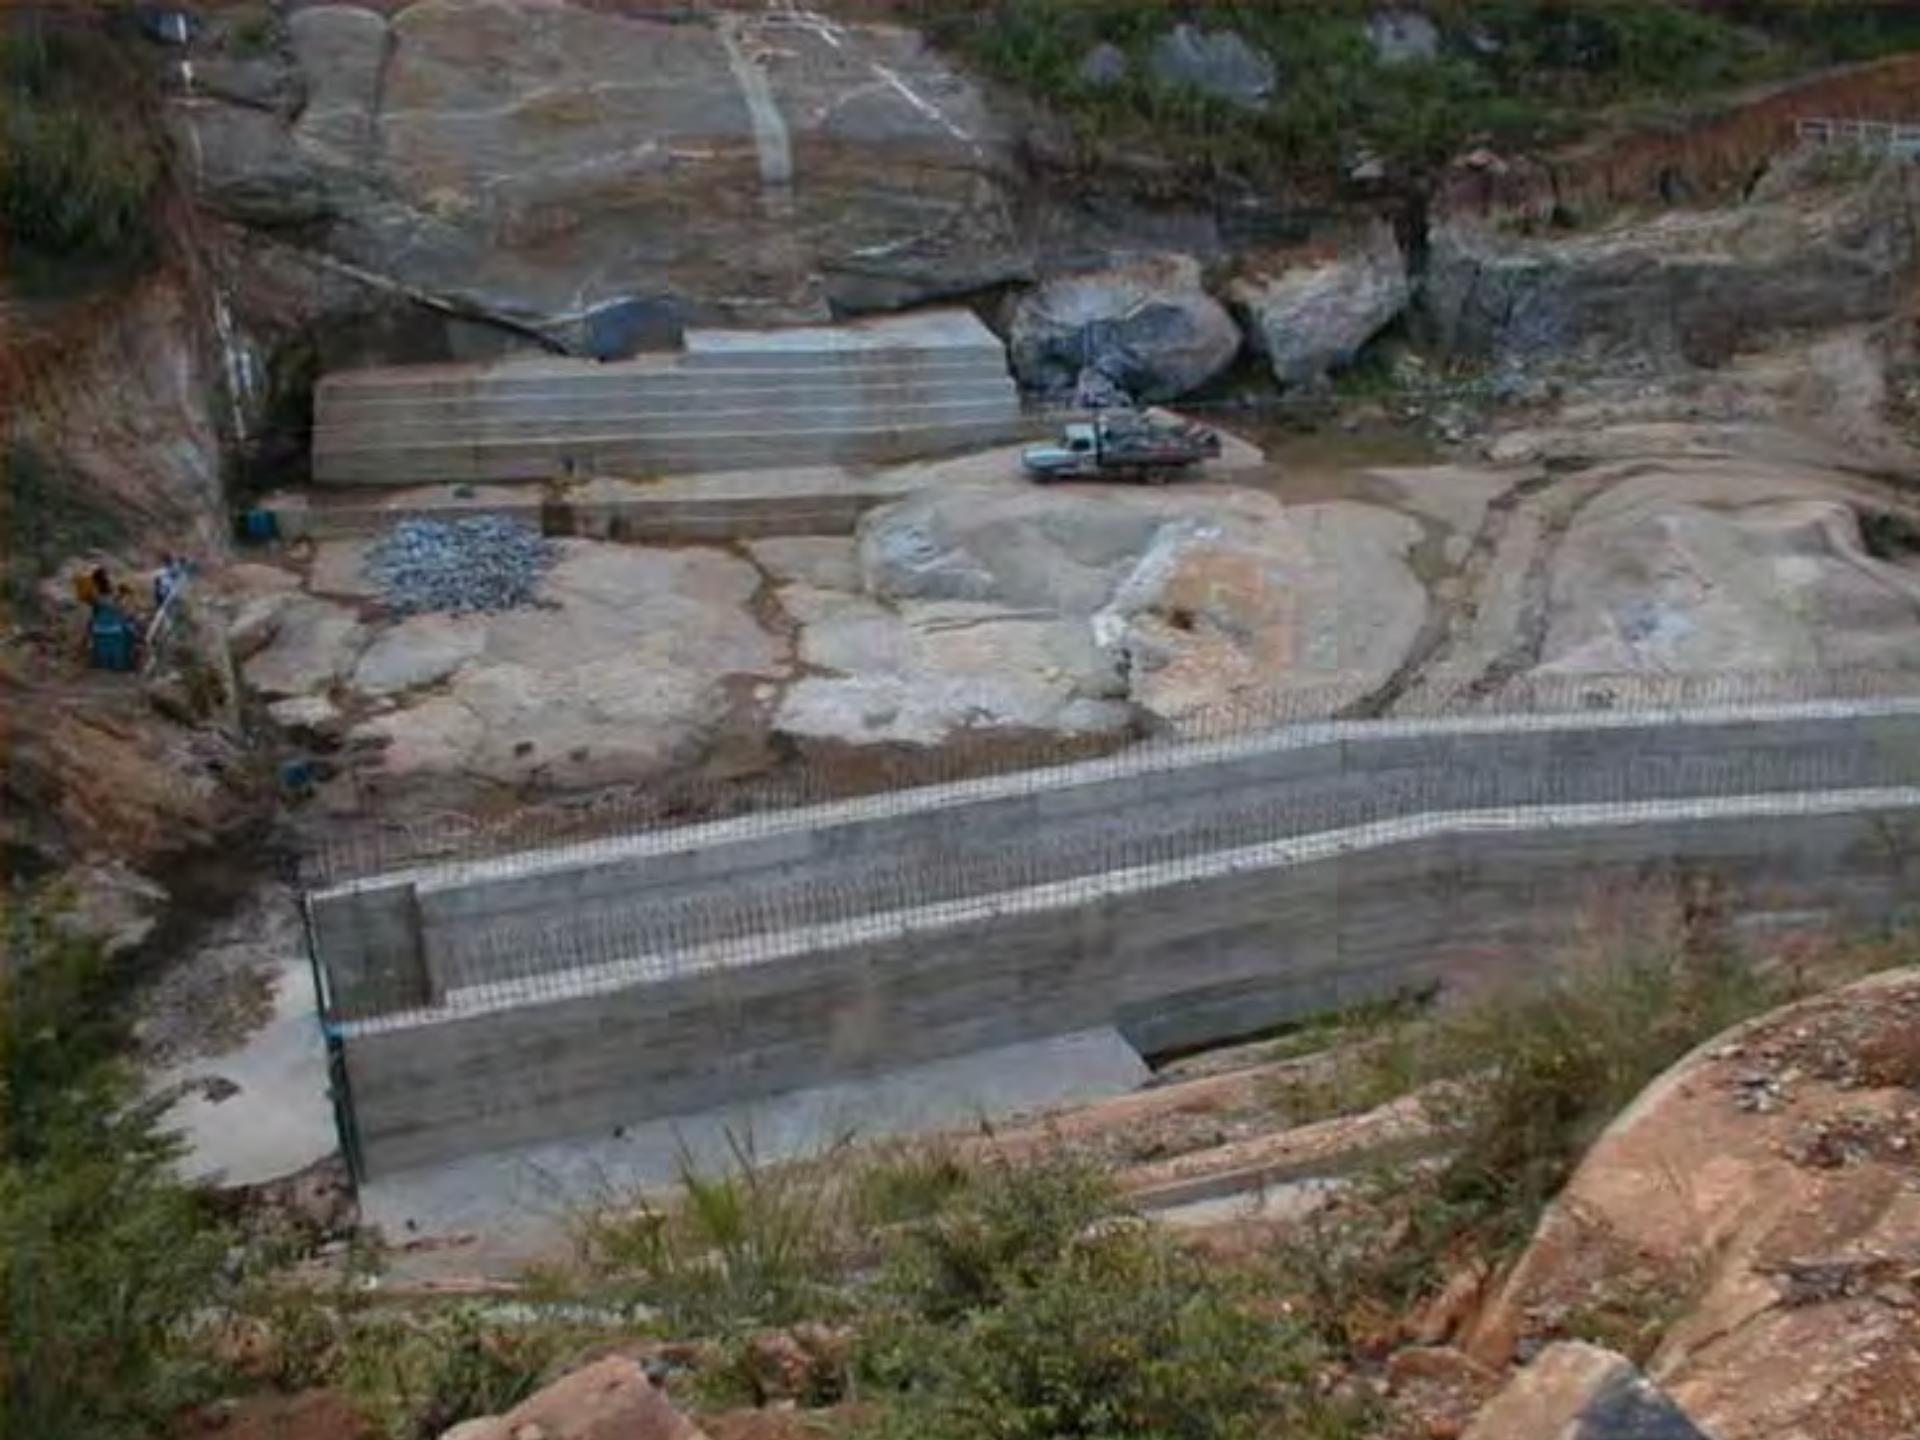
View of left abutment from downstream

View along crest showing failed bridge and continuous infilled fracture plane at left abutment
