Turning Geologic Data into Knowledge; A summary of dam failure case histories

Pete Shaffner P.G.

Senior Engineering Geologist Risk Management Center US Army Corps of Engineers Denver, Colorado

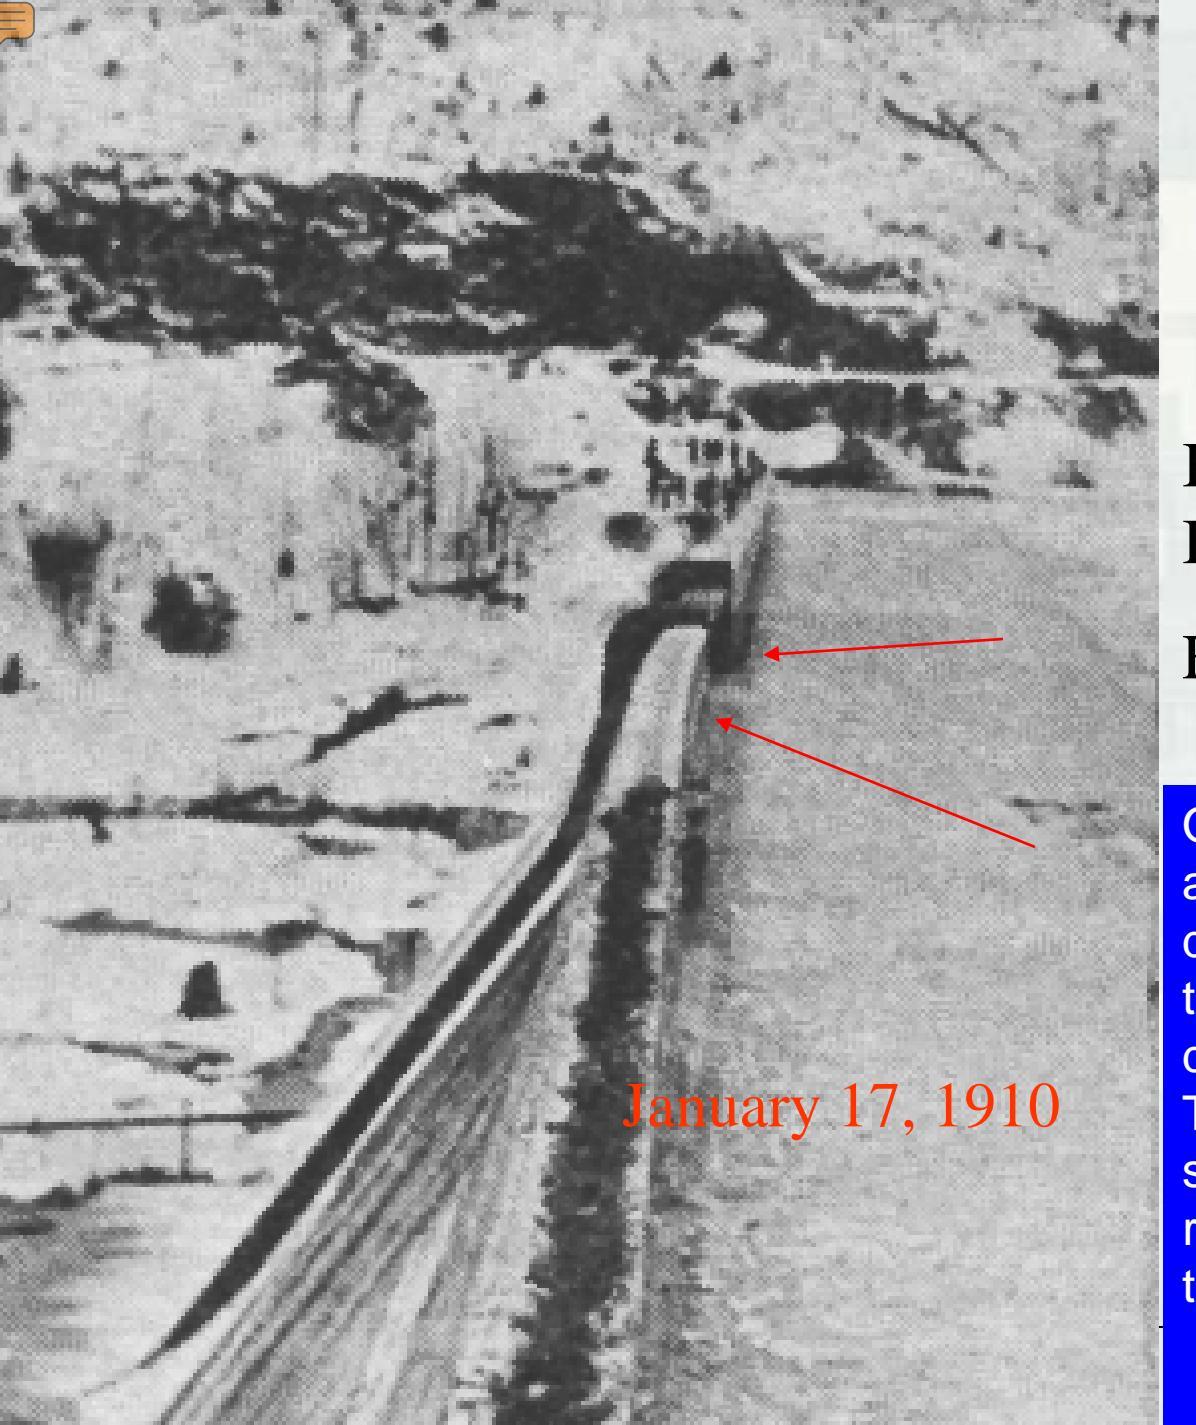
Austin Dam-50 ft high

Built and operated by Bayless Pulp & Paper Co. Failed in 1911

On January 17, 1910 a bulge appeared on the crest of the dam. Measurements indicated the dam had moved downstream on its foundation. The dam was taken out of service. A consultant review recommendation to strengthen the dam was ignored.
