APPLIED GEOLOGY IS AN “ESSENTIAL” PROFESSION

David F. Fenster
2019-2020 AEG Past President
Chicago Chapter – May 19, 2020

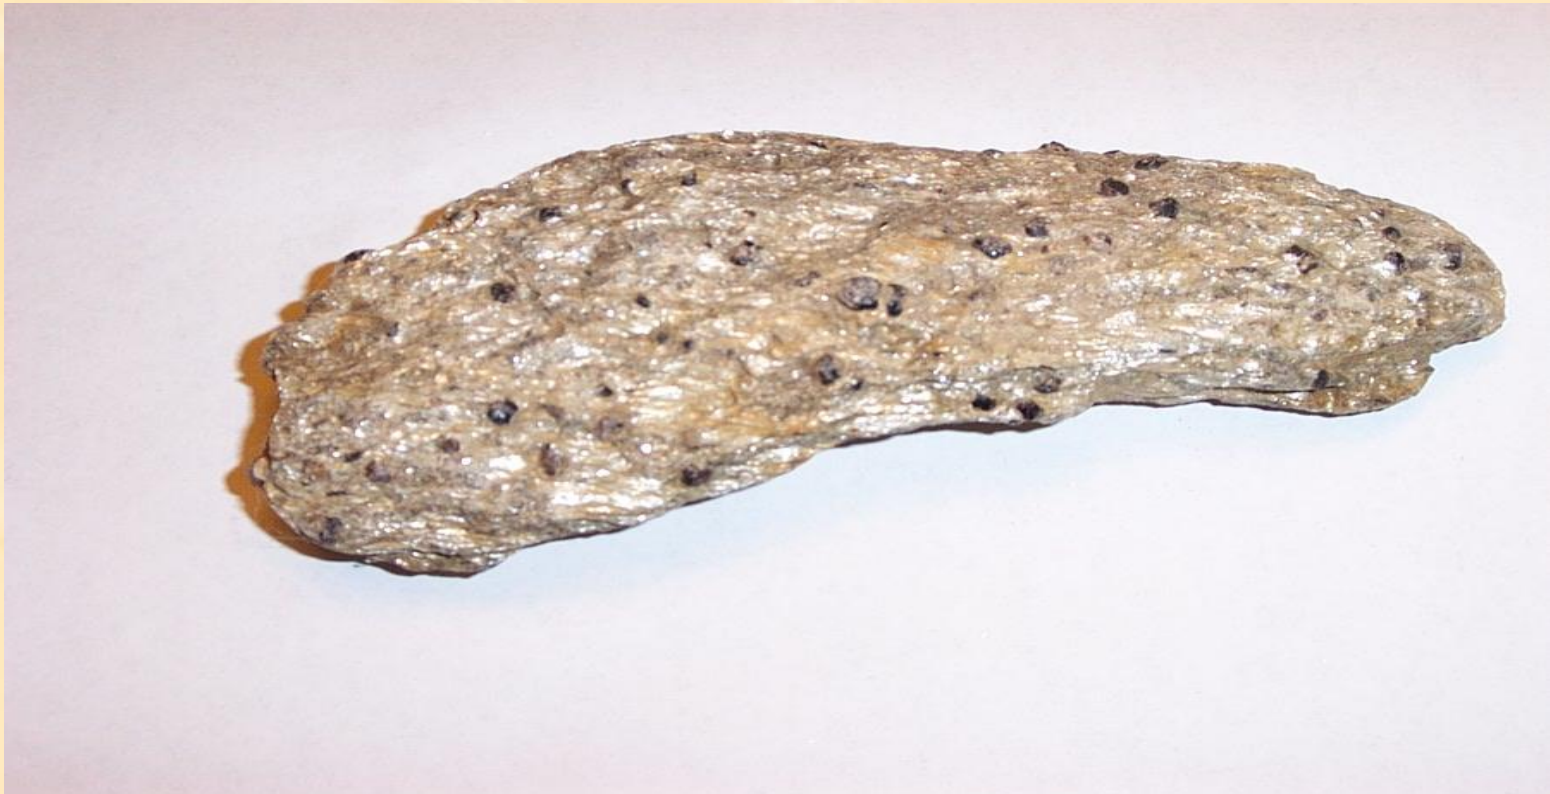
Wissahickon Fm.

- No longer mapped in MD
- Type section in Philadelphia
- Easily excavated near surface (saprolite)
- Excavation bid document

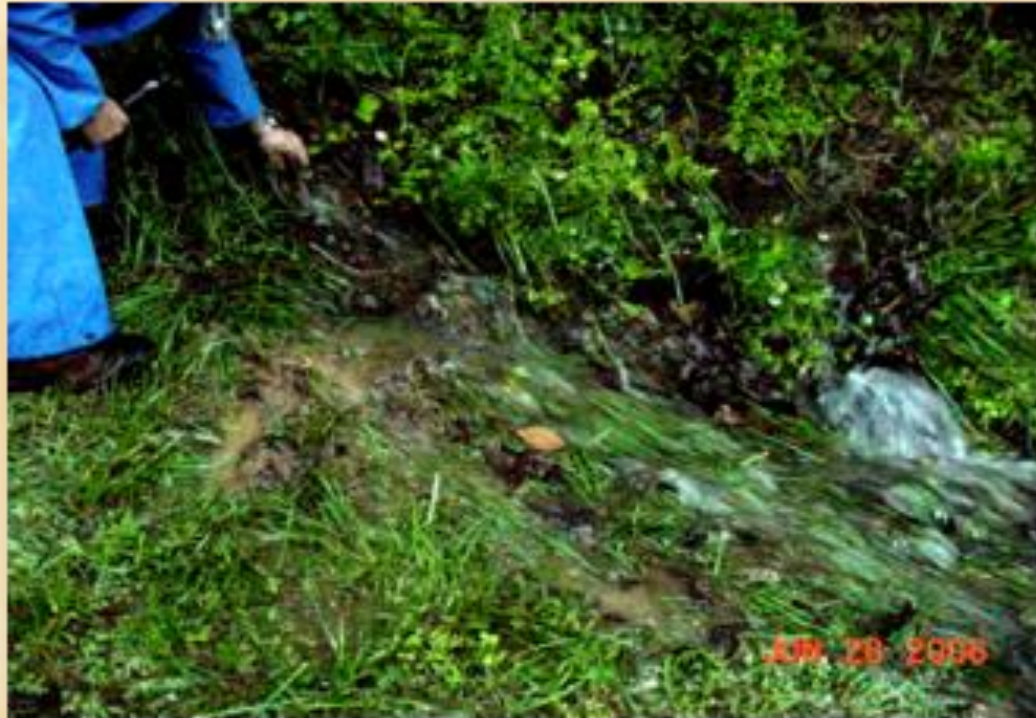
Seepage After Extreme Rain Event

- June 26, 2006 - heavy rains (~9 inches) resulted in a 23-foot rise in water level in the lake.
- June 28, 2006 – dam staff observed uncontrolled, concentrated seepage emanating from left abutment/embankment area (300 GPM), along with soil particles. This had significant potential for “piping failure”.

- Fracture flow through foundation rock;
- Flow through abutments;
- Flow through rock/embankment contact;
- Flow through embankment defects;
- Ineffectiveness of downstream blanket drain;
and
- Flow over the core in the dam
